July 14, 2022

RE: Outside Building 16 East
Structural Assessment
Jamestown, ND 58401
Project Number: EC22-04-219

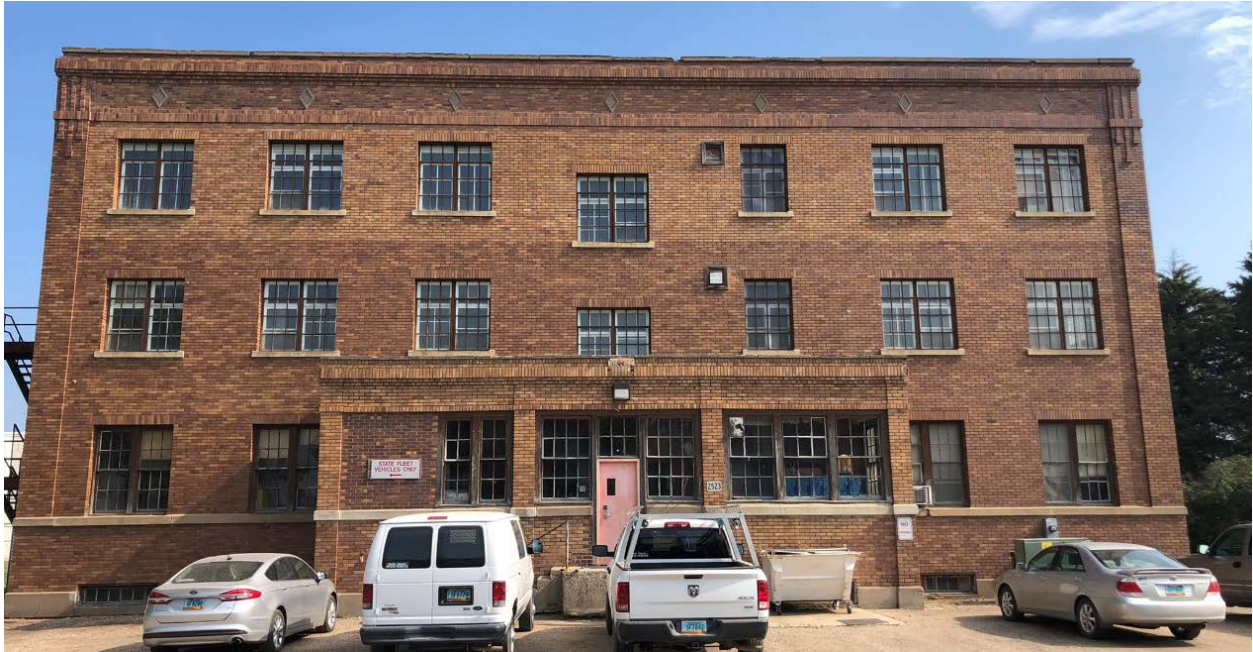
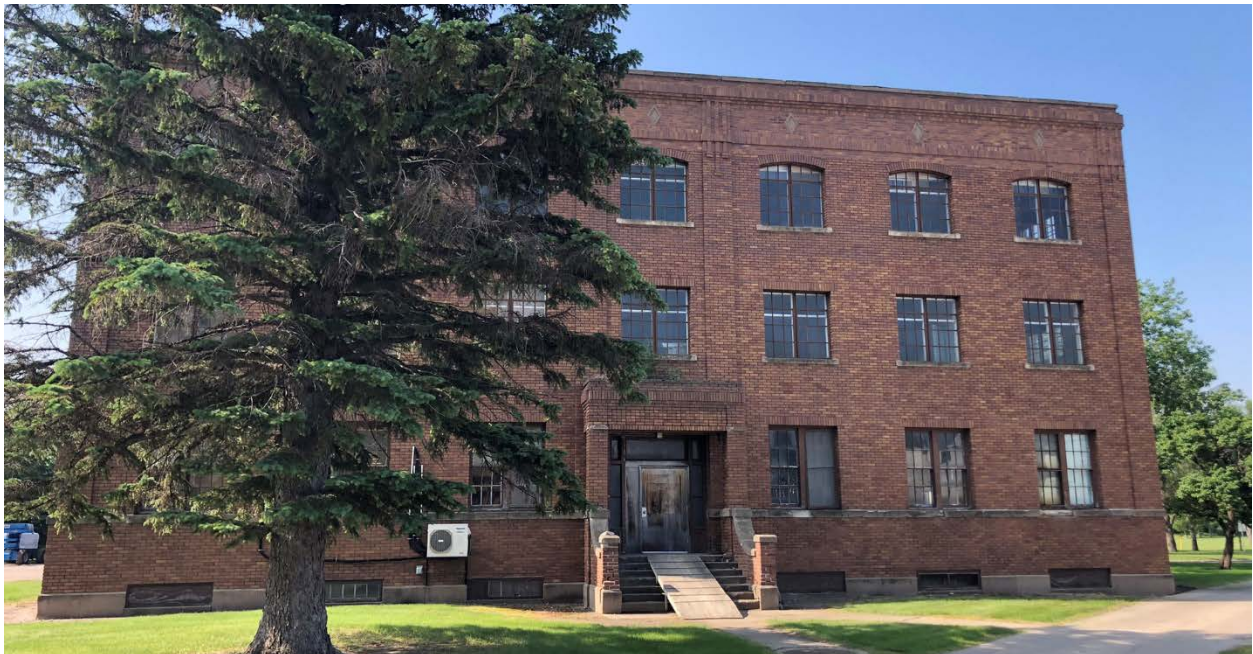
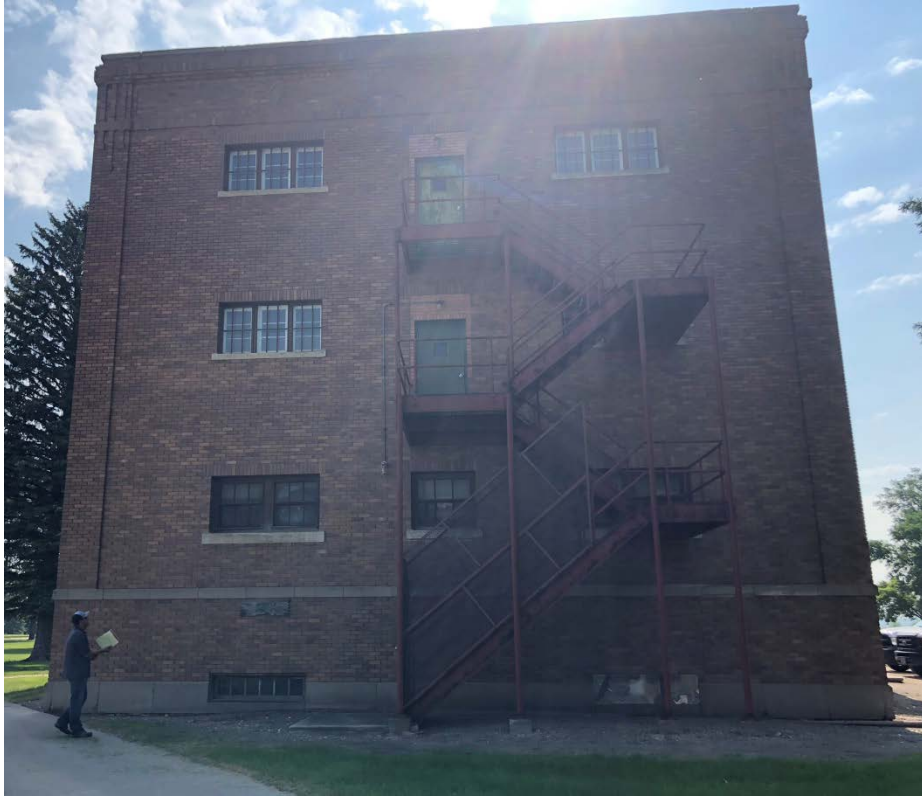
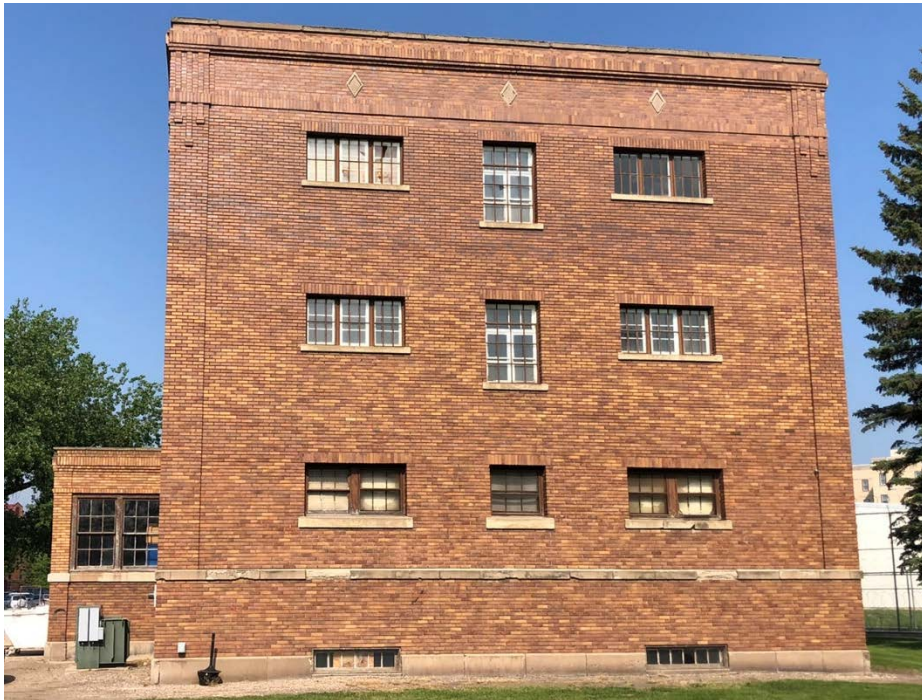
- The exterior of the building is in poor condition. **Image 1A-1D** show the side elevation views of the building. The brick mortar joints are in bad condition with some bricks starting to be loose. To repair this condition the brick walls should be tuckpointed on all sides of the structure.
- The roof is in bad condition, and needs to be replaced.
- Many of the windows are cracked or damaged and all of them need to be replaced. **Image No. 2** below shows damaged window and windowsills.
- All entrances front, rear, and the fire escape need improvements. The doors need to be replaced, and there is structural damage to the brick where tuckpointing and replacement is required. **Image No. 3** shows the damages to the front and rear entrances.

Image 1A: Building 16 East (South Elevation)

Image 1B: Building 16 East (North Elevation)

Image 1C: Building 16 East (West Elevation)

Image 1D: Building 16 East (East Elevation)

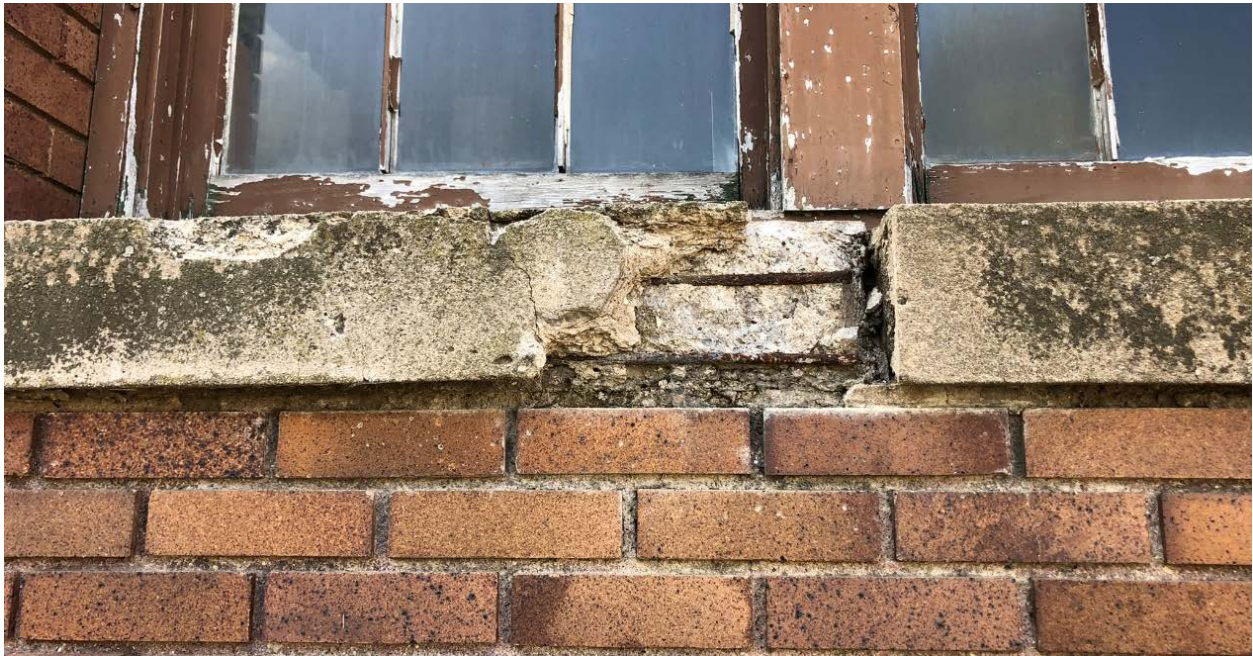
Image 2: Damaged Window and Window Sill

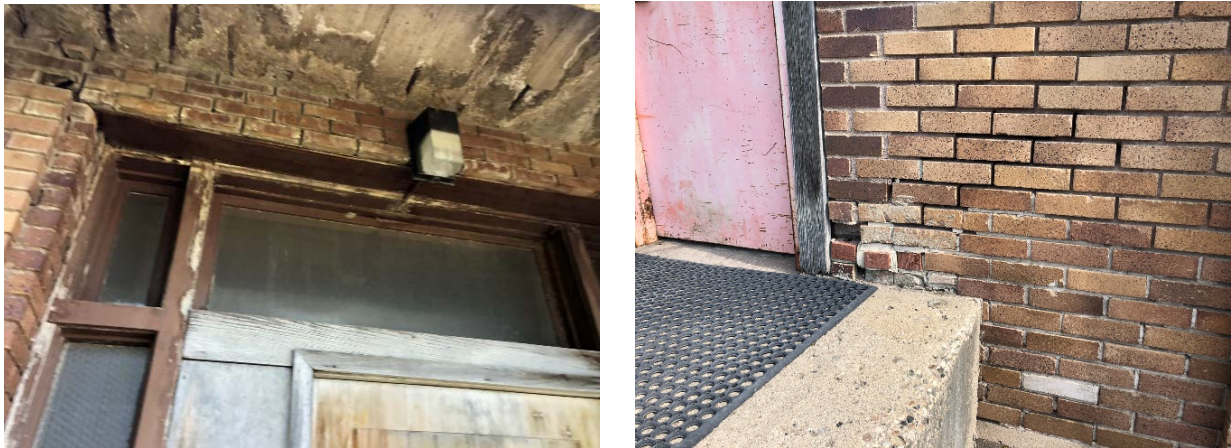
Image 3: North Entrance (Left) South Entrance (Right)

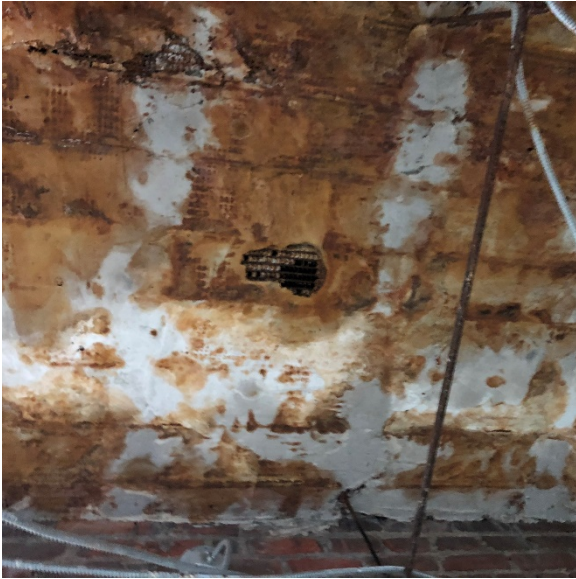
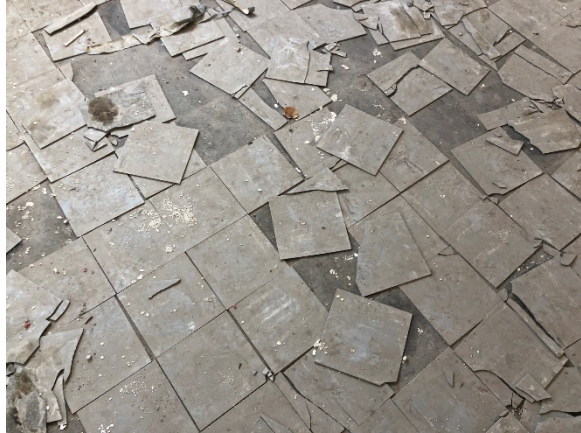
- The third floor has reached its useful life and needs to be repaired before it can be occupied and used. The ceiling walls and flooring are crumbling and needs to be removed and replaced.
- Due to the age of the facility, it is likely that there is asbestos and lead paint in this space.
- Many of the radiators have been removed or are inoperable. The heating and electrical would need to be renovated to bring it up into current code requirements.
- The bathroom on this floor is not operational.
- This floor would need to be completely renovated to be able to be used. **Image No. 4** shows the conditions of the third floor.

Image 4: Third Floor Ceiling (Left) Flooring (Right)

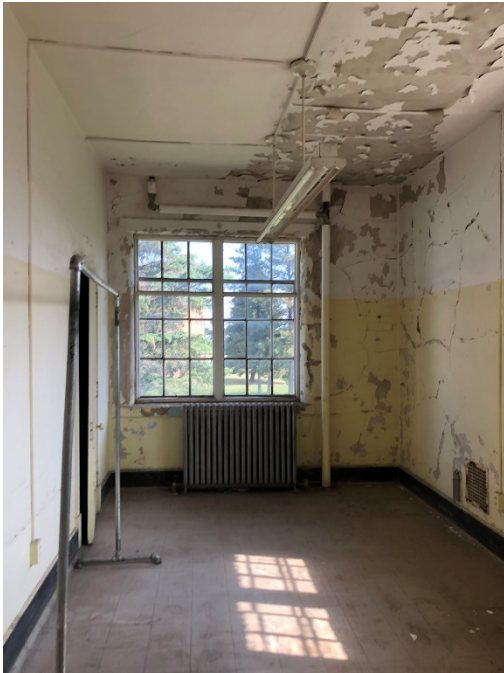
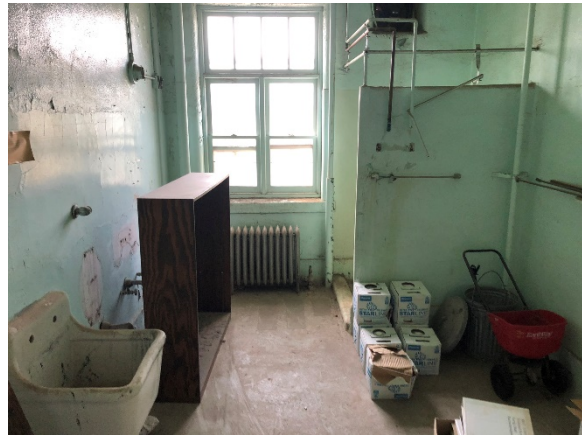
- The second floor is in slightly better condition than the third floor, however it is still in very poor condition. The ceiling, walls, and flooring are damaged throughout the space and needs to be removed and replaced.
- Due to the age of the facility, it is likely that there is asbestos and lead paint in this space.
- The heating and electrical would need to be renovated to bring it up into current code requirements.
- The bathroom on this floor is not operational.

- This floor would need major improvements to be able to useable space for anything other storage. **Image No. 5** shows the conditions of the second floor.

Image 5: Second Floor Ceiling (Left) Flooring (Right)

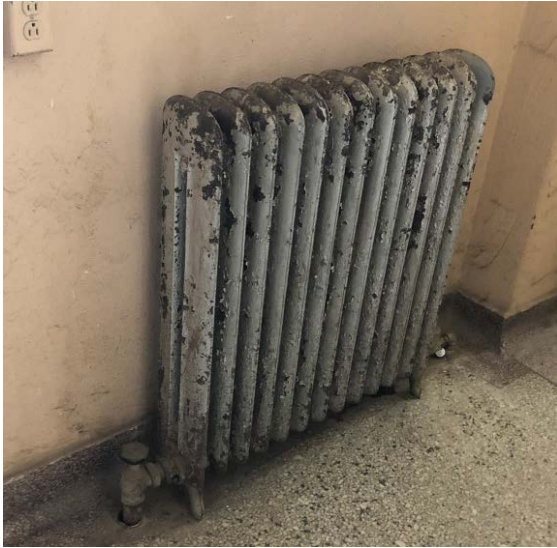
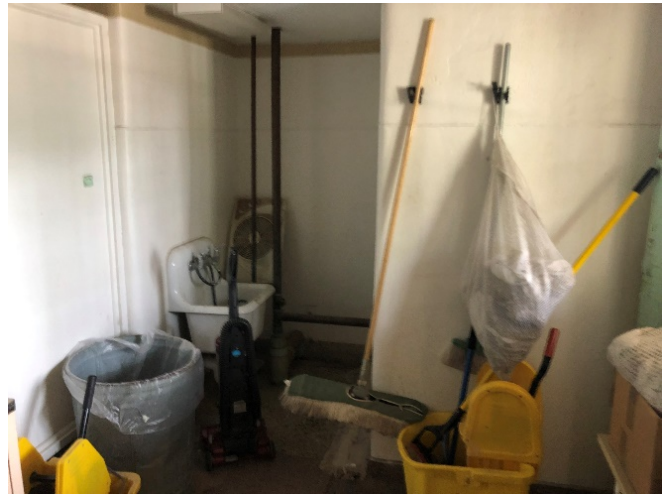
- The first floor is in the best condition of all the floors; however it is still in poor condition.
- This has the only functioning bathroom in the building, however it needs improvements, and is not handicap accessible.
- The radiators are old and need to upgrade.
- The floors walls and ceilings on this floor are in fair condition considering the age of the facility.
- This space would need minor improvements. **Image No. 6** shows the conditions of the first floor.

Image 6: First Floor Radiator (Left) Bathroom (Right)

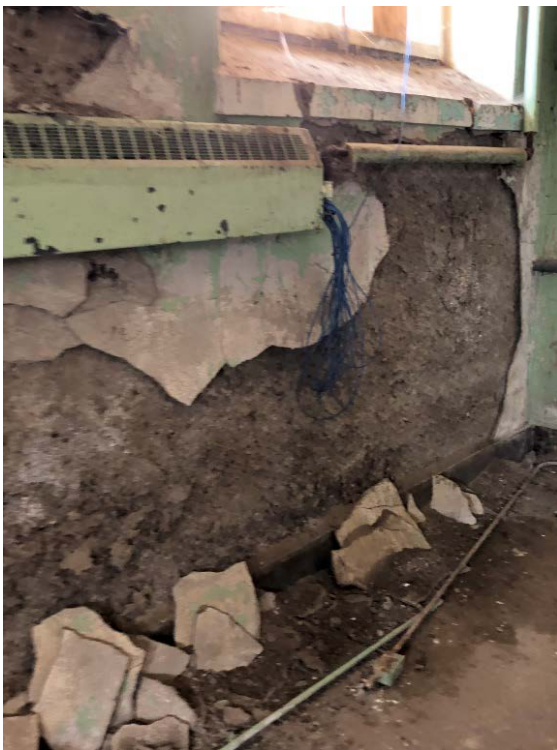
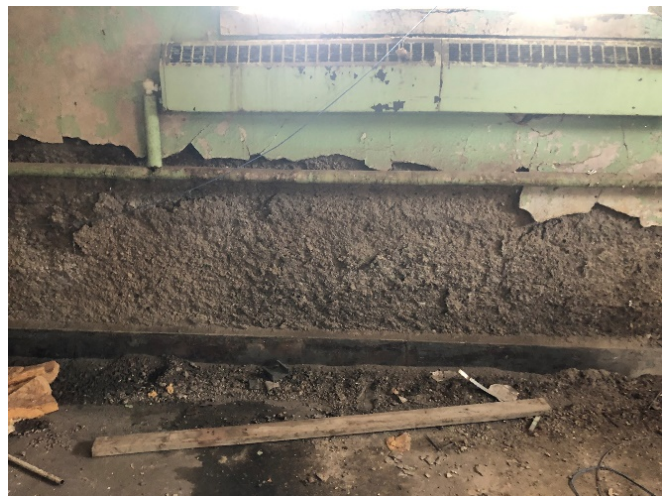
- The basement is currently in poor condition. There are several areas where the concrete foundation wall is starting to decay as seen in **Image 7** below.
- There is exposed rebar in the porch floor as seen in **Image 8** below.
- The foundation of the building has structural concerns and needs to be repaired.

Image 7: Damaged Foundation Wall

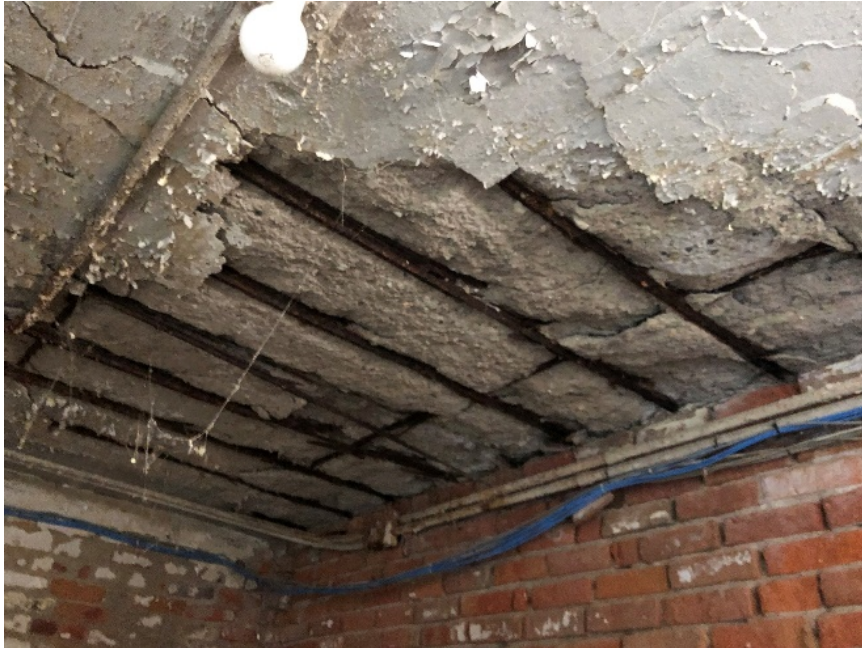
Image 8: Exposed Rebar in Basement
