**ICON**  
ARCHITECTURAL GROUP

**FACILITY ASSESSMENT FOR  
NORTH DAKOTA YOUTH CORRECTIONAL CENTER  
PHYSICAL PLANT**

Mandan, ND | July 2024

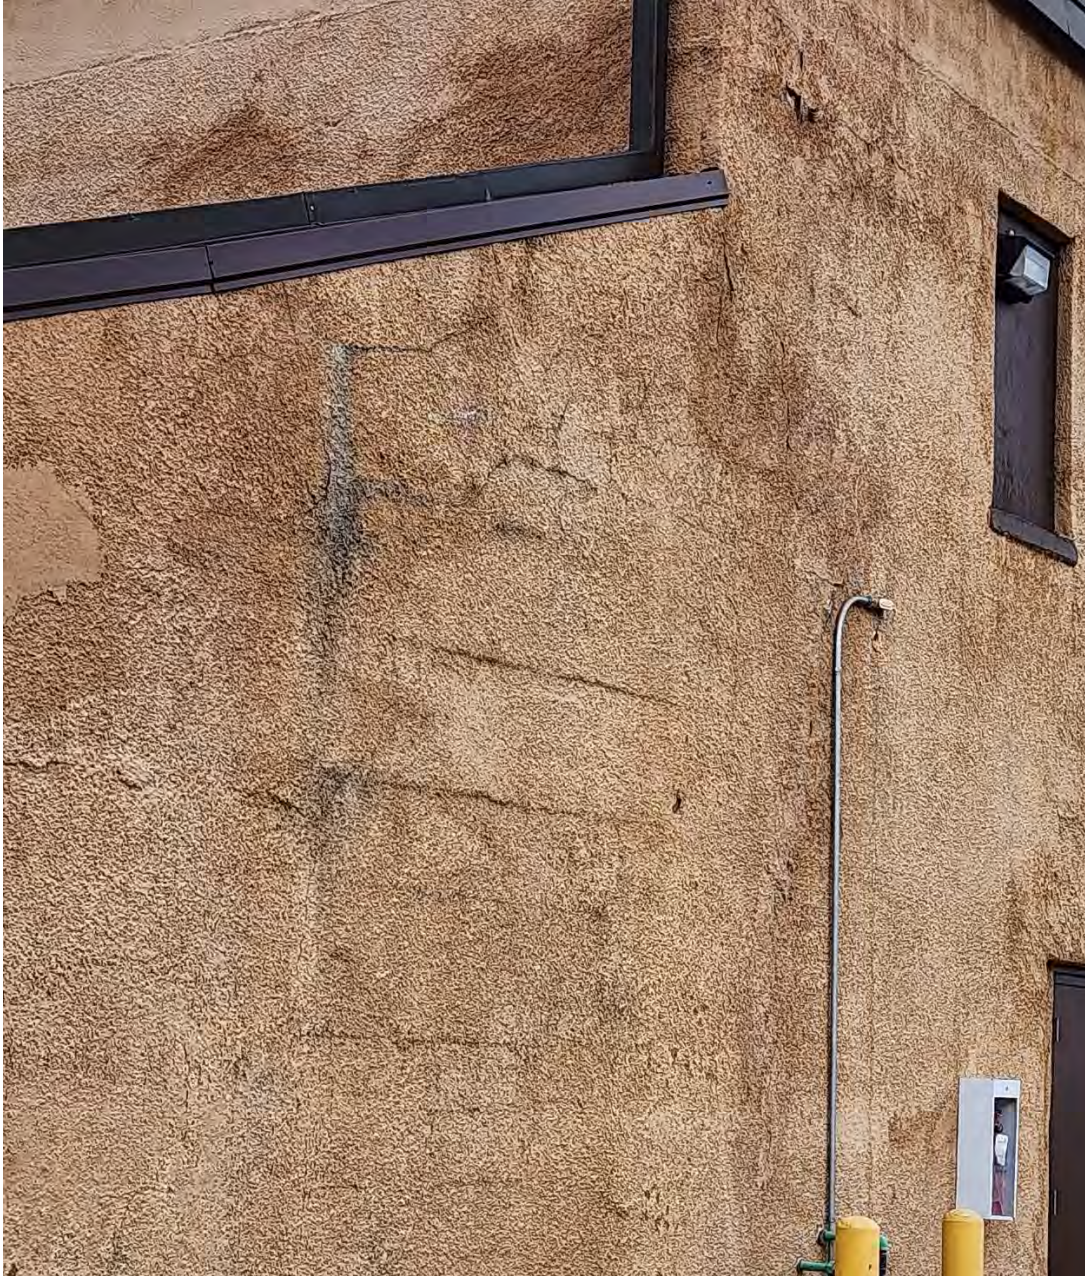
Exterior EIFS in poor condition.  
Extensive cracking and evidence of water infiltration causing material failure.  
(Photo: 20240216\_143818)

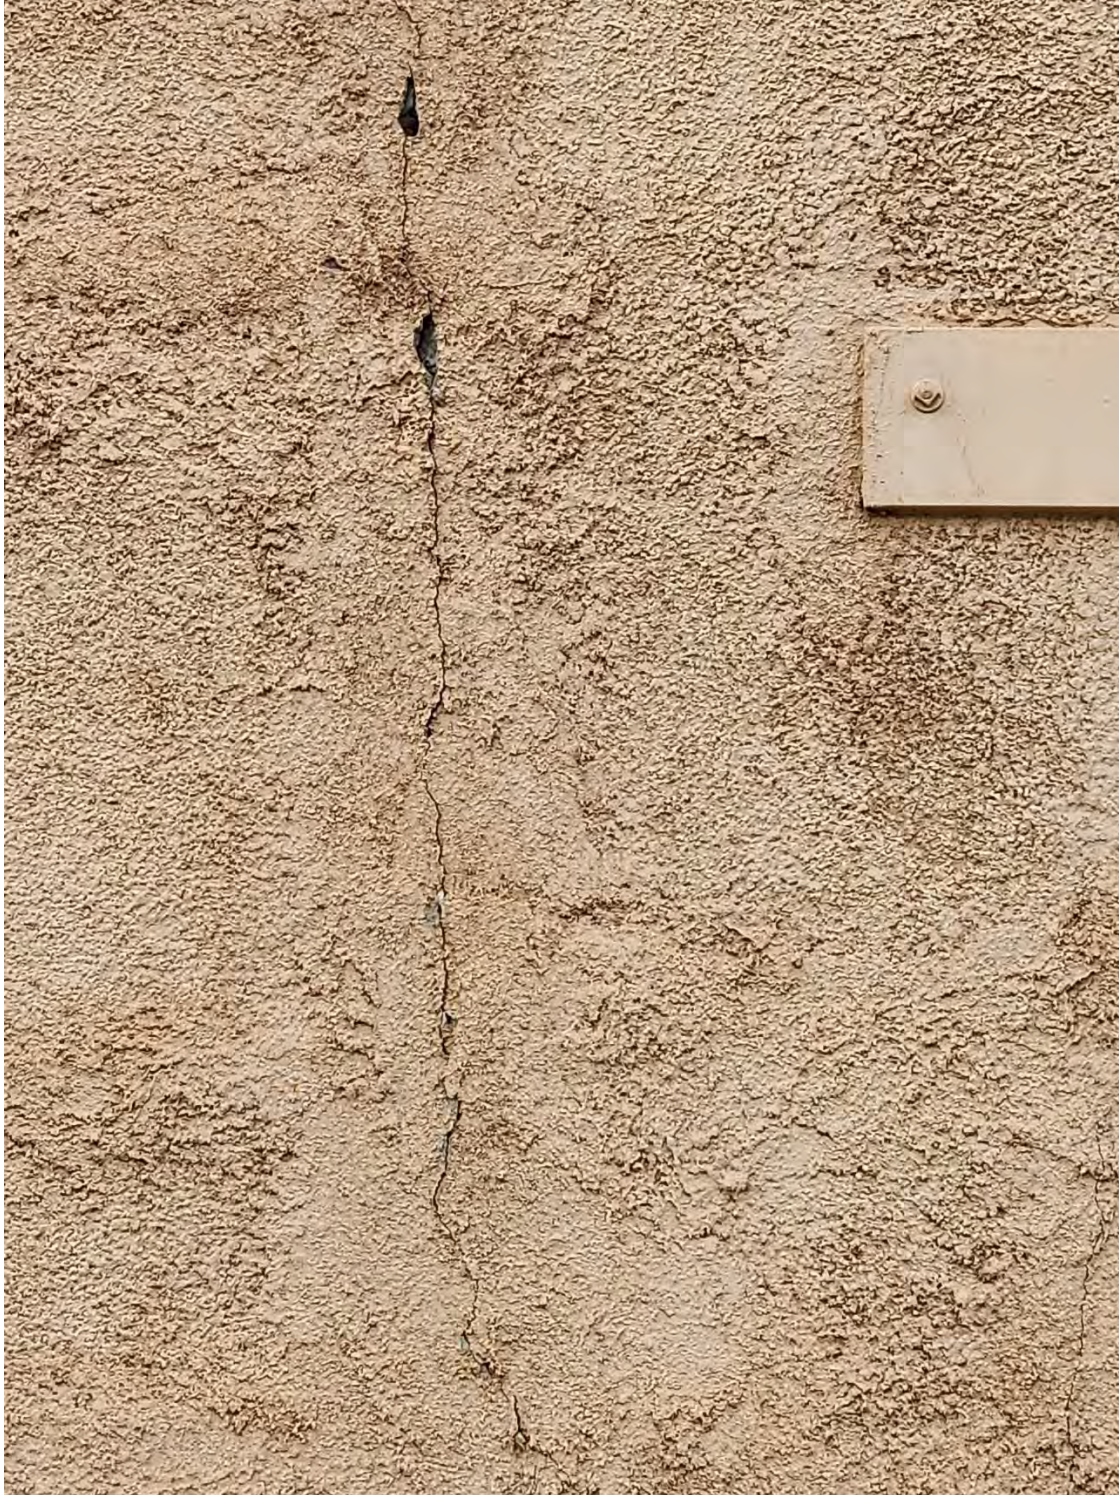
Exterior EIFS in poor condition.  
Extensive cracking and evidence of water infiltration causing material failure.  
(Photo: 20240216\_143856)

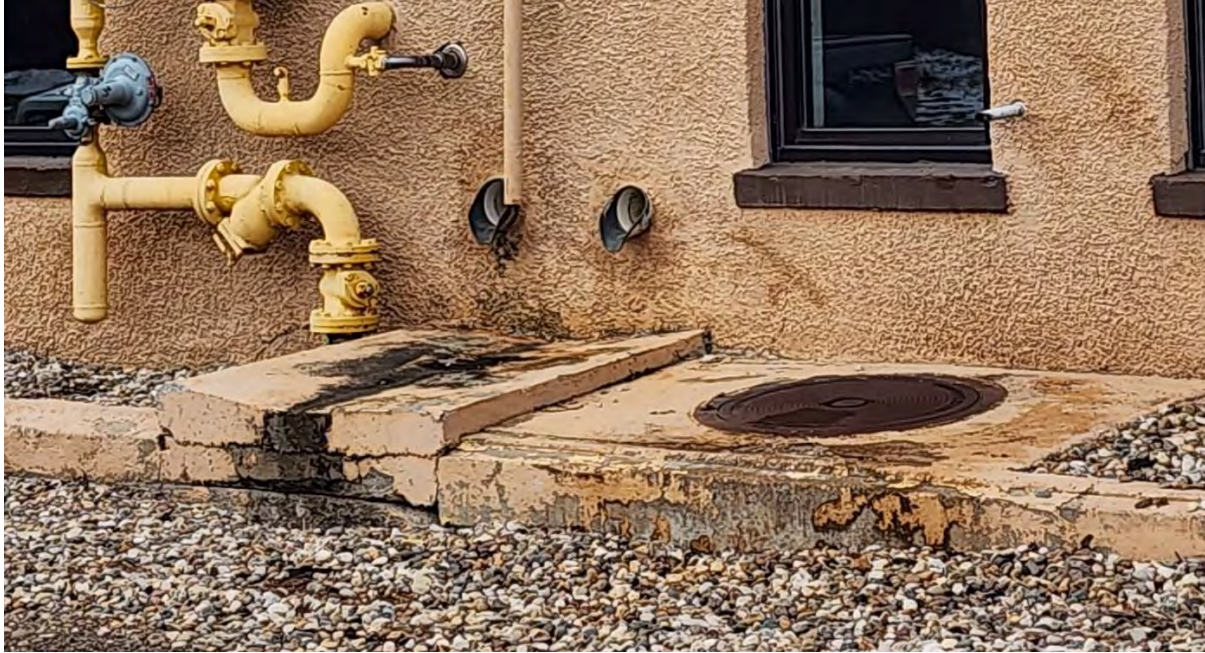
Exterior drainage along wall and foundation in poor condition.  
Evidence of water infiltration.  
(Photo: 20240216\_1440009)

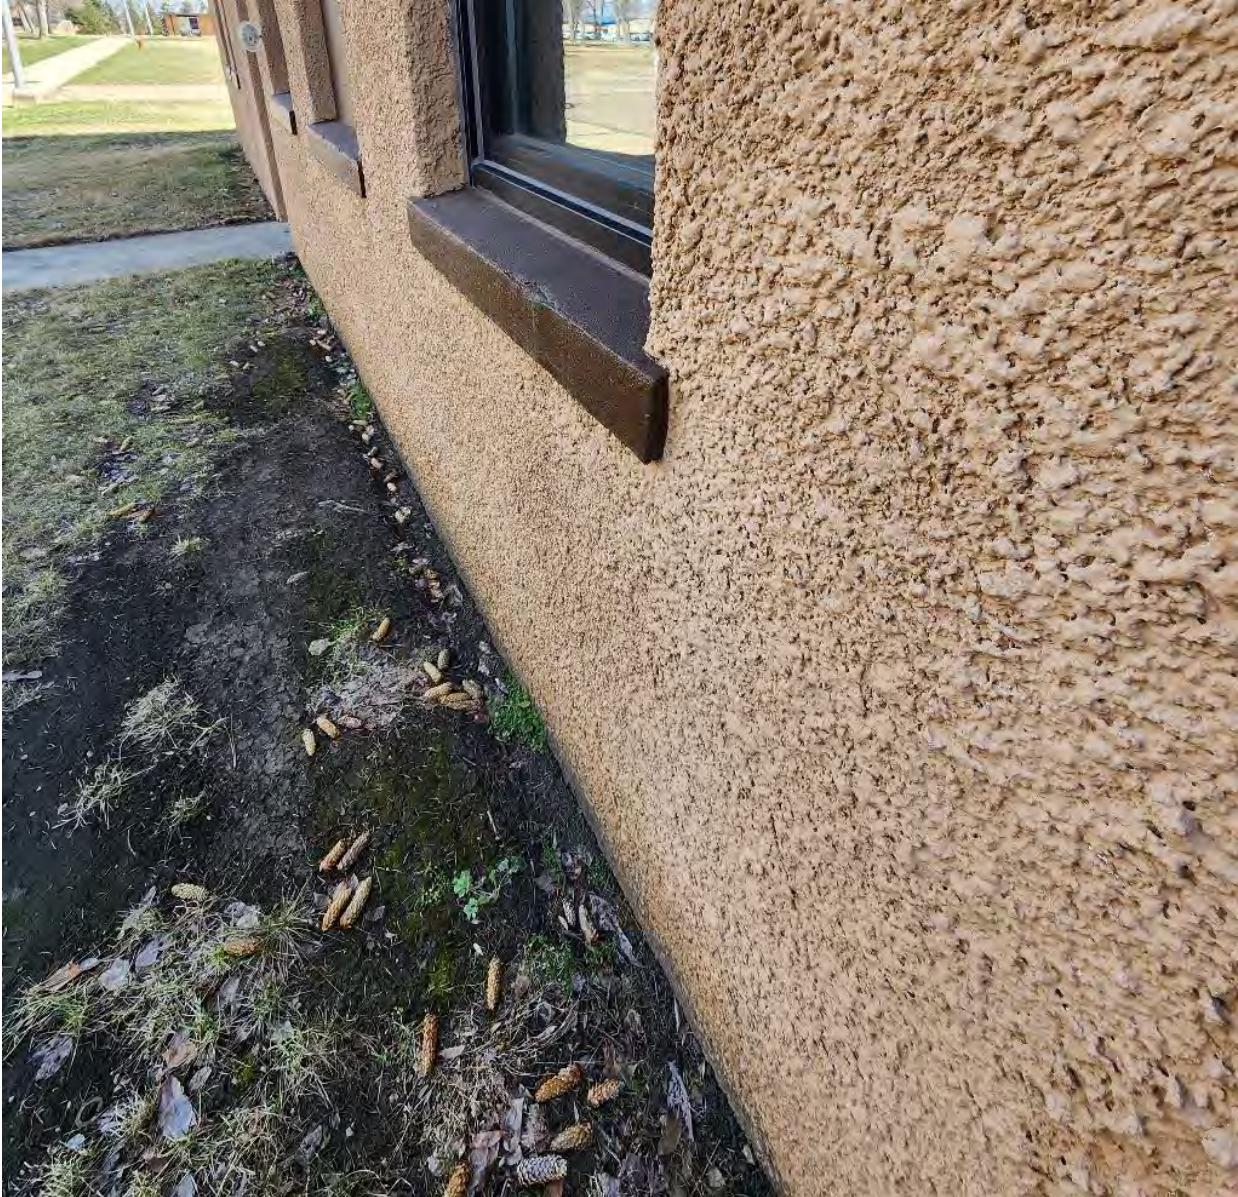
Exterior drainage along the wall and foundation in poor condition.  
Evidence of water sitting along the foundation wall.  
(Photo: 20240411\_145949)

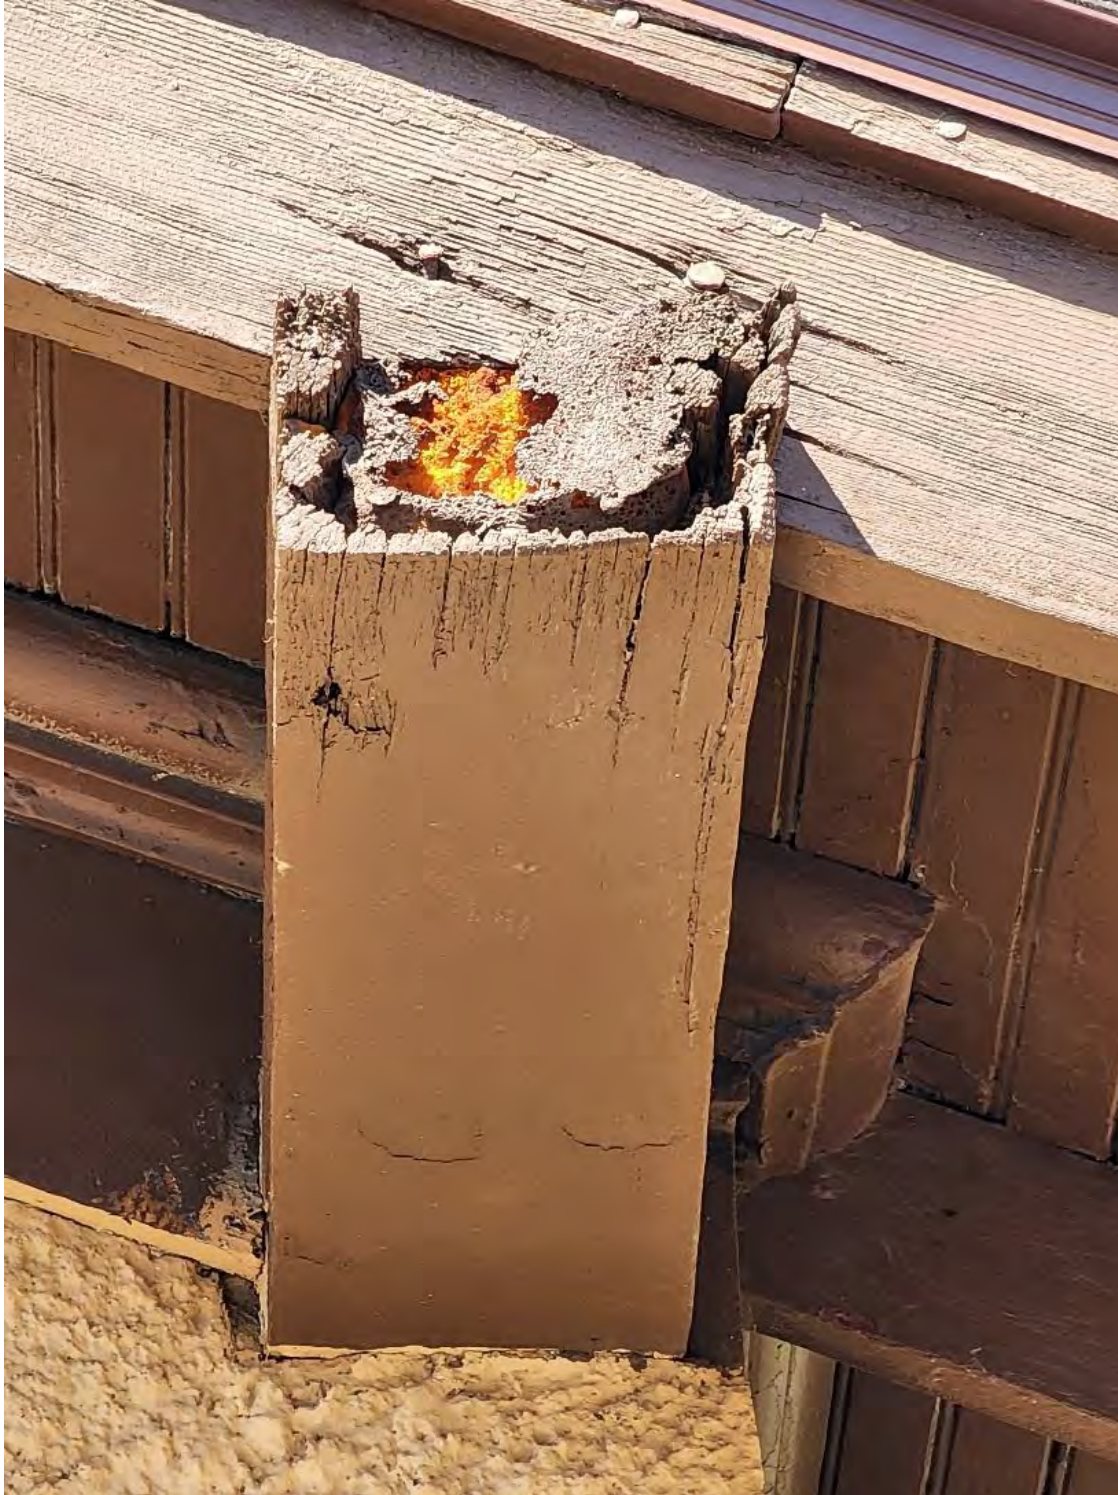
Exposed wood framing, including structural beams, are showing signs of decay and rotting. Structural failure has not occurred but is impending with the visibly poor condition of the wood beams.

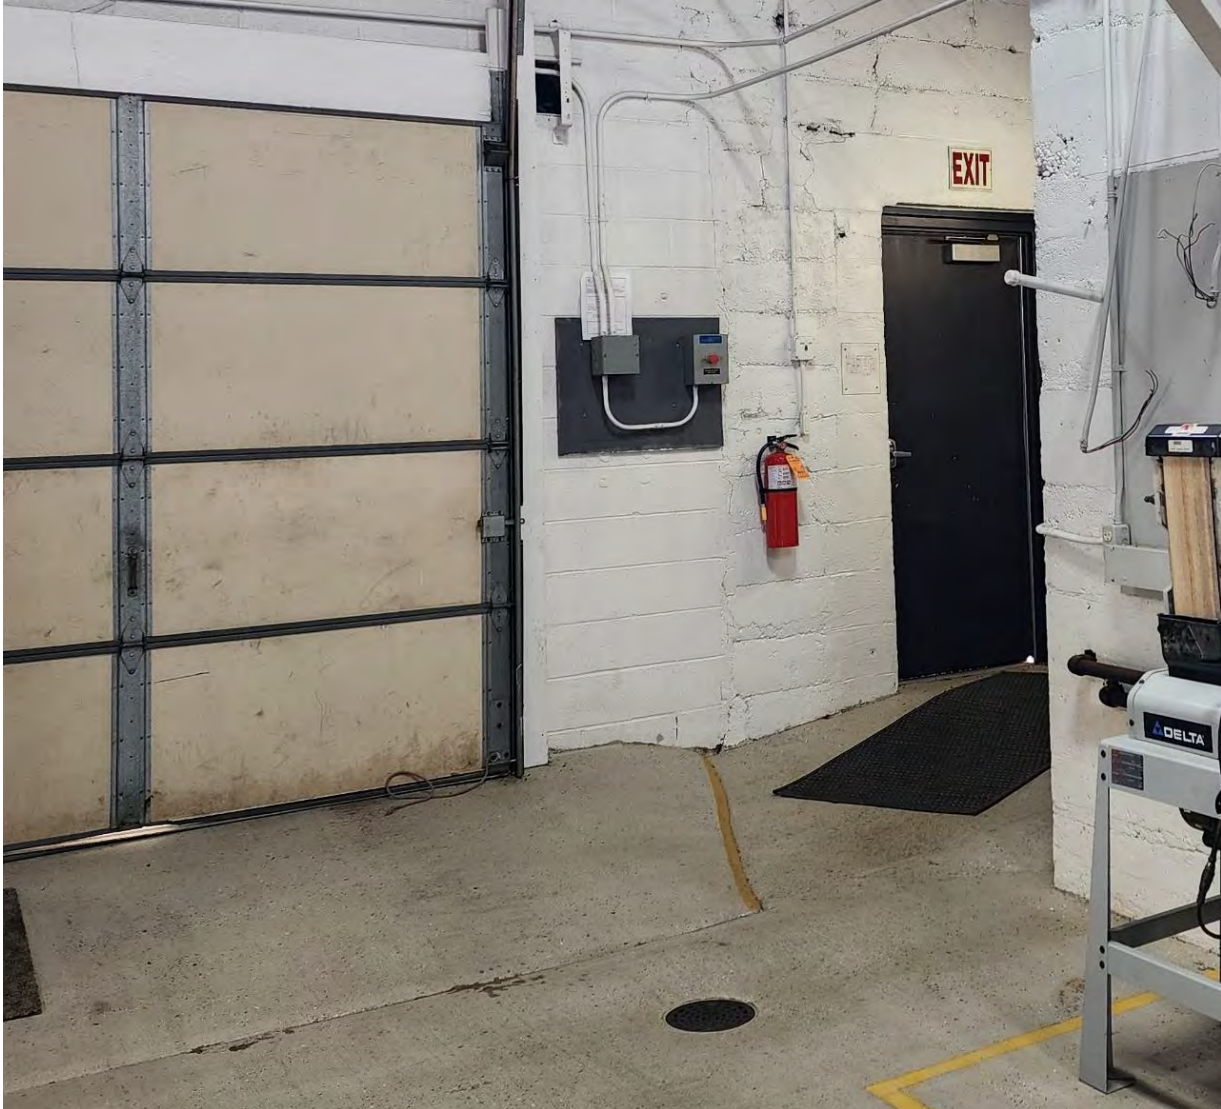
Uneven floor conditions not meeting ADA requirements.

Poor condition of interior CMU walls.

Daylight evident at doors.

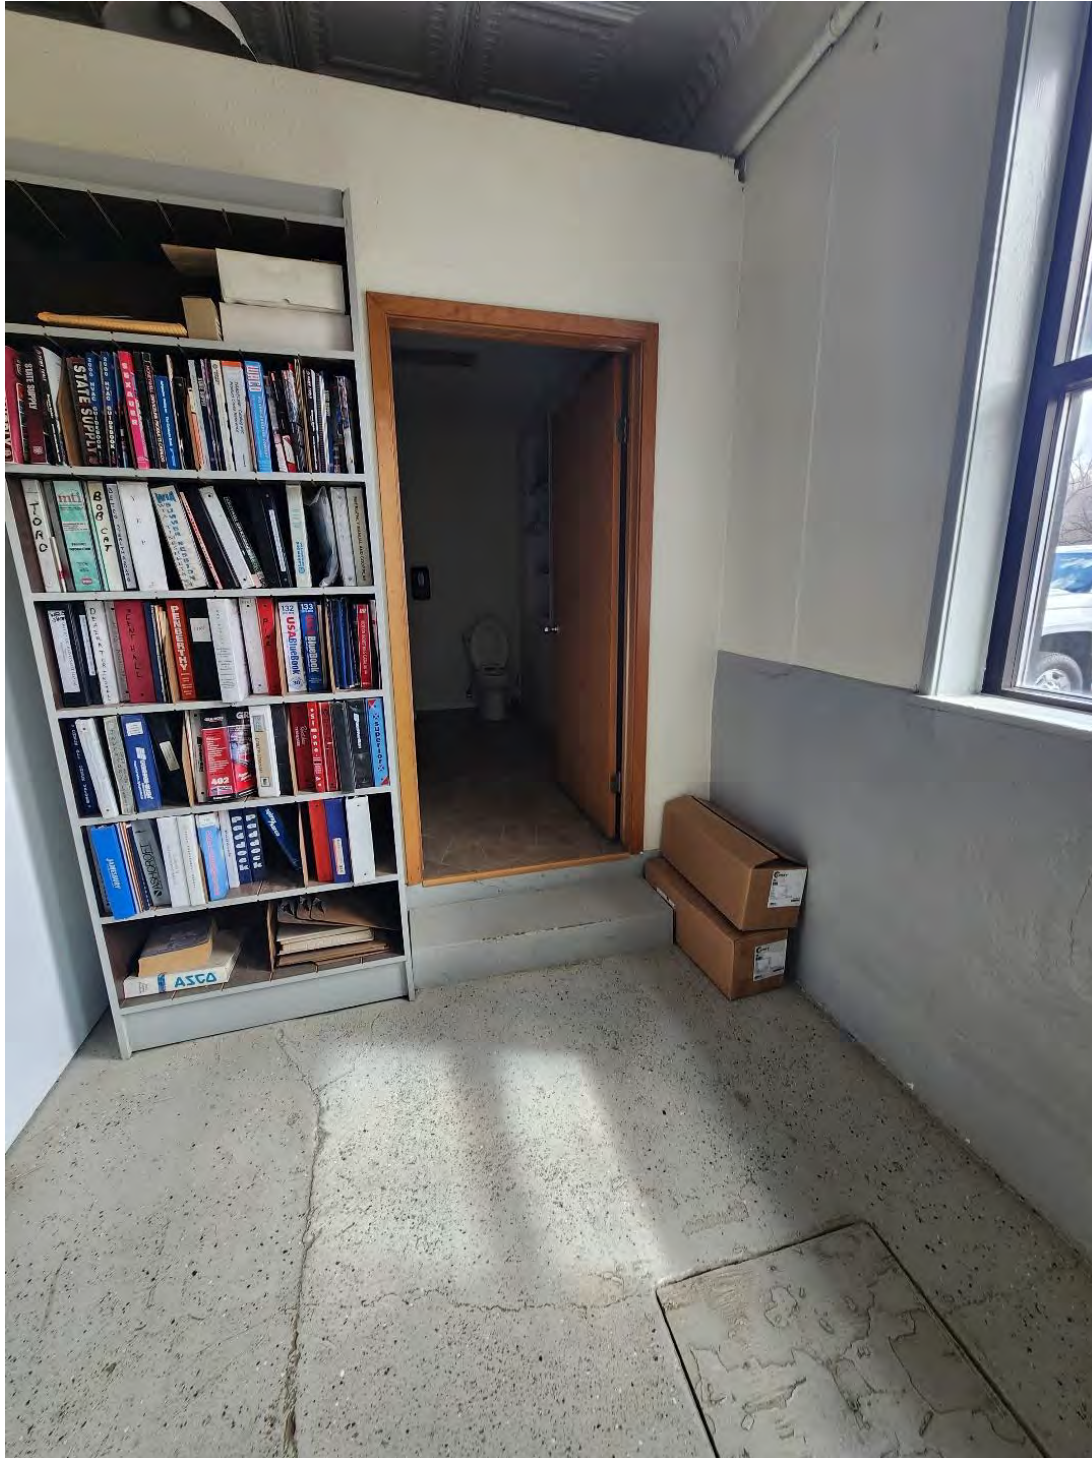
Restroom access does not meet ADA requirements.  
Wall does not extend to bottom of roof structure above.  
Extensive floor slab cracking  
(Photo: 20240216\_142755)

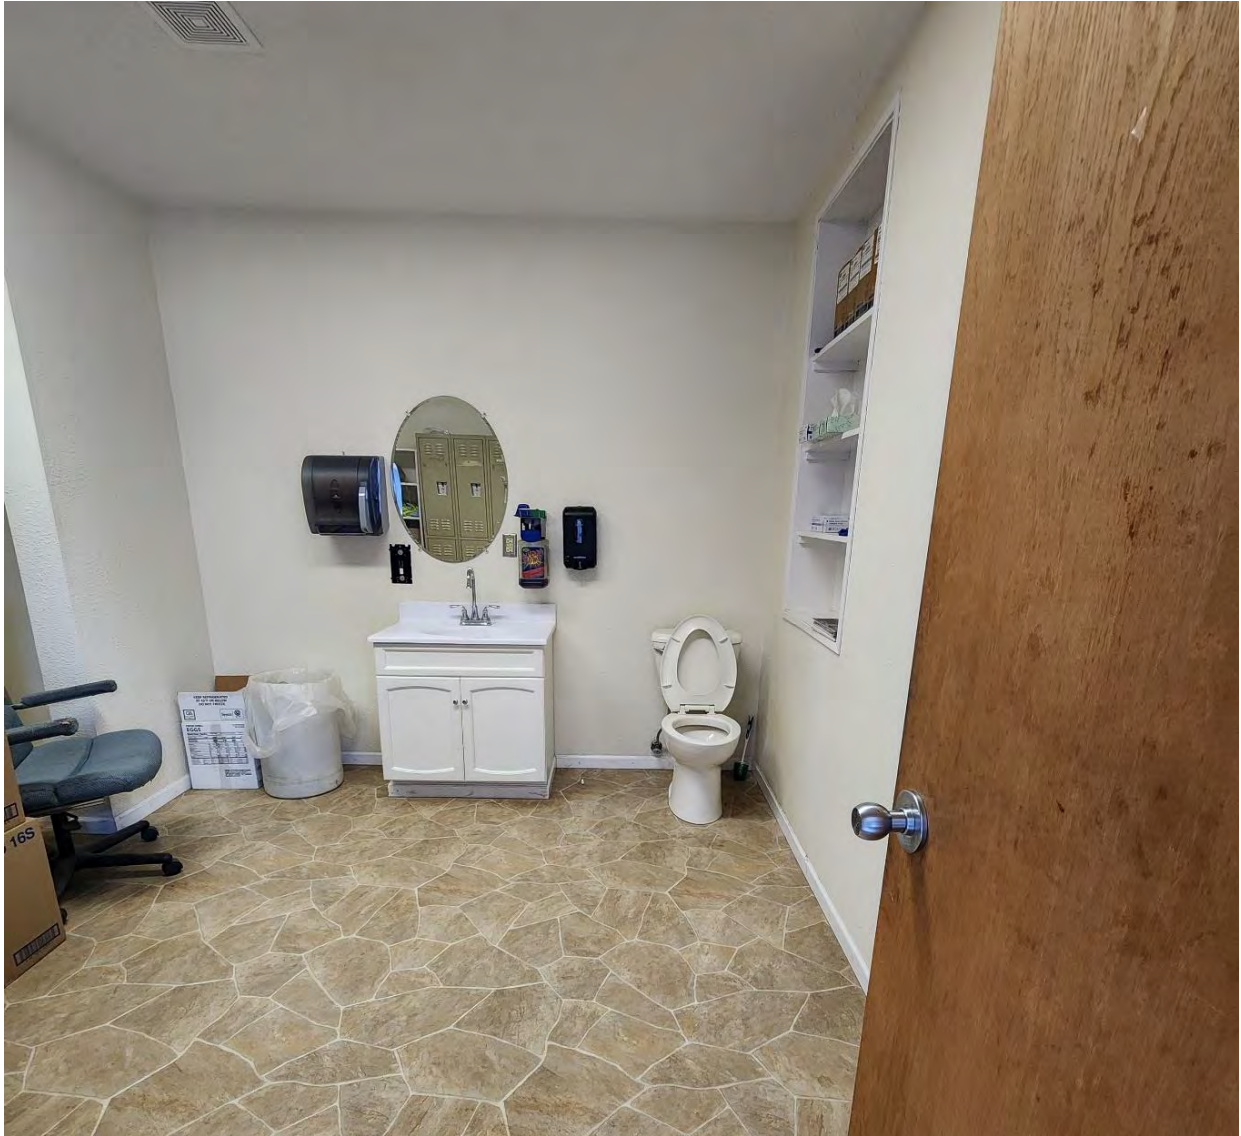
Restroom fixtures do not meet ADA requirements.  
No grab bars as required by ADA.  
Door hardware does not meet ADA requirements.  
(Photo: 20240411\_142814)

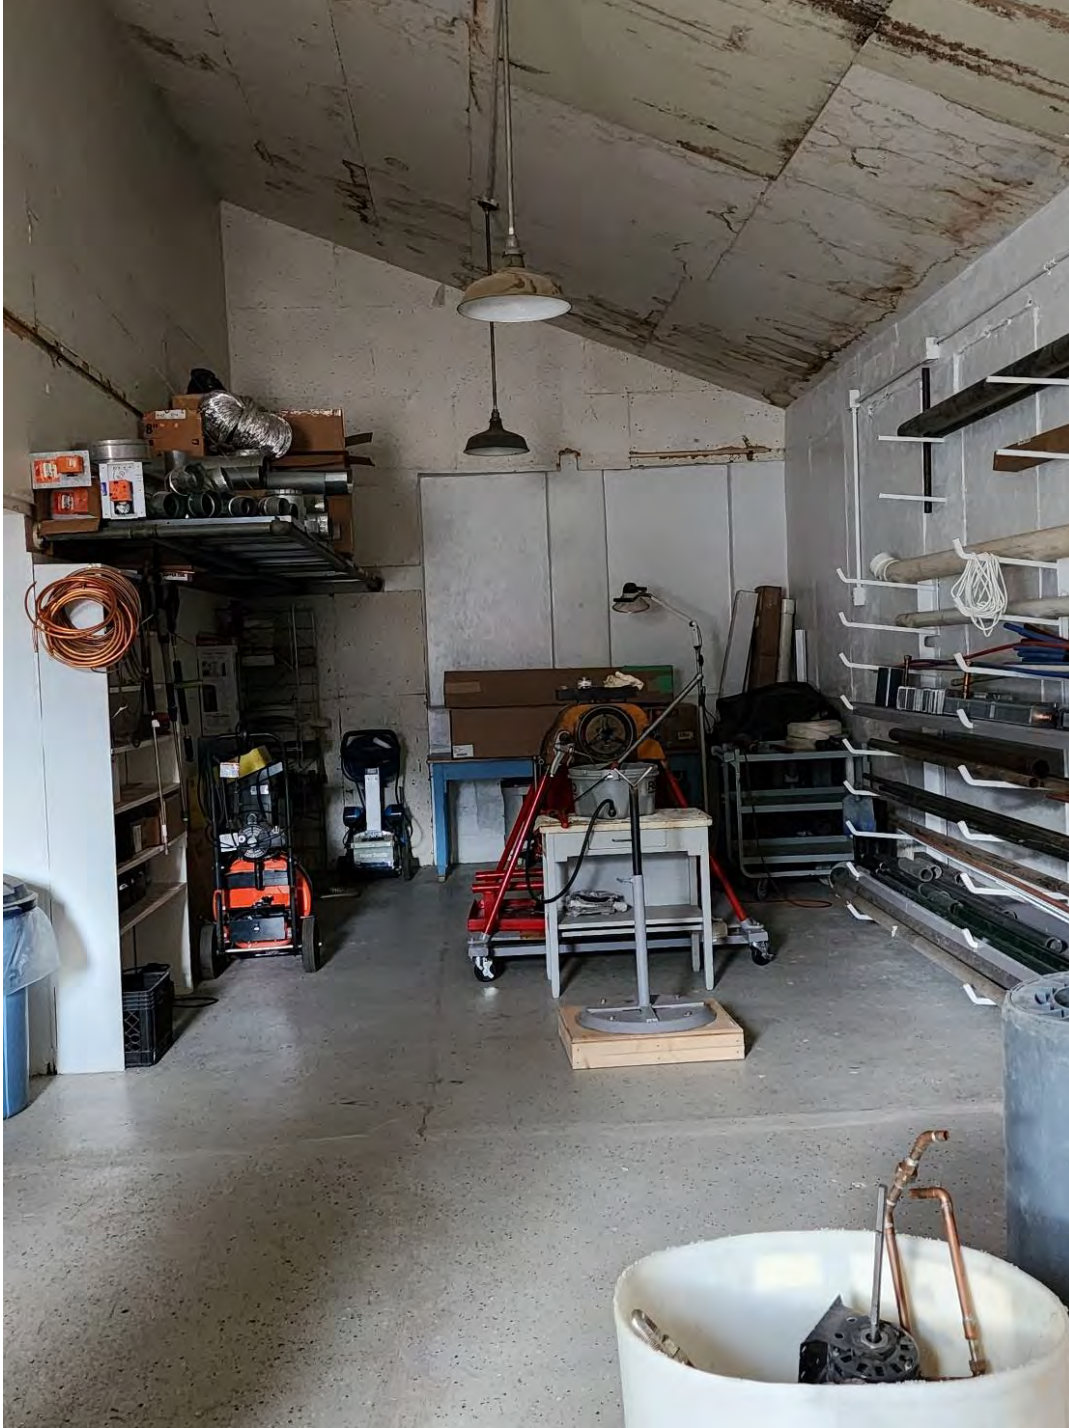
Improper ceiling material and installation.  
Extensive water damage on ceiling.  
Evidence of mold – not tested.  
No fire suppression.  
(Photo: 20240216\_142237)

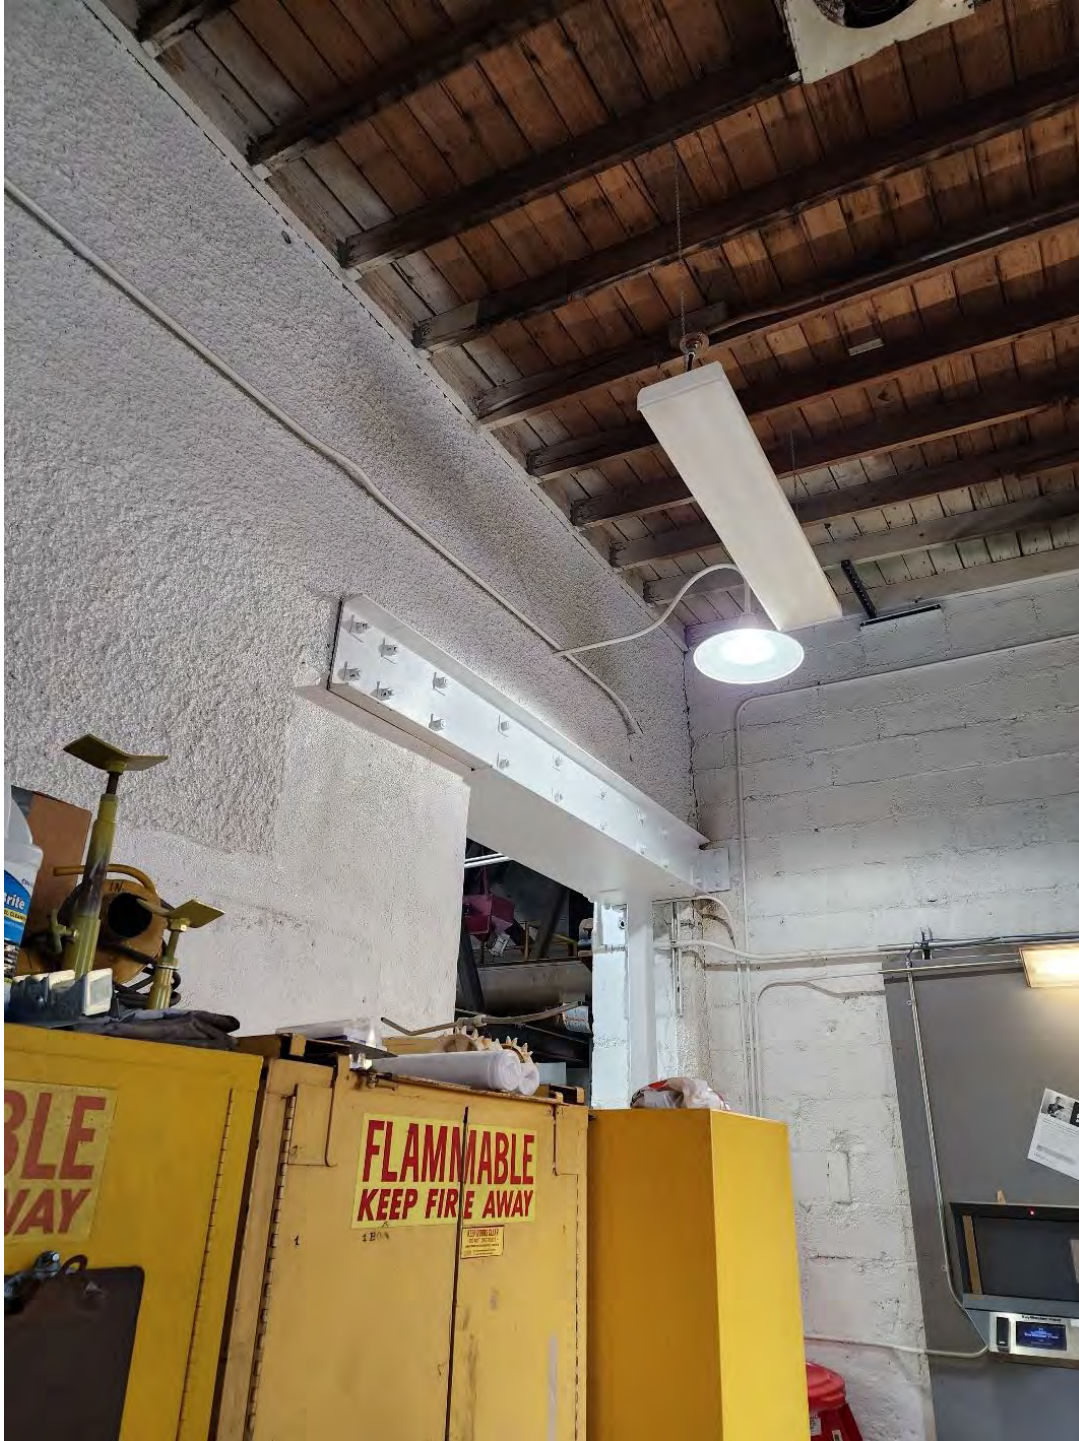
Unprotected ceiling structure.  
Interior walls in poor condition.  
No fire suppression.  
(Photo: 20240216\_141519)

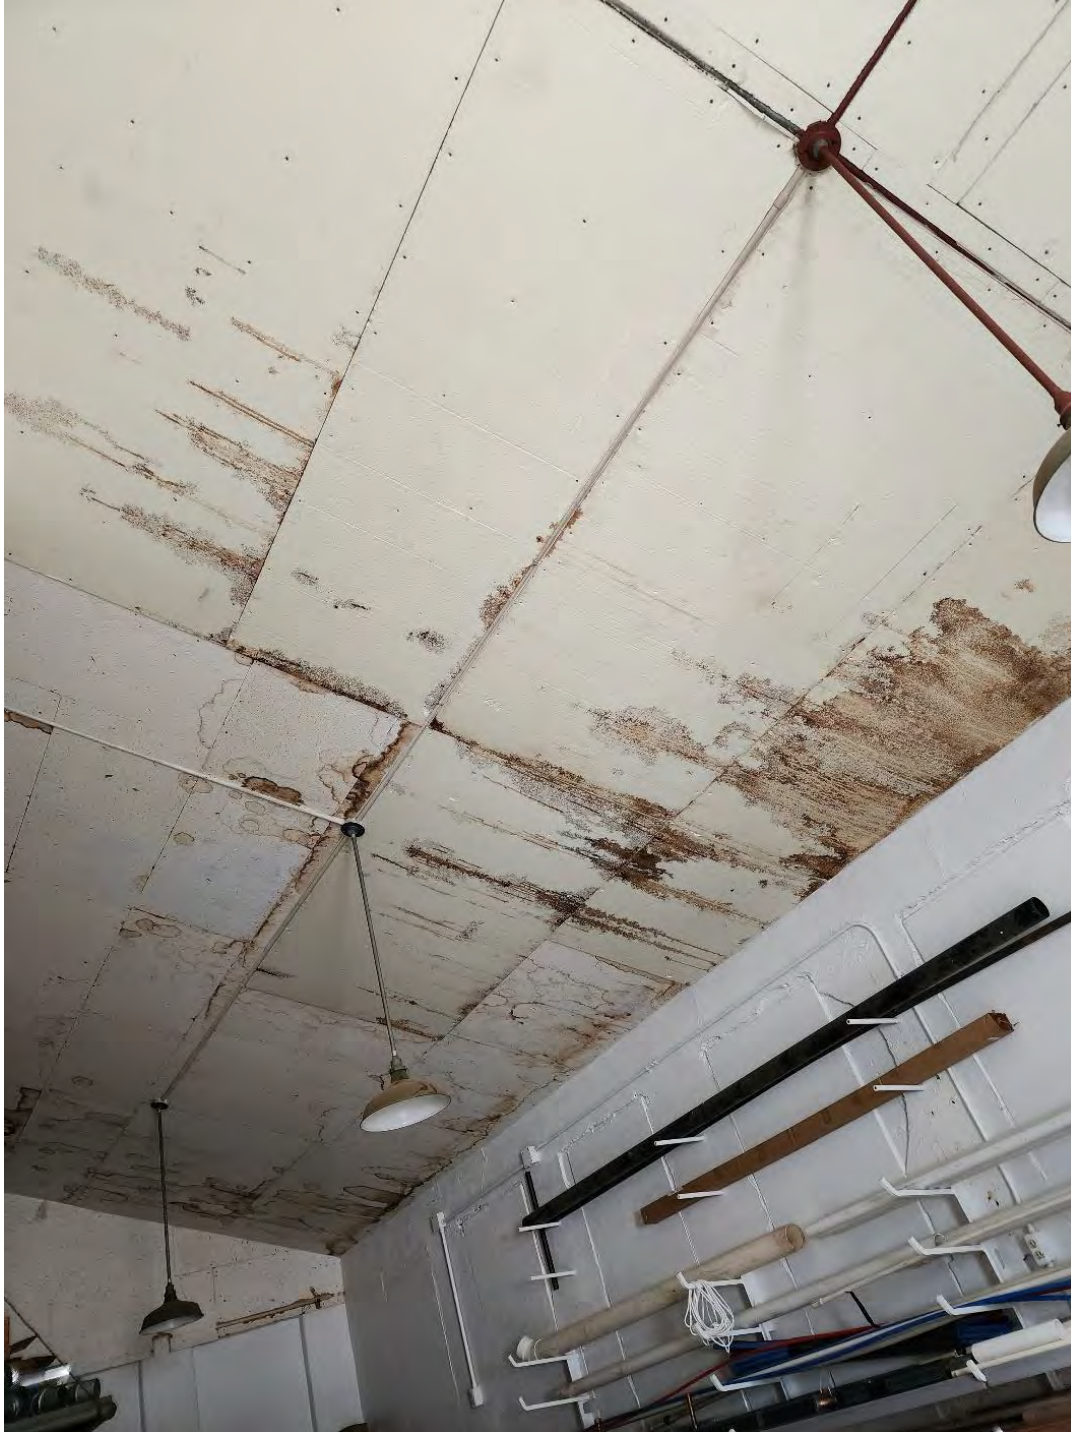
Extensive water damage on ceiling.  
Evidence of mold – not tested.  
No fire suppression.  
(Photo: 20240216\_142137)

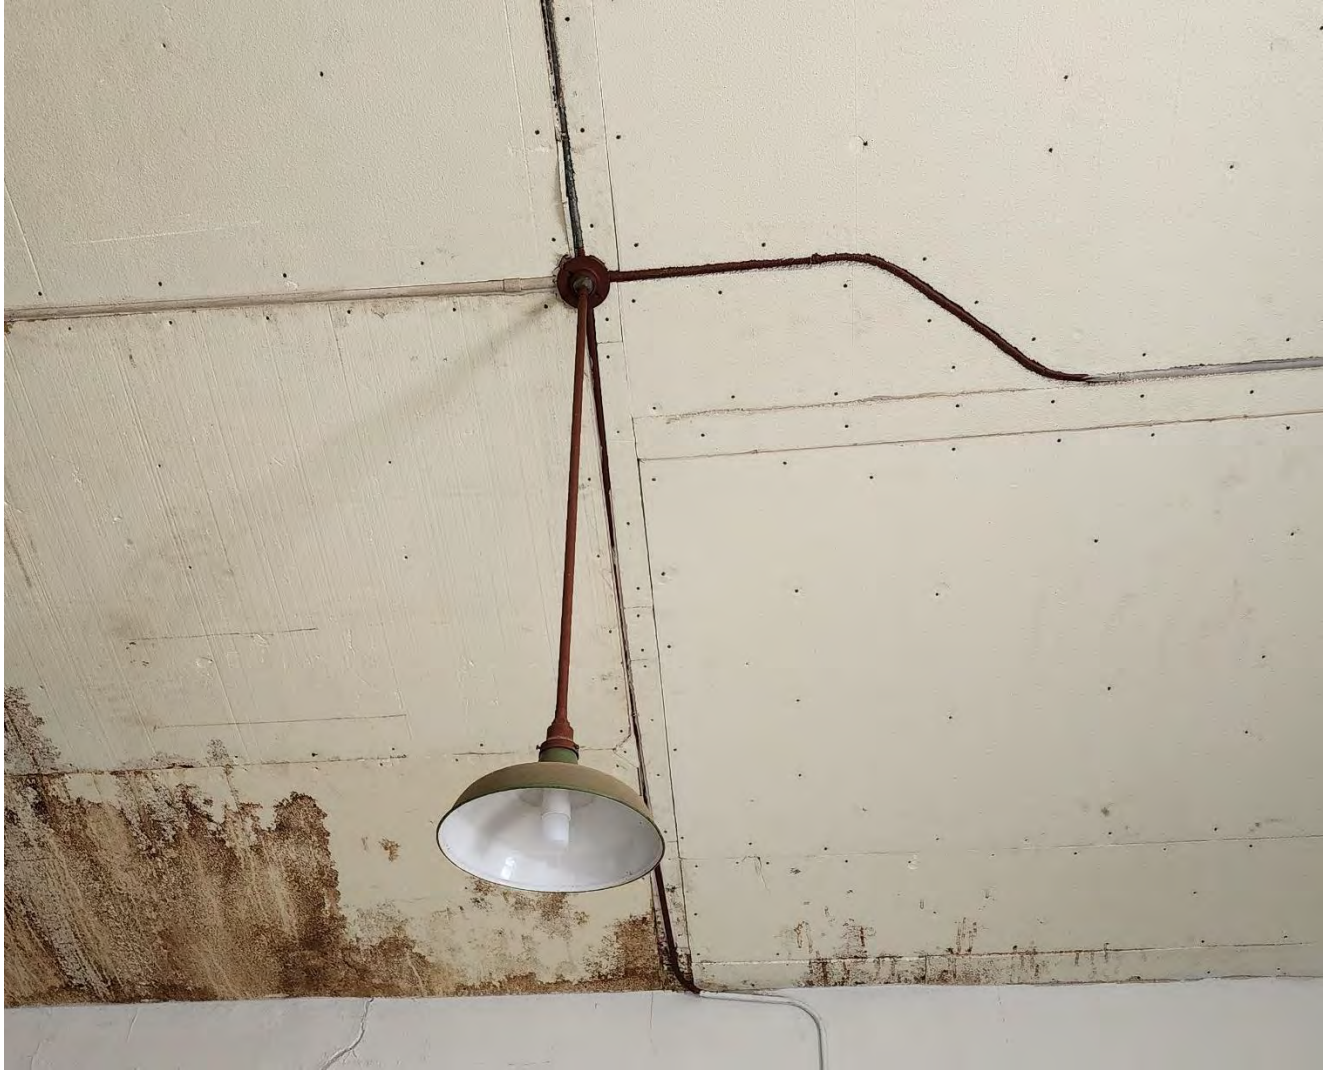
Extensive water damage on ceiling.  
Evidence of mold – not tested.  
Electrical conduit showing signs of water damage and rusting.  
Lighting has not been updated.  
(Photo: 20240216\_142139)

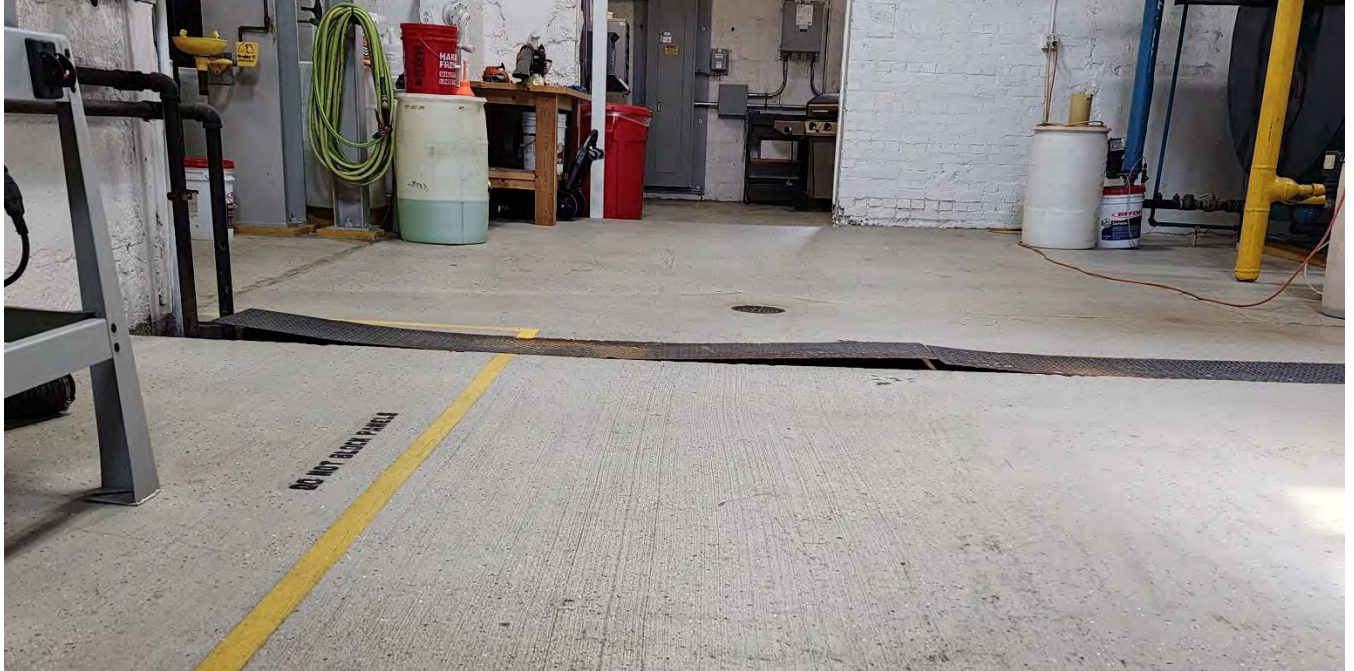
Bent trench drain covers within interior floor slab – potential tripping hazards.  
(Photo: 20240411\_141837)

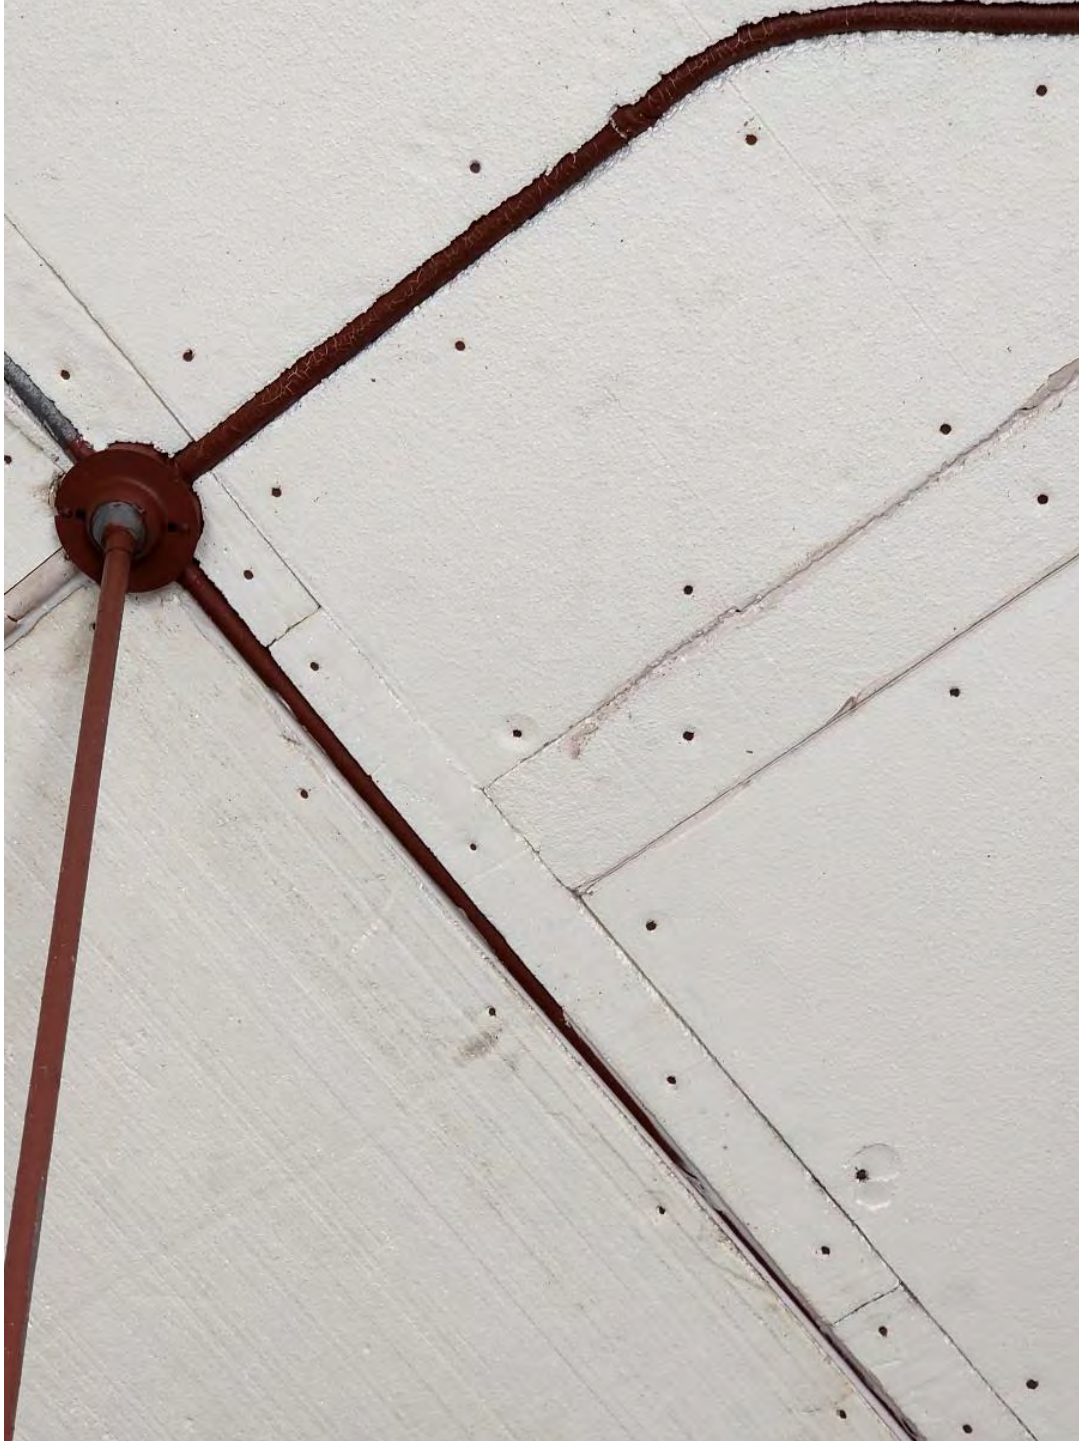
Nonstandard ceiling material.  
Electrical conduit showing signs of water damage and rusting.  
Lighting has not been upgraded.  
(Photo: 20240216\_142219)

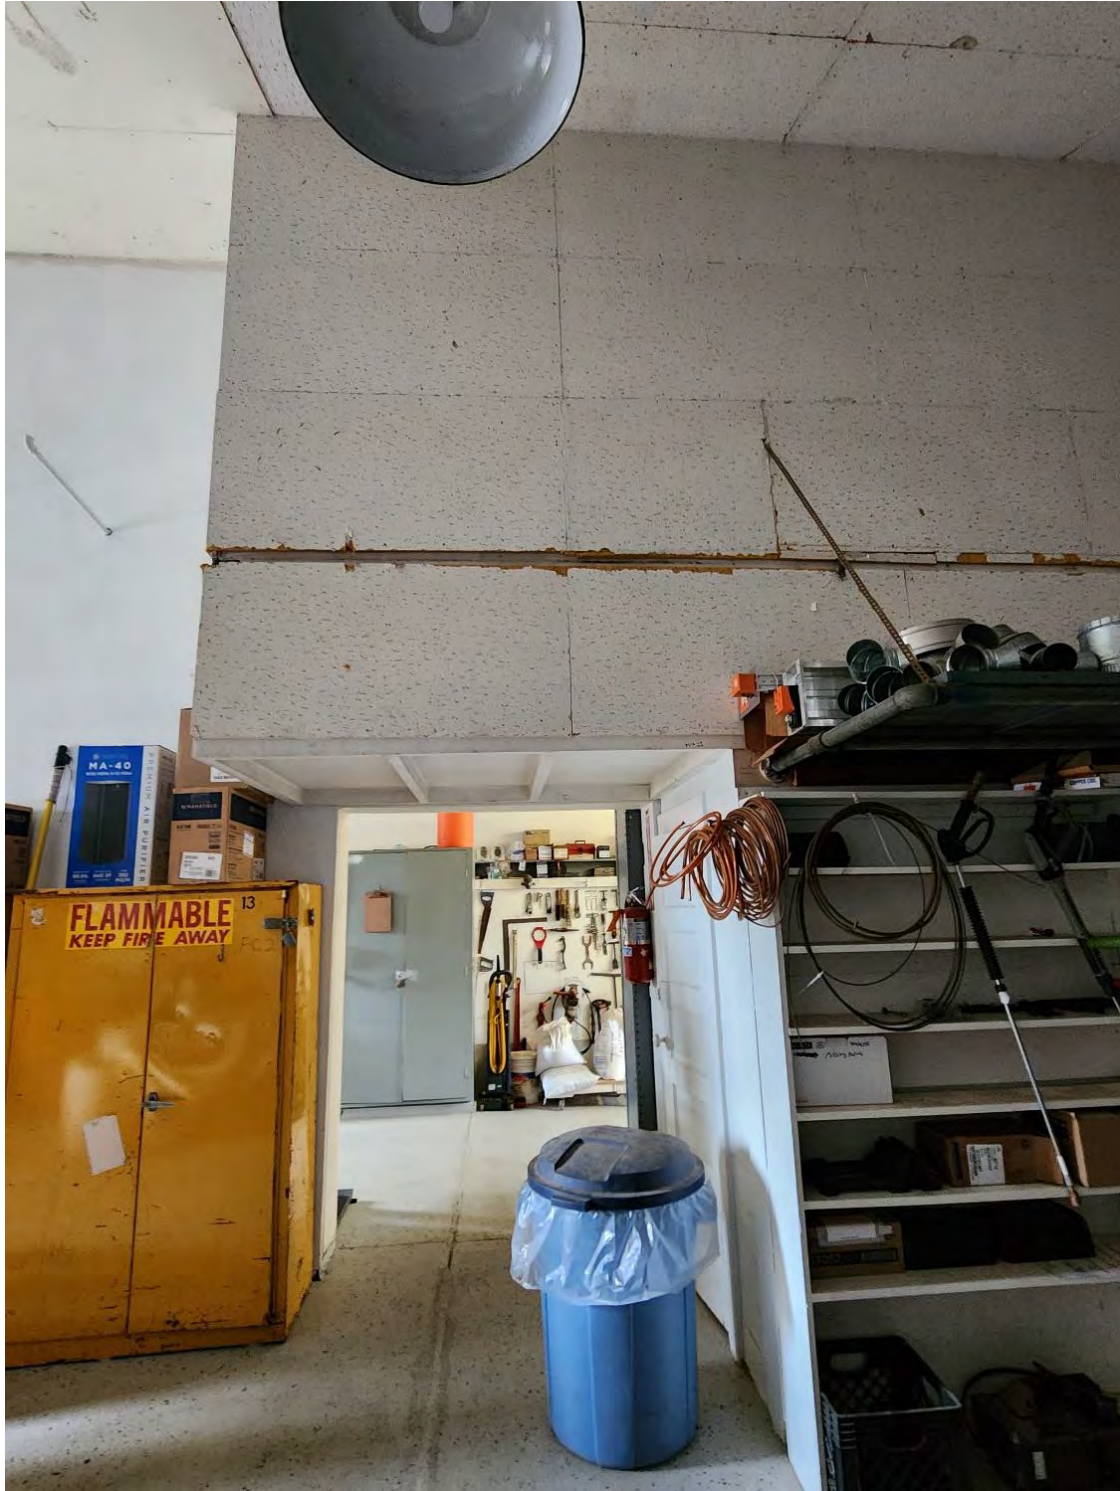
Minimum head clearance not met under stair.  
(Photo: 20240216\_142452)
