**ICON**  
ARCHITECTURAL GROUP

**FACILITY ASSESSMENT FOR  
NORTH DAKOTA YOUTH CORRECTIONAL CENTER  
PHYSICAL PLANT**

Mandan, ND | July 2024

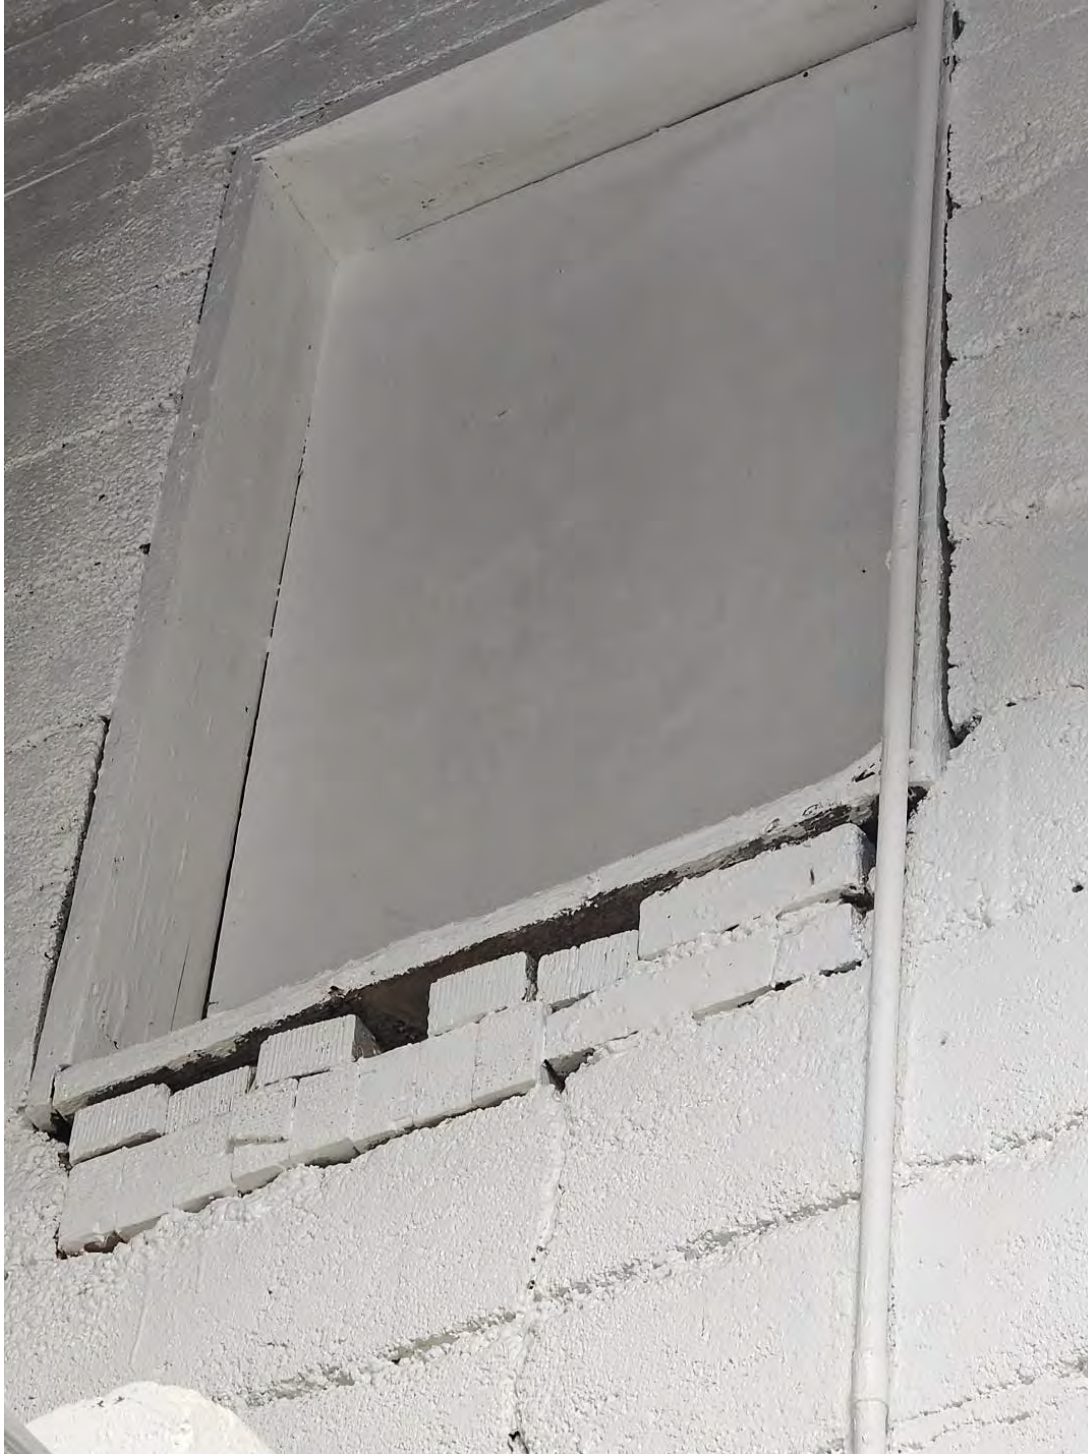
Window jambs and sills in poor condition and non-standard construction methods.  
Location of water and pest infiltration.  
(Photo: 20240411\_135835)

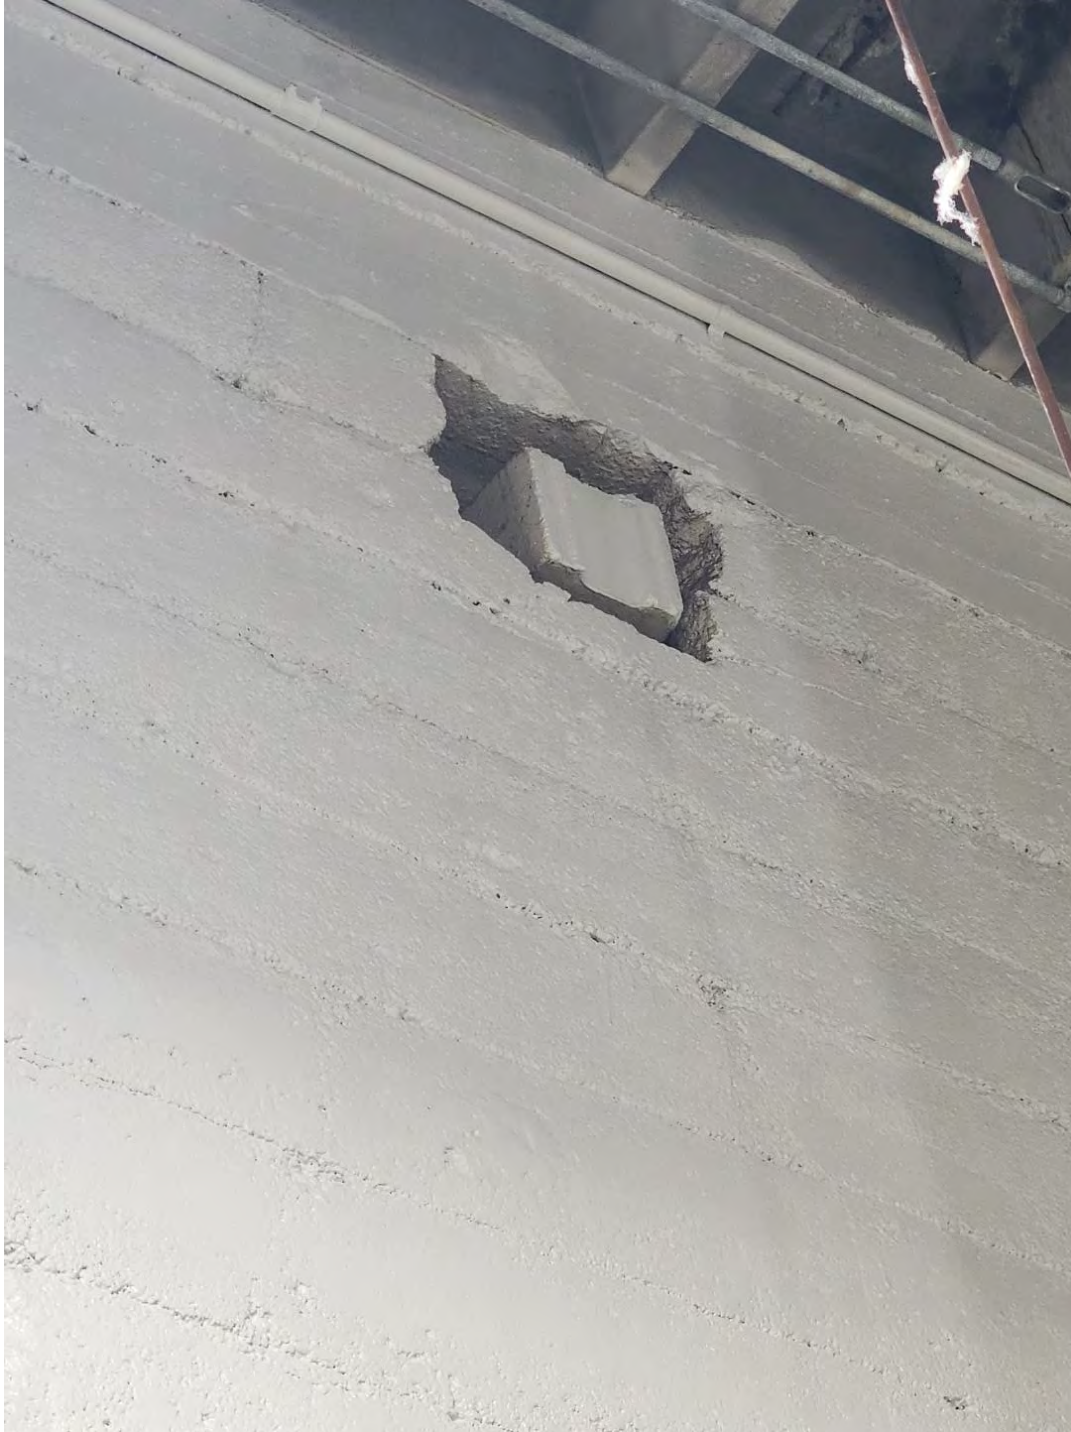
Wall penetrations infilled with non-standard construction methods.  
Non-rated ceiling assembly as required by building code.  
Location of water and pest infiltration.  
(Photo: 20240411\_135834)

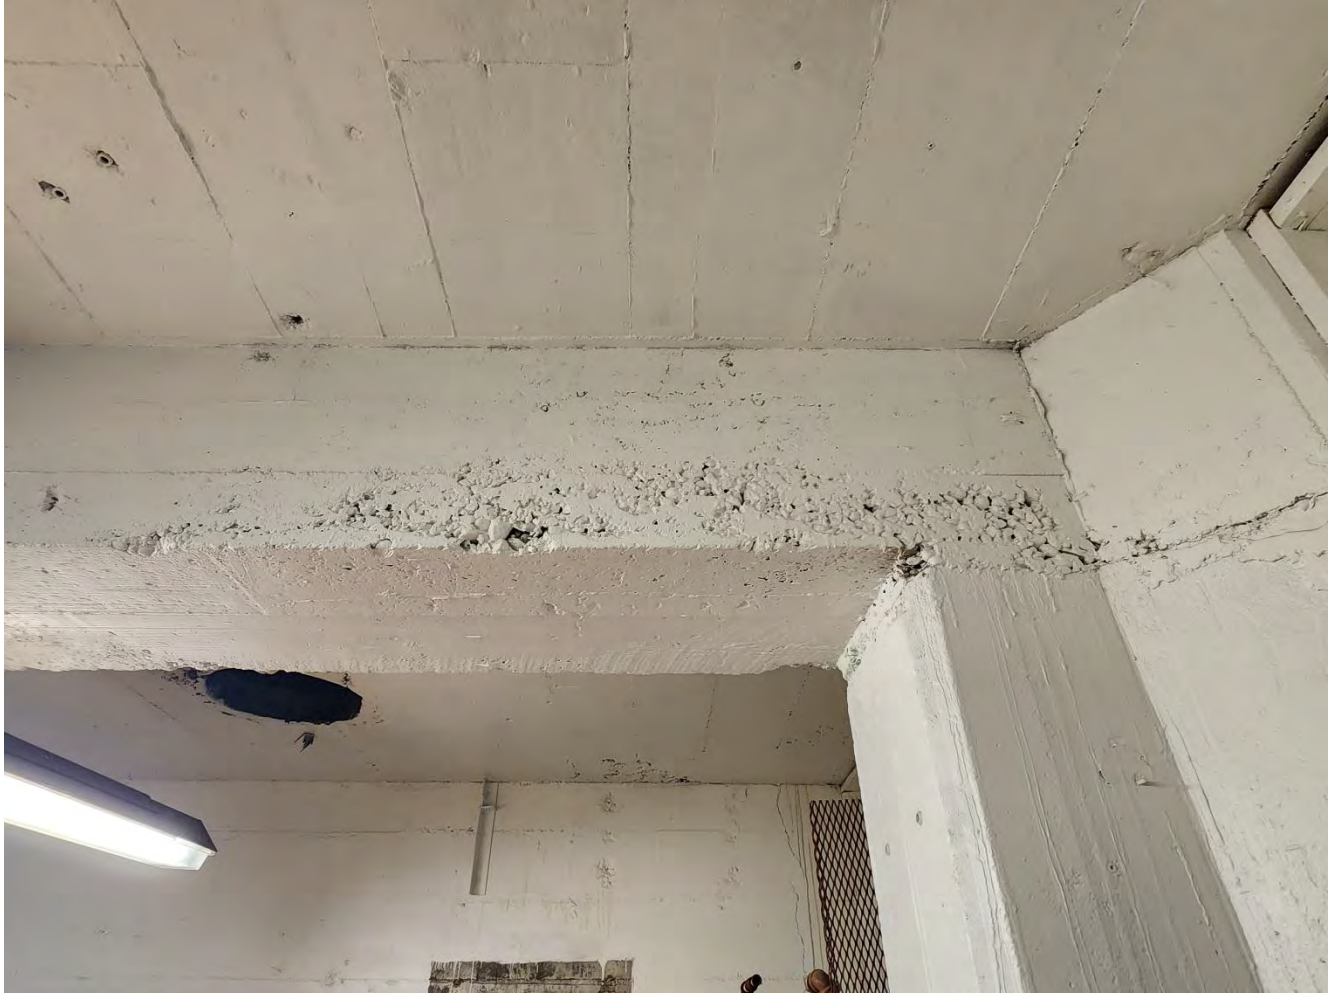
Ceiling penetrations not properly capped and protected.

There is visible evidence of concrete spalling and cracking which leads to exposure of concrete reinforcement, and a decrease in strength and load-carrying capacity of the members.

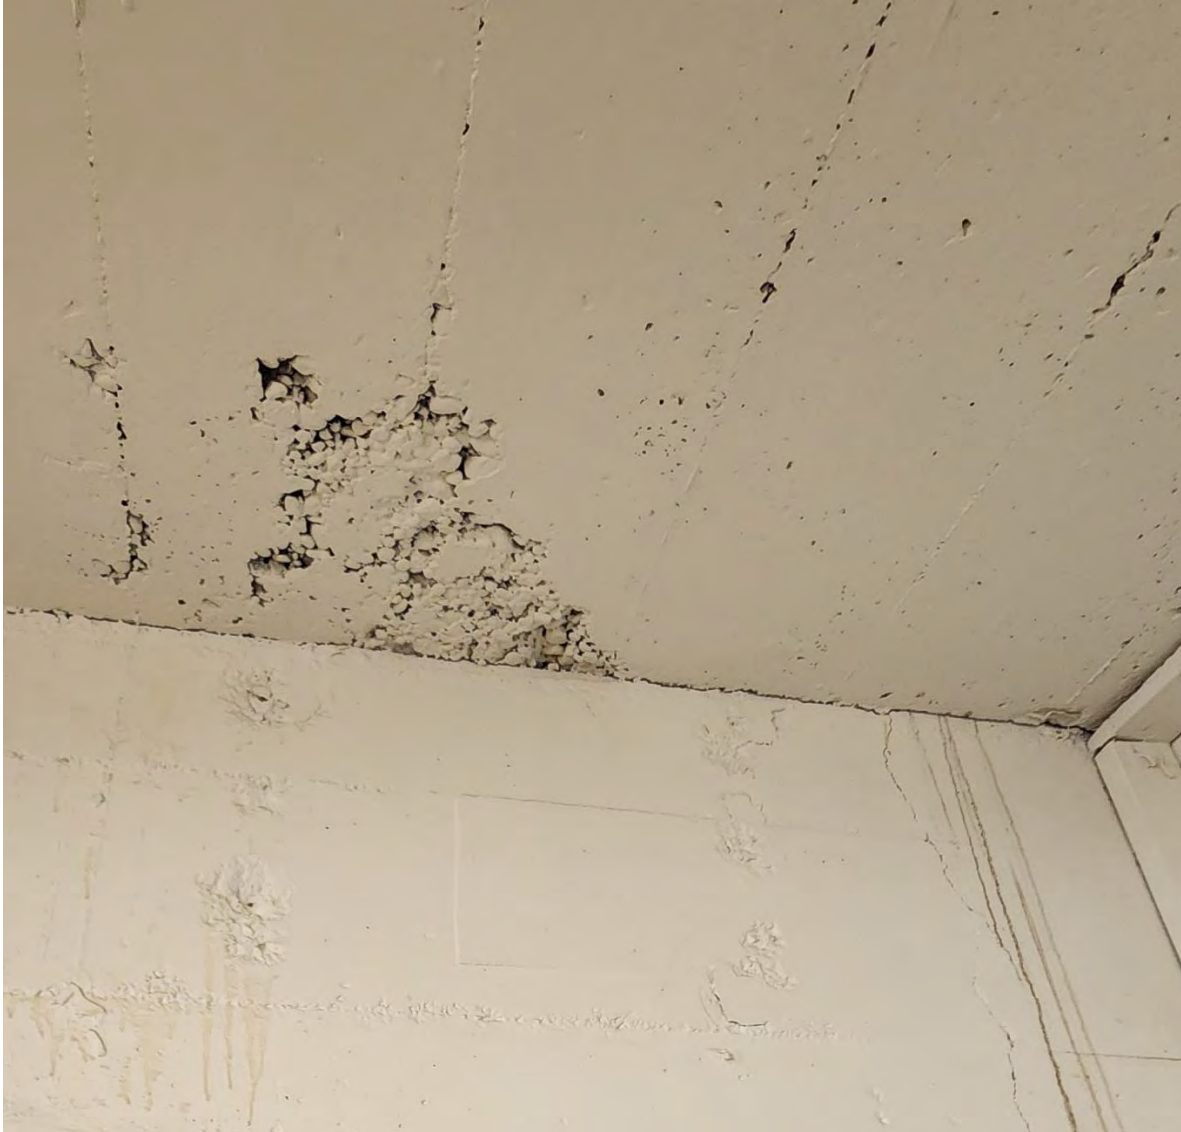
There is visible evidence of concrete spalling and cracking which leads to exposure of concrete reinforcement, and a decrease in strength and load-carrying capacity of the members.

Evidence of water infiltration.

Cracking at ceiling/wall connection.

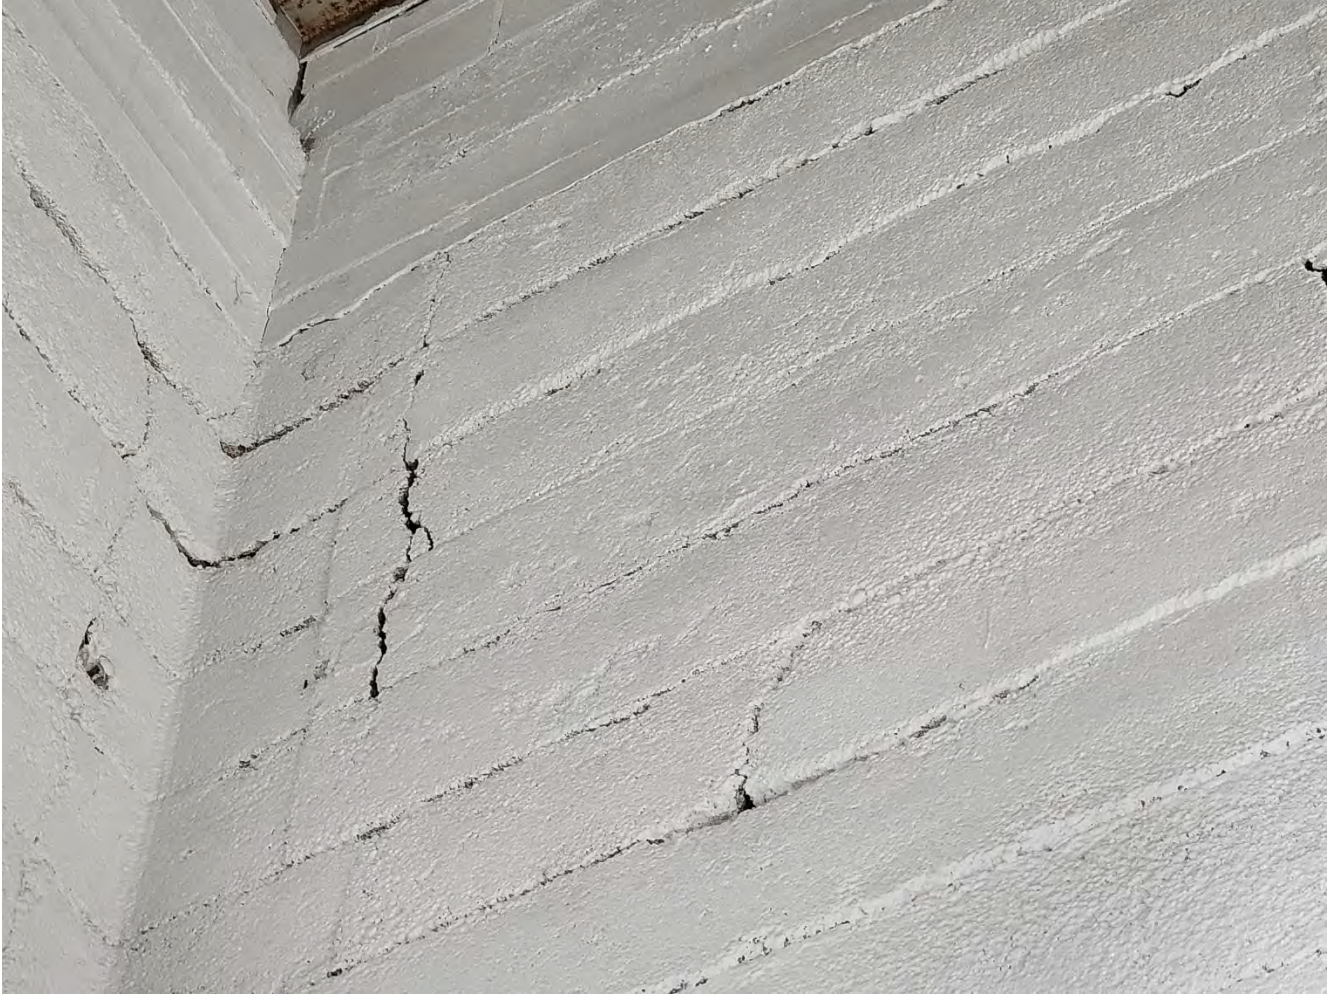
There is visible evidence of concrete spalling and cracking which leads to exposure of concrete reinforcement, and a decrease in strength and load-carrying capacity of the members.  
(Photo: 20240411\_141708)

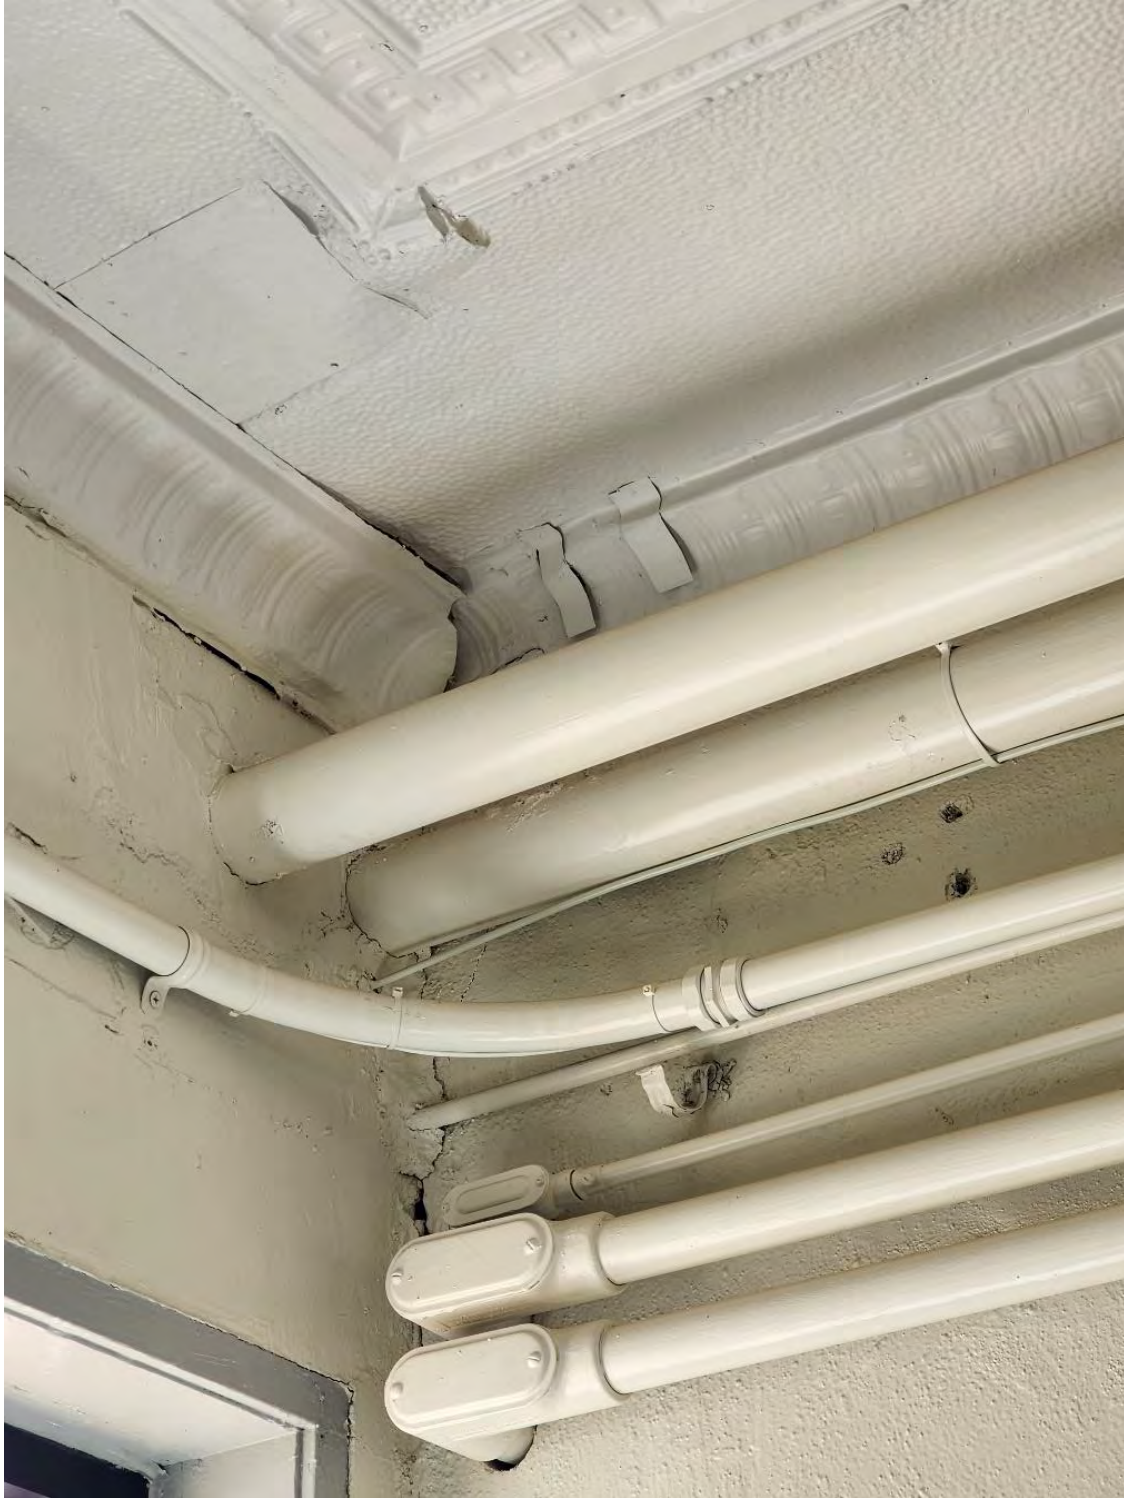
Wall penetrations not sealed.  
Finish material failure.  
(Photo: 20240411\_145007)

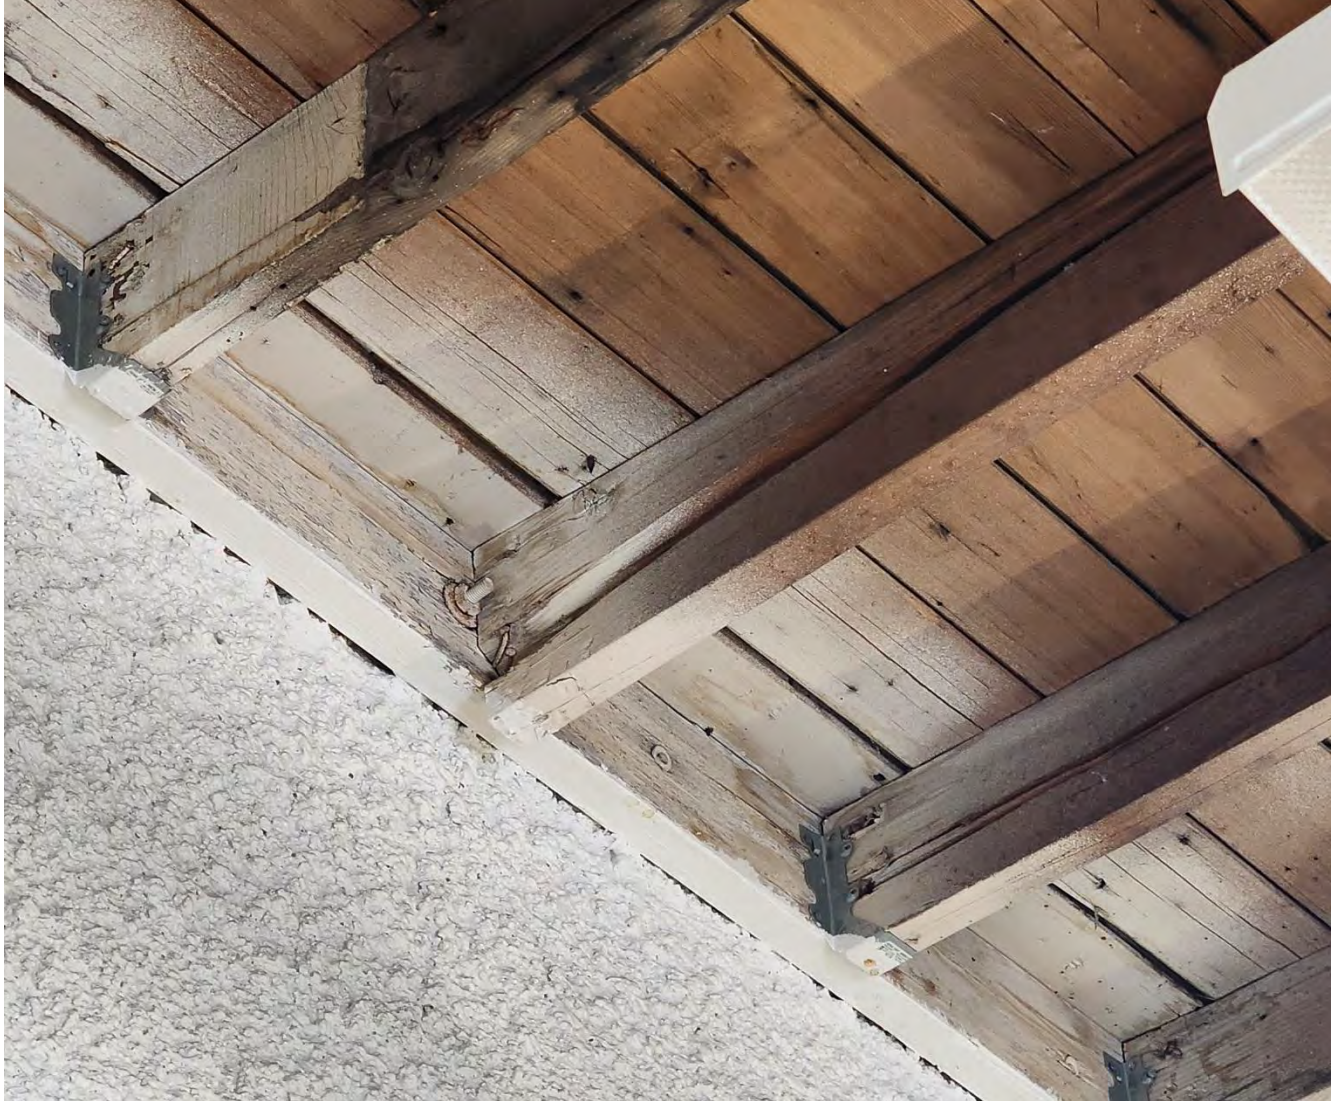
The ceiling joists of the Storage Room are cracked and failing. Joist hangers have been installed, but the joists themselves are still damaged and should be reinforced. There is the potential for roof failure as snow drifts onto this low roof from the higher Boiler area.

Non-protected ceiling assembly.

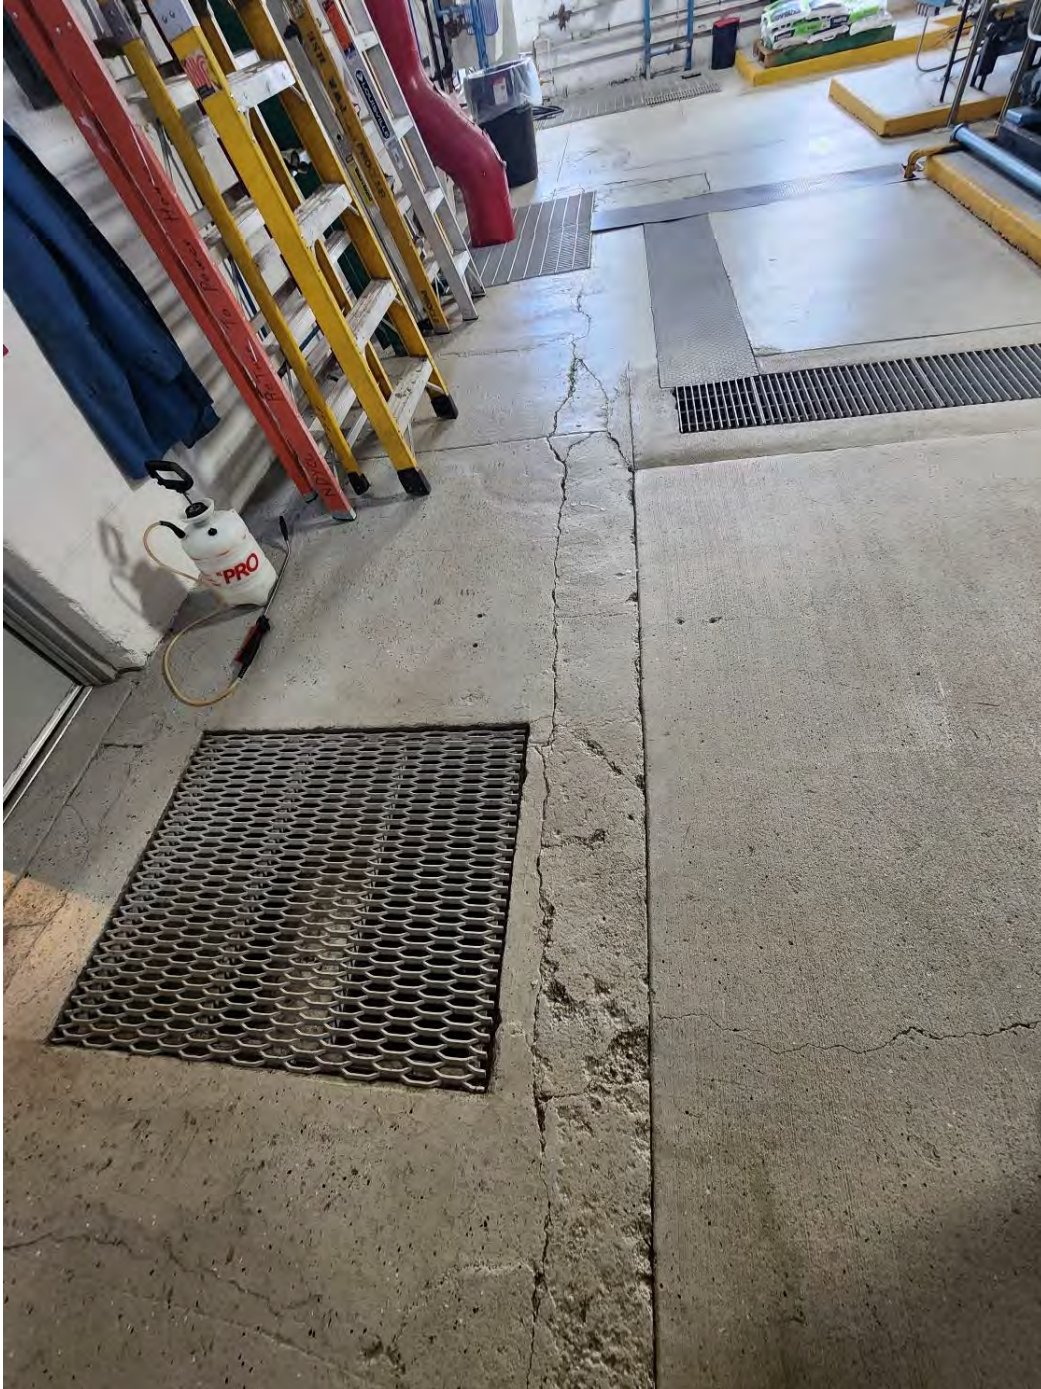
Floor slab cracking indicates settlement and differential movement between areas of the building. Some areas of the floor slabs are structural slabs over mechanical tunnels, and not slabs on grade. Cracking of these slabs could lead to water infiltration, reinforcement exposure, and failure of the slab. The cracking also creates potential trip hazards in the floor slab. (Photo: 20240411\_142636)

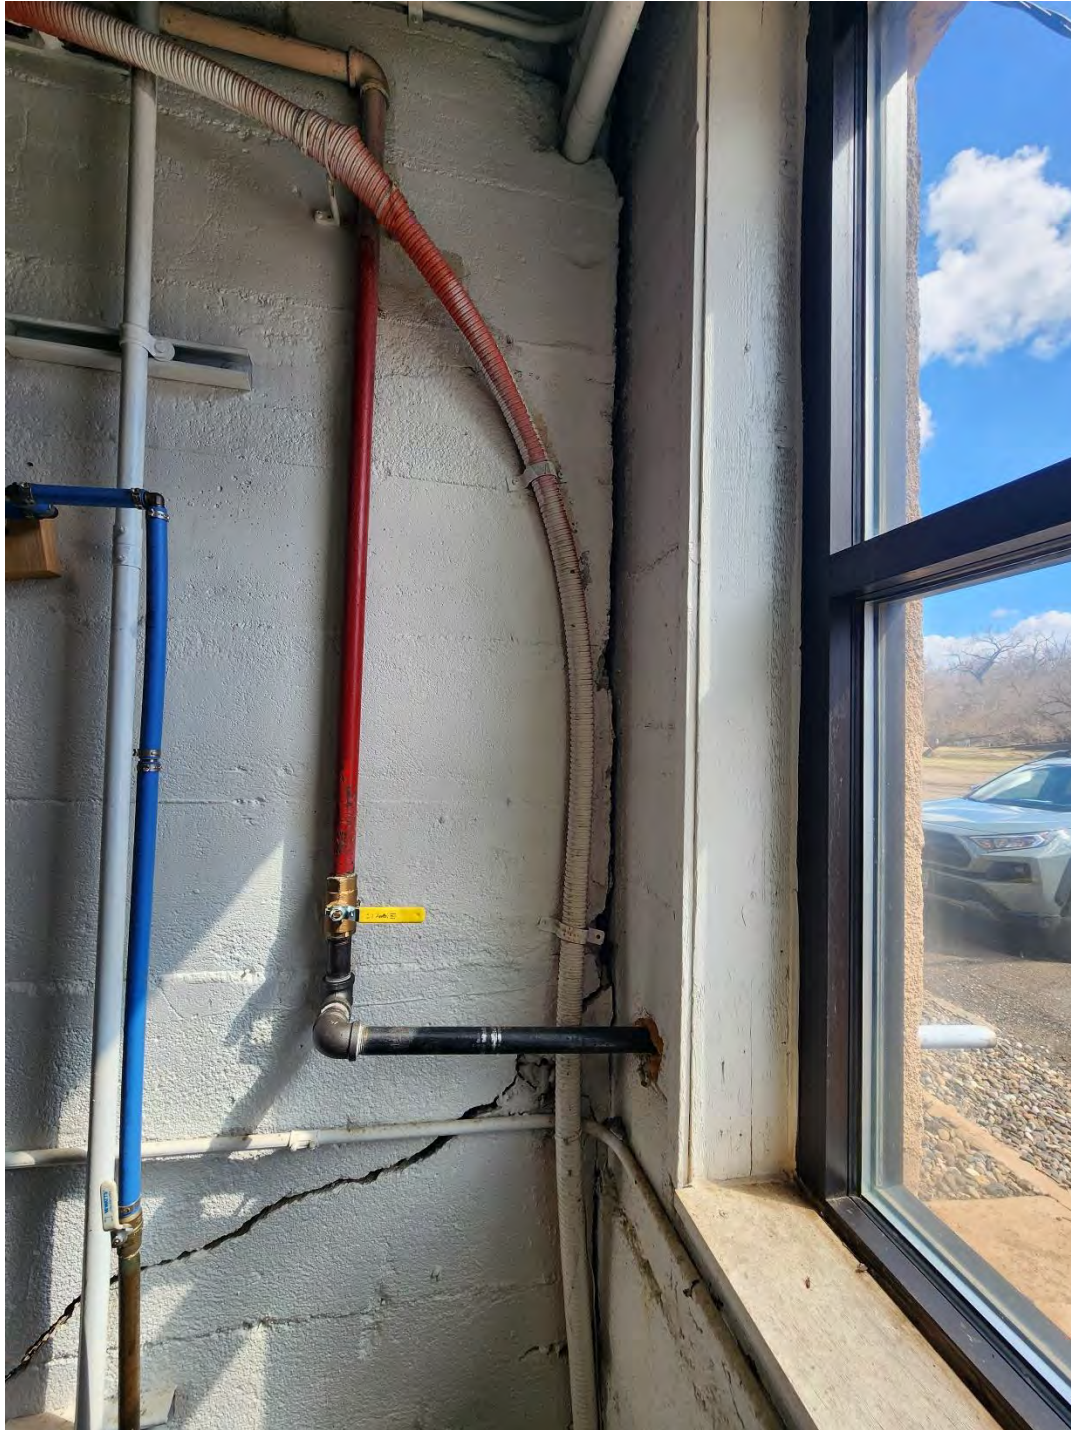
Interior wall and exterior wall pulling away from each other, with a 1" wide gap. Large diagonal crack that extends through the wall, located at the bottom of the north-south interior wall between the Heating Plant Office and Boilers. Both the crack and the gap are indicative of excessive building settlement. Wall penetrations not properly protected. (Photo: 20240411\_145052)

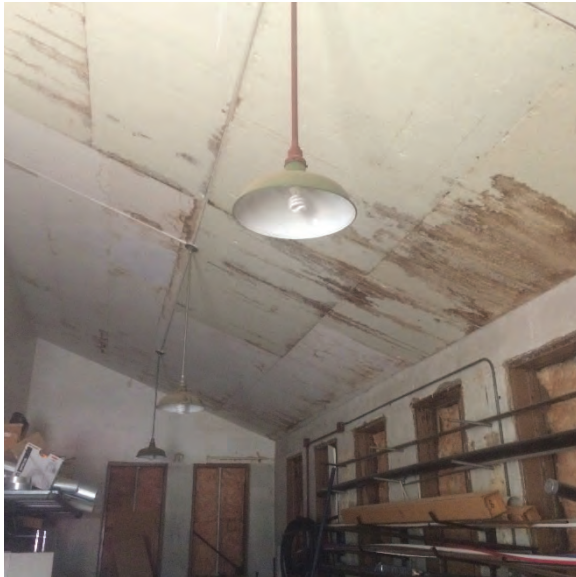
### **Plumbing Storage**

- The existing roof framing was not visible in the main plumbing storage area due to the finished ceiling. The ceiling showed visible signs of water damage, including sagging and discoloration. It is unknown what condition the framing is in, but it is most likely water damaged with possible mold and fungi growth.

Water damage to ceiling. Ceiling to be removed to verify structural condition of roof framing.

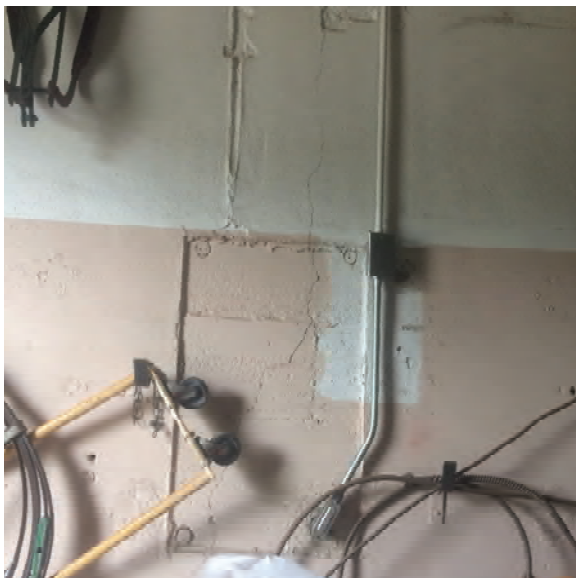
Visible crack in interior wall to be monitored.

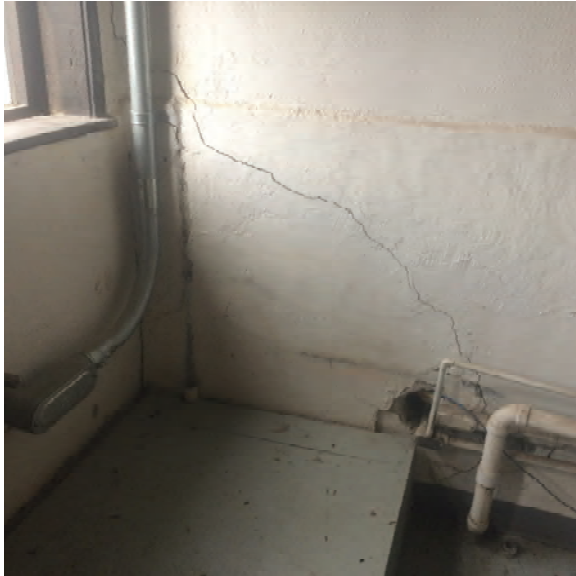
## Plumbing Shop & Heating Plant Office

Crack in interior concrete wall between Heating Plant Office and Boilers to be monitored.

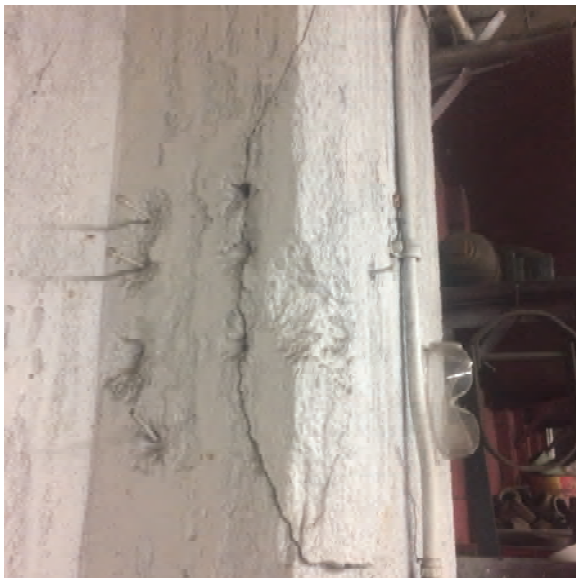
## Storage

Visible crack in concrete pier below concrete roof beam to be monitored. Note the indentations of previously installed anchors in the crack line.

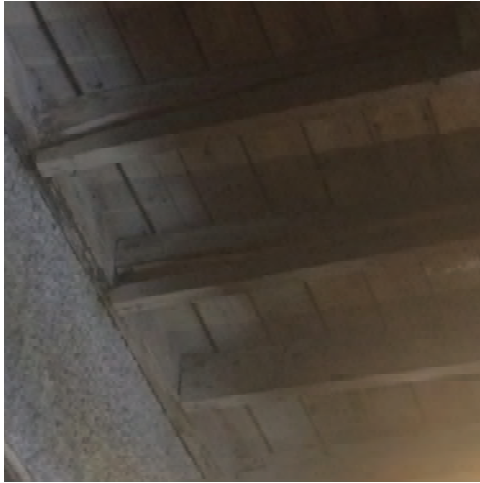
## Tools

Failed and cracked 2x6 roof joists that need to be repaired and / or replaced.

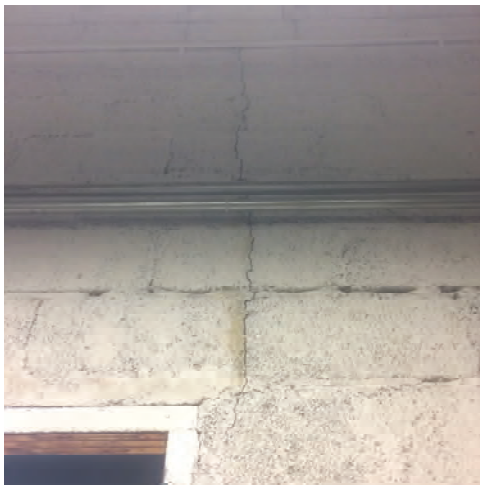
Vertical crack in wall at window corner, most likely due to a lack of control joints in the CMU wall.

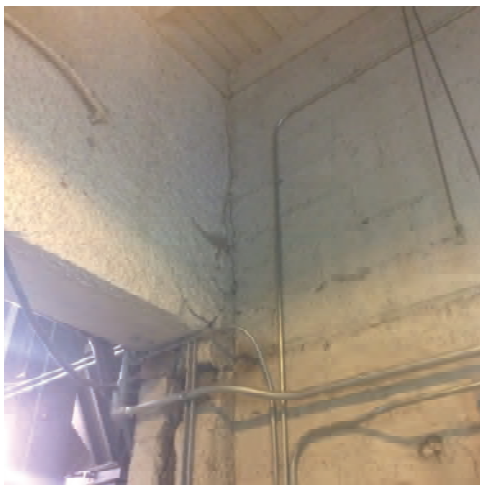
Cracked and damaged bearing at opening in wall between Tools and Boilers to be repaired – see the Boilers section for additional information.

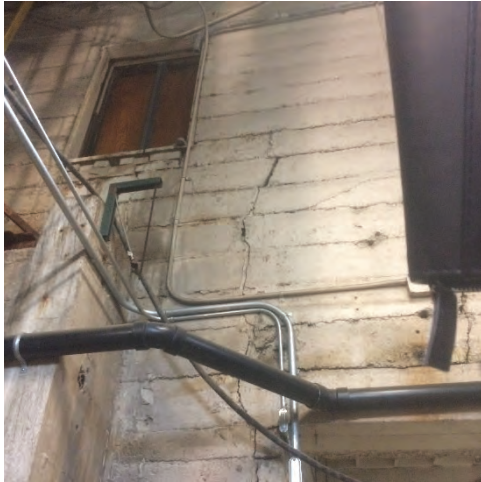
## Boilers

Large vertical crack in wall at corner of existing wall opening between Boilers and Tools. Opening to be repaired by installing new steel beam lintel.

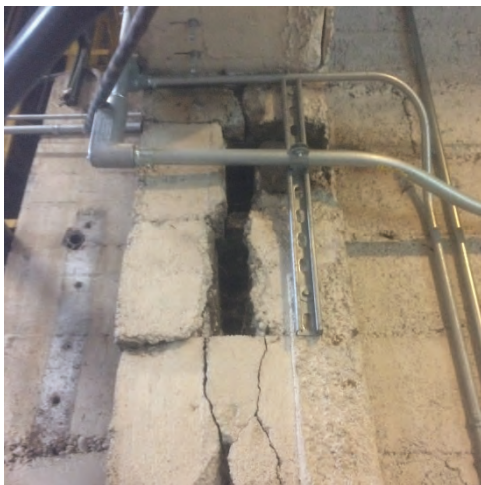
Cracked and broken concrete at bearing of existing wall opening between Boilers and Tools to be rebuilt and repaired – wall section view.

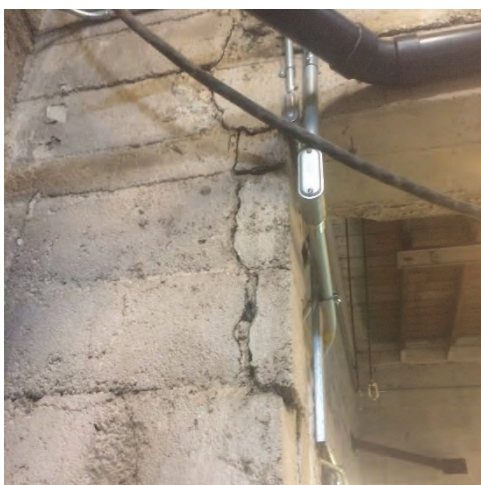
Cracked and broken concrete at bearing of existing wall opening between Boilers and Tools to be rebuilt and repaired – wall elevation view.

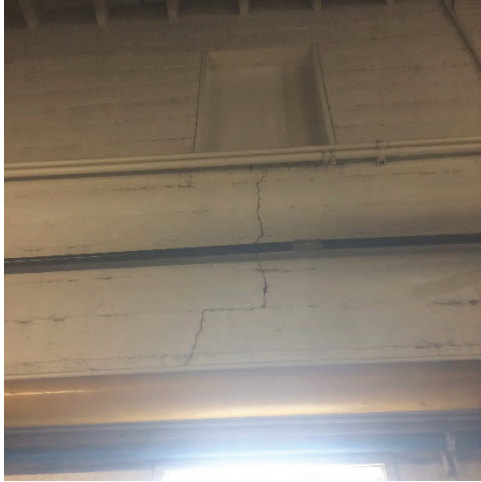
## Boilers (continued)

Typical wall cracking around window and door openings.

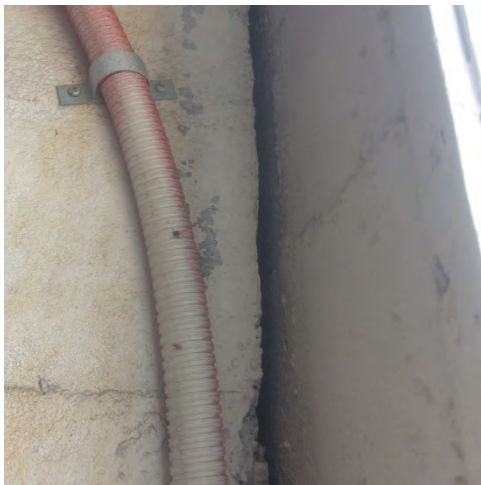
Gap between interior concrete wall and south exterior wall to be monitored.

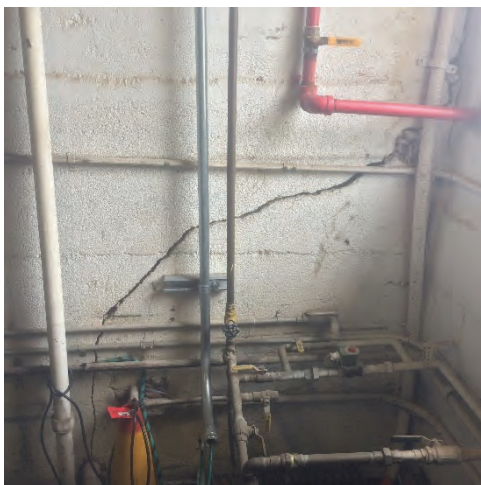
Diagonal crack in interior concrete wall that needs to be monitored.
