ADA Accessibility Assessment

Date: January 20, 2020; Updated July 16, 2020

Project: State Capitol Building ADA Review

J2 Studio Project No.: J21932

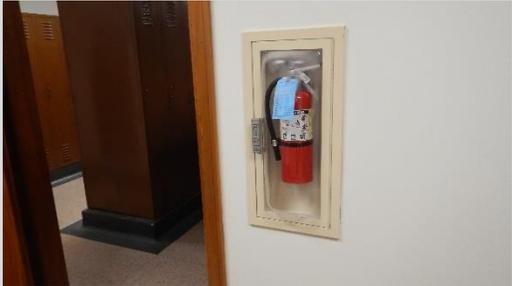
<p>Fire extinguishers are mounted too high throughout public spaces of Capitol. (2010 ADA; Sections 308.2 and 308.3)</p> <p><i>Suggested Resolution: Where possible, extinguishers shall be mounted with the top at 48" A.F.F.</i></p>

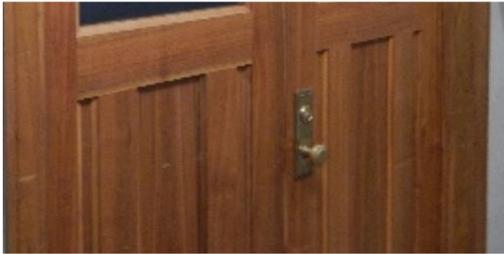
<p>Locksets are noted to be knobs throughout Capitol building and should be levers for ADA accessibility. (2010 ADA; Sections 309.4 and 404.2.7)</p> <p><i>Suggested Resolution: Replace existing knobs or add modified levers to existing knobs as required.</i></p>

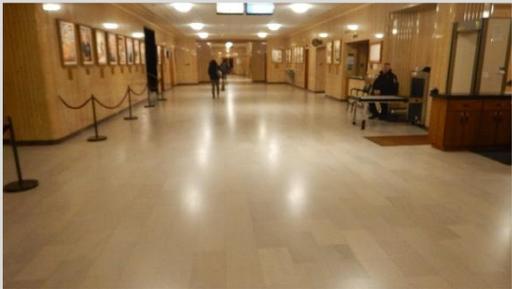
<p>It was noted that there are few benches throughout the main corridor of the Capitol building, near the main entry. (Suggestion; Not ADA Requirement)</p> <p><i>Suggested Resolution: Add bi-level benches in the legislative corridor and cafeteria corridor at the main level and on the first floor.</i></p>

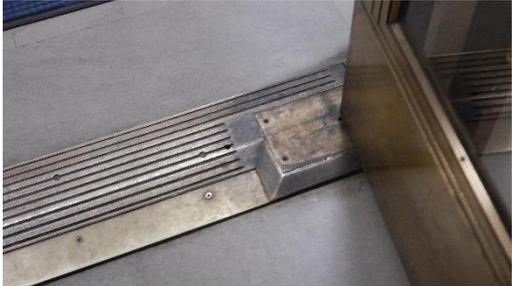
<p>Legislative Wing</p>		
<p>Main Corridor - West Entry</p>	<p>Threshold is noted to be too high. (2010 ADA; Section 303)</p> <p><i>Suggested Resolution: Replace threshold to one that is less than ¼" change in height vertically.</i></p>

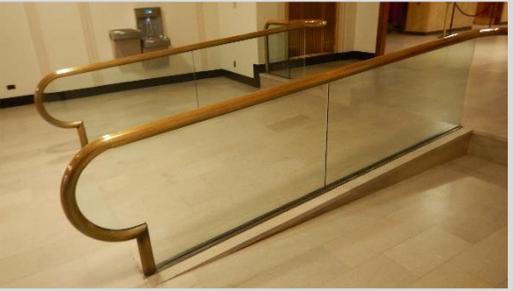
<p>Main Corridor - Ramps</p>	<p>Gripping surface of handrail is too large in diameter. (2010 ADA; Section 505.7.1)</p> <p><i>Suggested Resolution: Surface mount new railing to existing guardrail that meets ADA gripping surface requirements.</i></p>

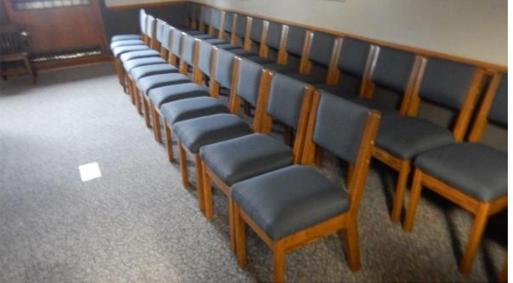
<p>Furniture is too close to doors and aisles. (2010 ADA; Sections 403.5.1 and 404.2.4)</p> <p><i>Suggested Resolution: Move chairs/furniture as required for accessibility during hearings.</i></p>

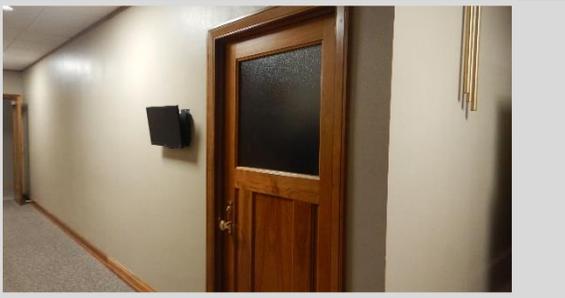
<p>Press Studio (Outside Fort Lincoln Room)</p>	<p>Door is noted to be hard to push/pull open. (2010 ADA; Section 404.2.9)</p> <p><i>Suggested Resolution: Verify force required for push/pull is 5 lbs. maximum. Adjust closer as required.</i></p>

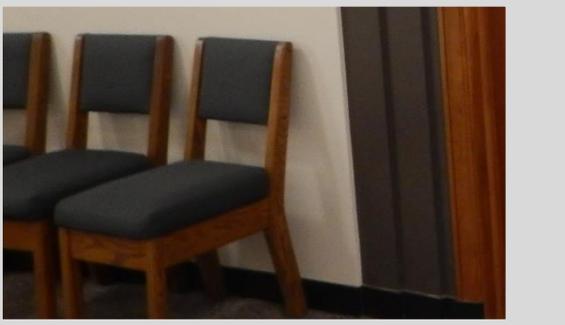
<p>Chairs outside of door interfere with clear floor space requirements. (2010 ADA; Sections 403.5.1 and 404.2.4)</p> <p><i>Suggest Resolution: Move chairs to at least 12" from latch of door.</i></p>

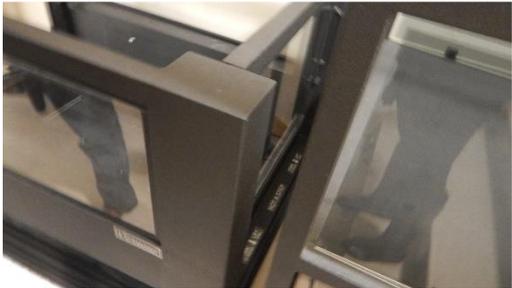
<p>There is a noted gap between the lift and the floor structure when the lift is raised. (2010 ADA; Section 410.4)</p> <p><i>Suggested Resolution: Install new threshold from manufacturer that bridges gap between lift and floor structure.</i></p> <p><i>Upon further review, it was noted that the weight limit and current width do not meet the needs of powered wheelchairs. Consider replacing lift in its entirety.</i></p>

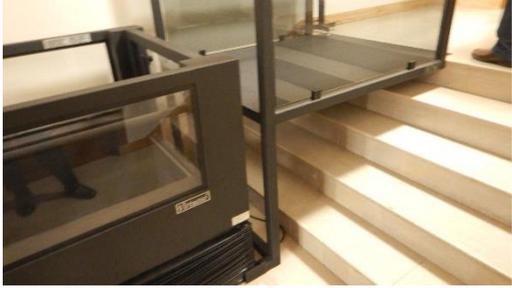
<p>Lift door does not automatically open when raised and it is difficult to open when in a wheelchair (2010 ADA; Section 410.6)</p> <p><i>Suggested Resolution: Coordinate with lift manufacturer for automatic opening or operator options.</i></p> <p><i>Upon further review, it was noted that the existing lift does not meet the current needs of the Capitol. The weight limit and current width do not meet the needs of powered wheelchairs. Consider replacing lift in its entirety.</i></p>

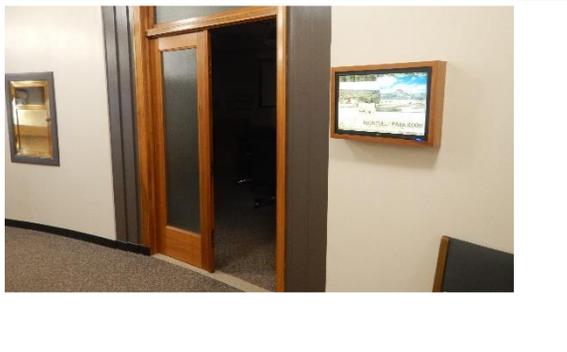
<p>Roosevelt Park Room</p>	<p>Clear width at double doors is too narrow if only 1 leaf open (2 - 30" leaves). (2010 ADA; Section 404.2.3)</p> <p><i>Suggested Resolution: Both leaves need to be open at the same time during hearings (Requires policy change). If doors need to be closed during hearings, two options:</i></p> <ul style="list-style-type: none"> - <i>Install operators at both doors</i> - <i>Install (1) 36" wide door, and 24" sidelight or fixed leaf in lieu of double doors.</i>

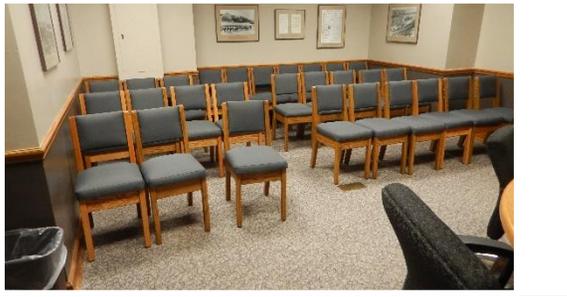
<p>Furniture is too close to doors and aisles. (2010 ADA; Sections 403.5.1 and 404.2.4)</p> <p><i>Suggested Resolution: Move chairs/furniture as required for accessibility during hearings.</i></p>

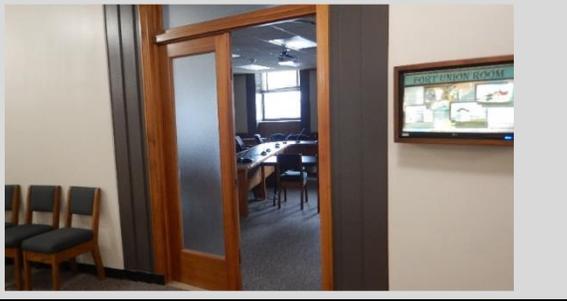
<p>Fort Union Room</p>	<p>Clear width at double doors is too narrow if only 1 leaf open (2 - 30" leaves). (2010 ADA; Section 404.2.3)</p> <p><i>Suggested Resolution: Both leaves need to be open at the same time during hearings (Requires policy change). If doors need to be closed during hearings, two options:</i></p> <ul style="list-style-type: none"> - <i>Install operators at both doors</i> - <i>Install (1) 36" wide door, and 24" sidelight or fixed leaf in lieu of double doors.</i>

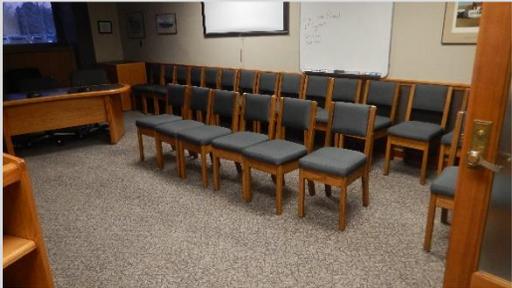
<p>Furniture is too close to doors and aisles. (2010 ADA; Sections 403.5.1 and 404.2.4)</p> <p><i>Suggested Resolution: Move chairs/furniture as required for accessibility during hearings.</i></p>

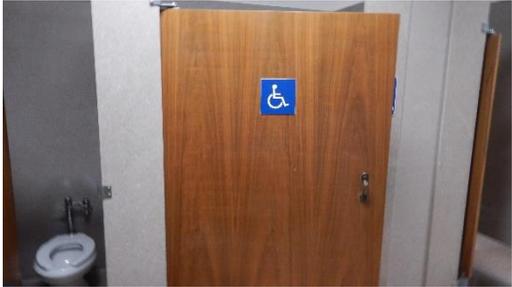
<p>Men's Restroom (All at Ground Floor)</p>	<p>ADA stall is not deep enough with floor mounted toilet (58" deep, 59" required) (2010 ADA; Section 604.8.1.1)</p> <p><i>Suggested Resolution: Reconfigure restroom for ADA compliant stall.</i></p>

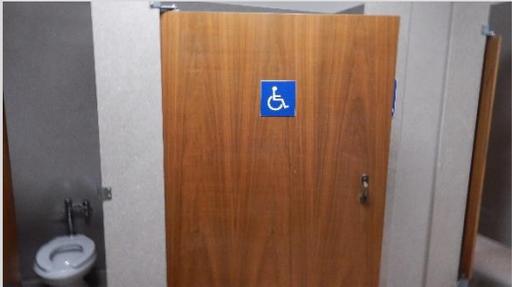
<p>Door is noted to be hard to push/pull open. (2010 ADA; Section 404.2.9)</p> <p><i>Suggested Resolution: Verify force required for push/pull is 5 lbs. maximum. Adjust closer as required.</i></p>

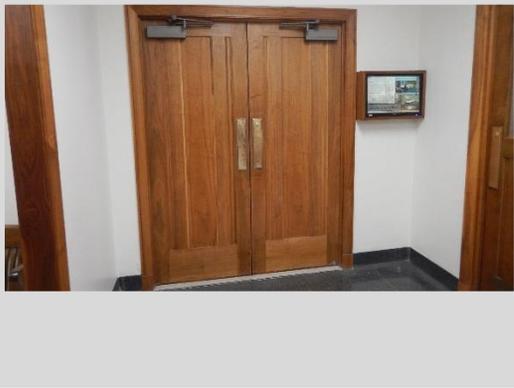
<p>Door is noted to be hard to push/pull open. (2010 ADA; Section 404.2.9)</p> <p><i>Suggested Resolution: Verify force required for push/pull is 5 lbs. maximum. Adjust closer as required.</i></p>

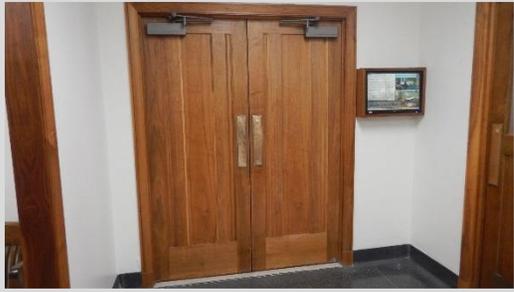
<p>Furniture is too close to doors and aisles. (2010 ADA; Sections 403.5.1 and 404.2.4)</p> <p><i>Suggested Resolution: Move chairs/furniture as required for accessibility during hearings.</i></p>

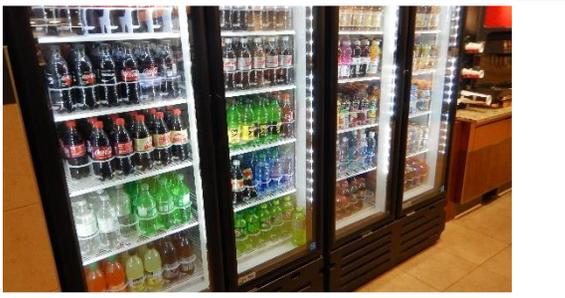
<p>Cafeteria</p>	<p>Handles on pop coolers are not accessible (recessed handles) (2010 ADA; Sections 228.1, 309.4 and 404.2.7)</p> <p><i>Suggesting Resolution: Work with vendor to replace or modify coolers for ADA accessible handles</i></p>

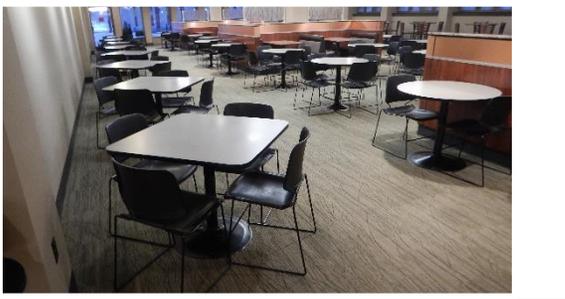
<p>Denoted accessible seating is lacking (2010 ADA; Sections 206.2.5 and 226)</p> <p><i>Suggested Resolution: Install ADA plaques at tables, distributed equally throughout cafeteria seating area. Verify that pedestals at existing tables meet ADA requirements. Replace if they do not.</i></p>

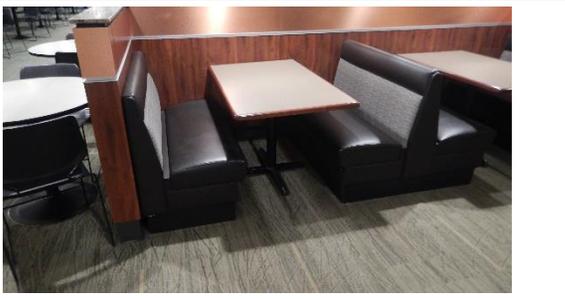
<p>Booths are not wide enough for wheelchair accessibility (2010 ADA; Sections 226, 802.1.5 and 902)</p> <p><i>Suggested Resolution: Add a booth bench to north wall with chairs at other side.</i></p>

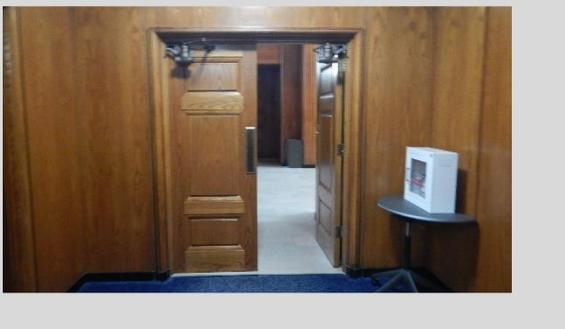
<p>House Chambers</p>	<p>Clear width at double doors is too narrow if only 1 leaf open (2 - 32" leaves) (2010 ADA; Section 404.2.3)</p> <p><i>Suggested Resolution: There are two options:</i></p> <ul style="list-style-type: none"> - <i>Install operators at both doors</i> - <i>Reconfigure existing doors into one larger and one smaller leaf. Cut existing leaves to make (1) 36" wide opening and dowel.</i>

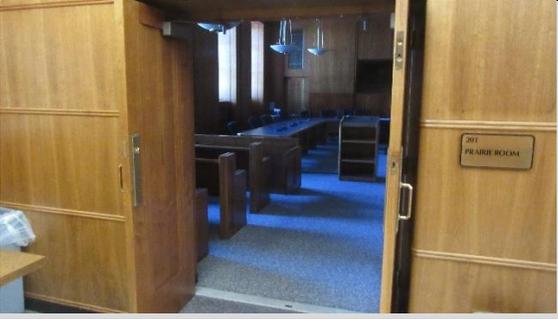
<p>Furniture is too close to doors and aisles. (2010 ADA; Sections 403.5.1 and 404.2.4)</p> <p><i>Suggested Resolution: Remove one set of benches to provide ADA Seating.</i></p>

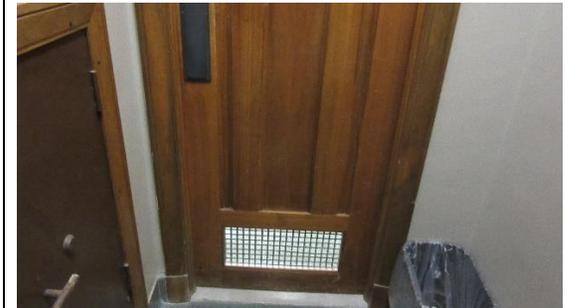
Restroom does not have an ADA stall, nor the required turning radius of 5'.

Suggested Resolution: Remove one water closet to create an accessible stall. Review clear floor space to determine if urinal can maintain clear floor space. Note: Recommend to convert 50% of the men and 50% of the women's restrooms to be ADA Compliant dispersed evenly in tower.

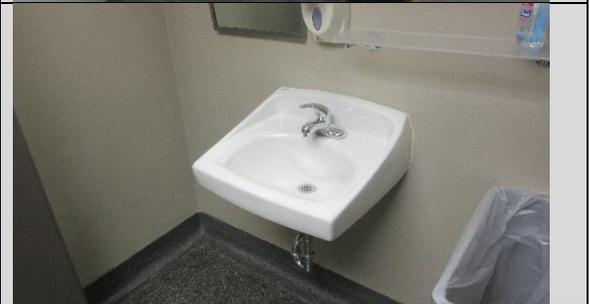
<p>Sink Trap/Supply Exposed. (2010 ADA; Section 606.5)</p> <p><i>Suggested Resolution: Install trap/supply covers.</i></p>

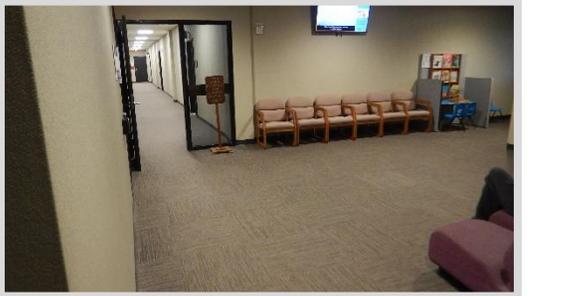
Supreme Court	<p>Doors are noted to be hard to push/pull open. (2010 ADA; Section 404.2.9)</p> <p><i>Suggested Resolution: Verify force required for push/pull is 5 lbs. maximum. Adjust closer as required. Install operator on at least one door for accessibility.</i></p>
