October 28, 2011

**Application for
Prepayment of Consulting and Planning Fees
Bismarck State College
Center for Creativity and Communications**

October 10th, 2011

Re: Bismarck State College Library Building – Structural Inspection and Evaluation

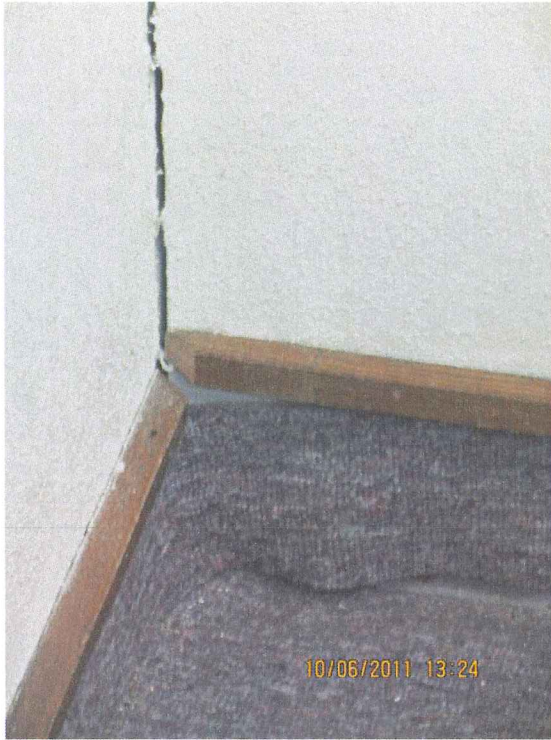
There are particular signs of distress along the exterior walls of the building on the main floor such as cracked drywall and CMU as well as separation of drywall at the intersection of interior and exterior walls. The interior walls intersecting the exterior walls appear to have translated upward and rotated outward from the exterior walls at their bases (see attached **Photo #1**). The same interior walls have also been pushed into the exterior walls at their tops (see attached **Photo #2**) crushing the drywall at the top of the wall. The vertical separation between the interior and exterior walls is evident in joints in the trim, ceiling tile, etc. (see attached **Photos #1, #2 and #8**).

Photo #1: Separation of interior wall and finishes from the west exterior wall (base of wall).

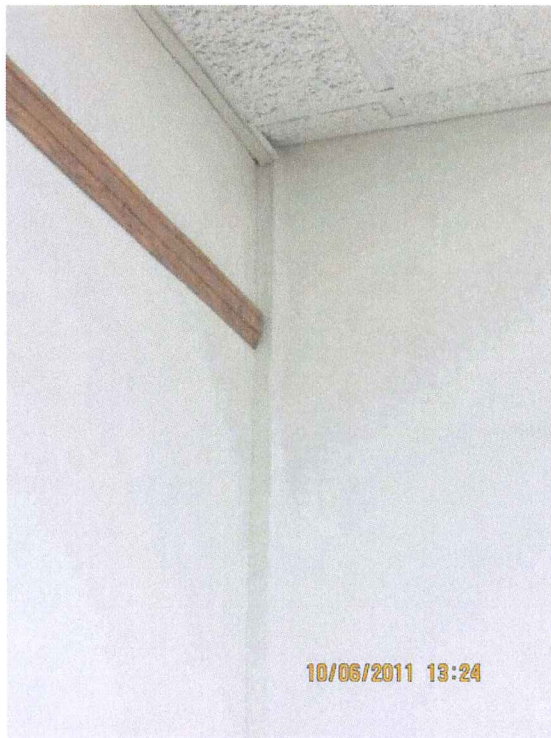
The signs of distress in interior wall finishes, such as torn and compressed drywall at intersecting wall joints at both interior and exterior walls, are also indicative of the effects highly expansive clay soils. The intersecting line between the interior partition walls and the exterior walls are telegraphing the movement of the interior slabs-on-grade. The interior partition walls intersecting the exterior walls are being pushed upward on their interior ends relative to their ends adjoining the exterior walls. The taped drywall joints and wall finishes at the base of the interior walls intersecting the exterior walls are tearing as the interior wall moves upward and inward relative to the exterior wall construction at the bottom of the walls (see attached **Photo #1**). The drywall joints on the same walls are being torn and compressed as the top of the interior walls move upward and inward relative to the exterior walls (see attached **Photo #2**).

Photo #2: Separation of interior wall and finishes from the west exterior wall (top of wall).

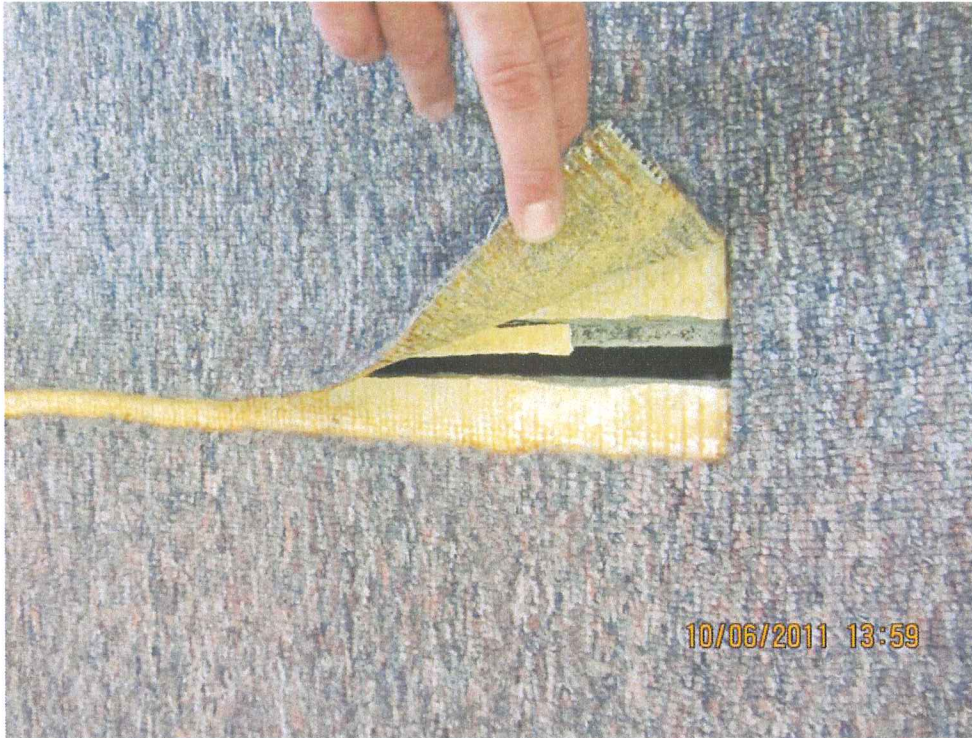
Also, as the interior portion of the slab-on-grade is being heaved upward the resulting crowned shape they obtain is very noticeable particularly at openings or penetrations in the slab. This is evident in the library stack area at the interior steel column bases. The small squares of slab cast around the column bases are cast separately of the remaining interior slab-on-grade. These small sections of slab appear to be relatively unaffected by the soils swelling as they are bonded to the column bases and their foundation, however, the relatively light slab around them is being pushed upward severely. As the interior surrounding slab is being pushed upward it separates vertically and horizontally at the slab surface along construction joints. This is evident by the severe horizontal and vertical separation between the two slabs adjacent to the column interior column bases (see attached **Photo # 3**).

Photo #3: Separation of the slab-on-grade construction joint at the interior steel column locations.

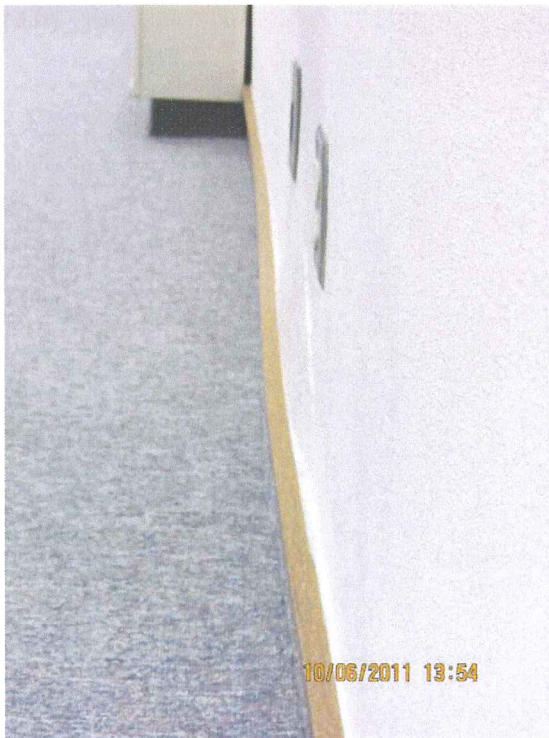
Joints between the slab-on-grade and the exterior foundation wall are showing signs of movement as the finishes on the exterior wall are buckling. This is evident along the west wall of the library stack area (see attached **Photo #4**). There is also evidence of movement between the slab-on-grade and the exterior wall along the north side of the building at the exterior walls of the classrooms (see attached **Photos #7 and #10**).

Photo #4: Buckling of wall finishes at west exterior wall.

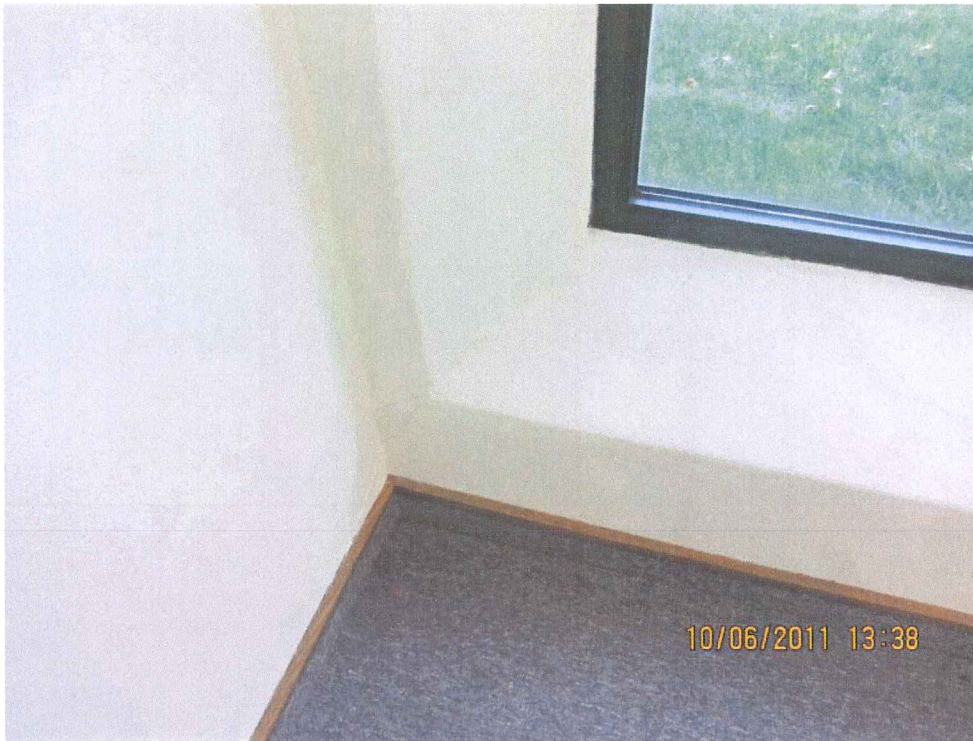
There are also signs of distress in exterior wall finishes such as cracks in the precast concrete exterior wall panels (see attached **Photo #5**). These cracks are present in the library stack area; the rooms on the west side of the stack area and in the classrooms on the north side of the building.

Photo #5: Distress at exterior precast concrete wall panels – north exterior wall.

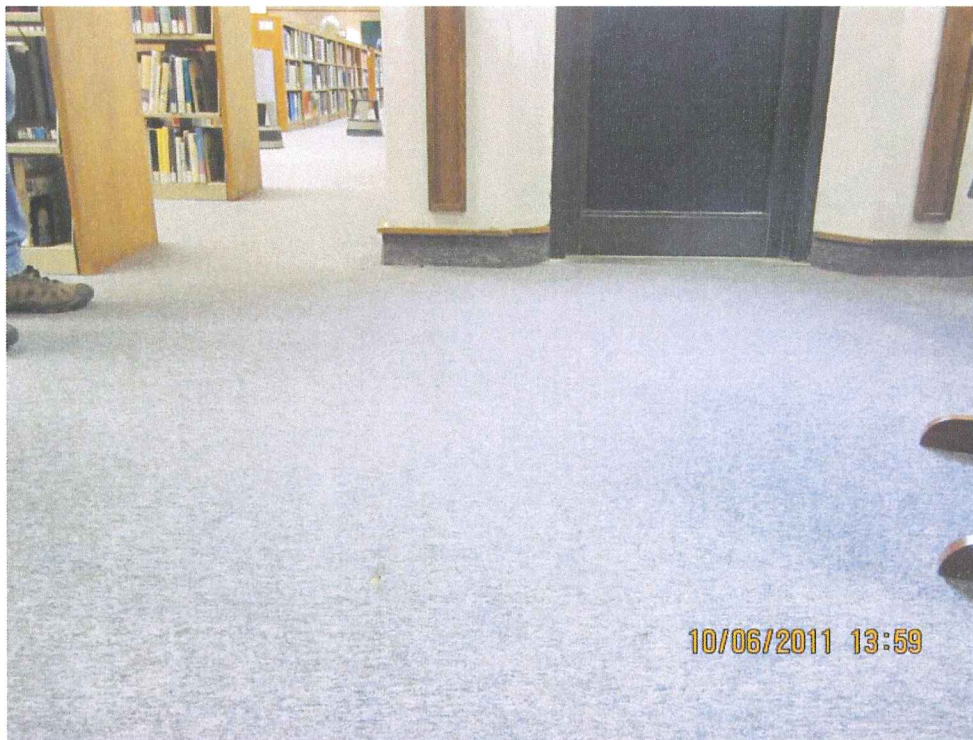
The interior slabs are separating vertically and horizontally at the construction joints. The vertical separation is as much as 1/2" and the horizontal separation as much as 3/4" in some areas. The slab joint in the main floor corridor on the north side of the building is showing such signs of separation (see attached **Photo #11**). The slab joint beneath the carpet in the library stack area near the emergency exit door is also showing signs of separation (see attached **Photo #6**).

Photo #6: Separation of interior slab-on-grade at construction joints near emergency exit door.

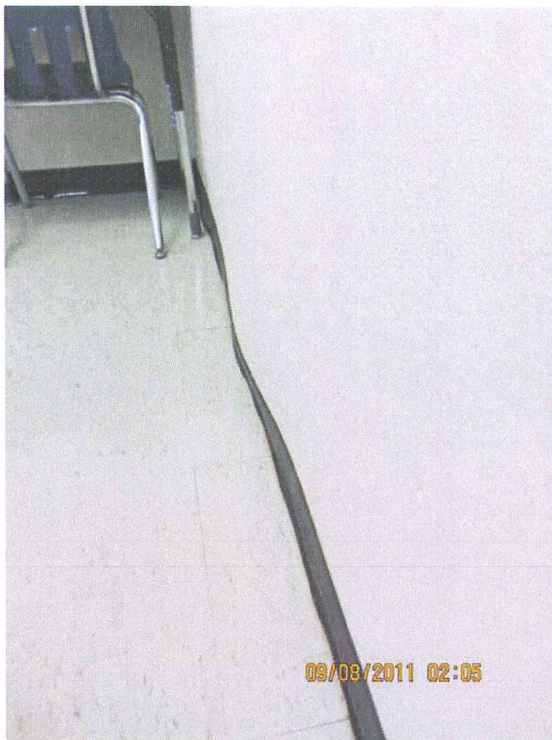
Photo #7: Buckling of wall finishes at classrooms on north exterior wall.

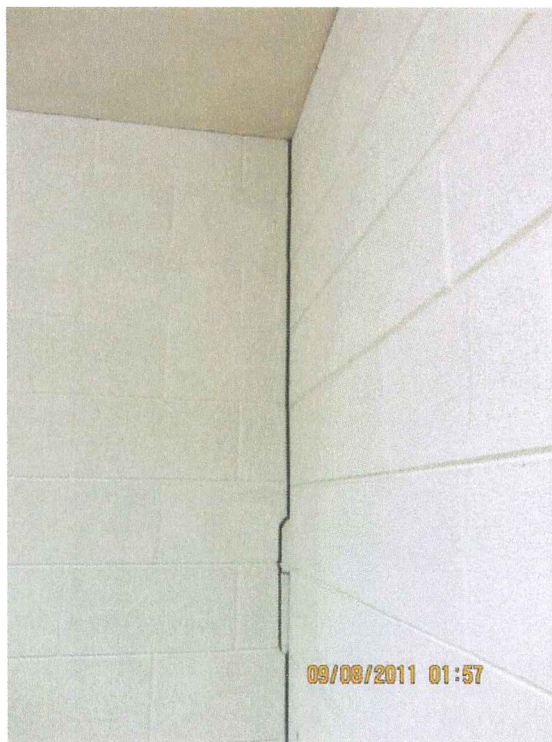
There is severe cracking in the finishes of the interior walls throughout the building. There are cracks in the wall finishes of the rooms along the west side of the stack area (see attached **Photo #12**) as well as in the classrooms on the north side of the building (see attached **Photos #8 and #9**).

Photo #8: Vertical and horizontal separation of interior CMU wall at classrooms on north side of building.

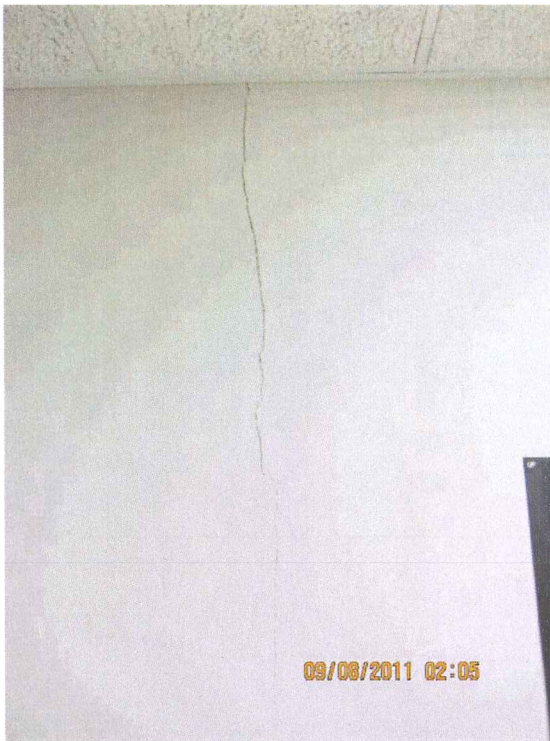
Photo #9: Cracking of interior wall finishes in classroom on north side of building.

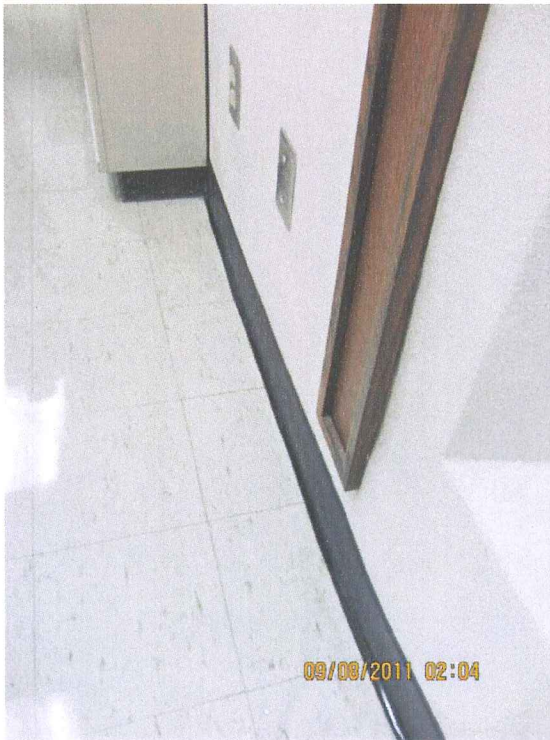
Photo #10: Buckling of floor and wall finishes on north exterior wall of classroom.

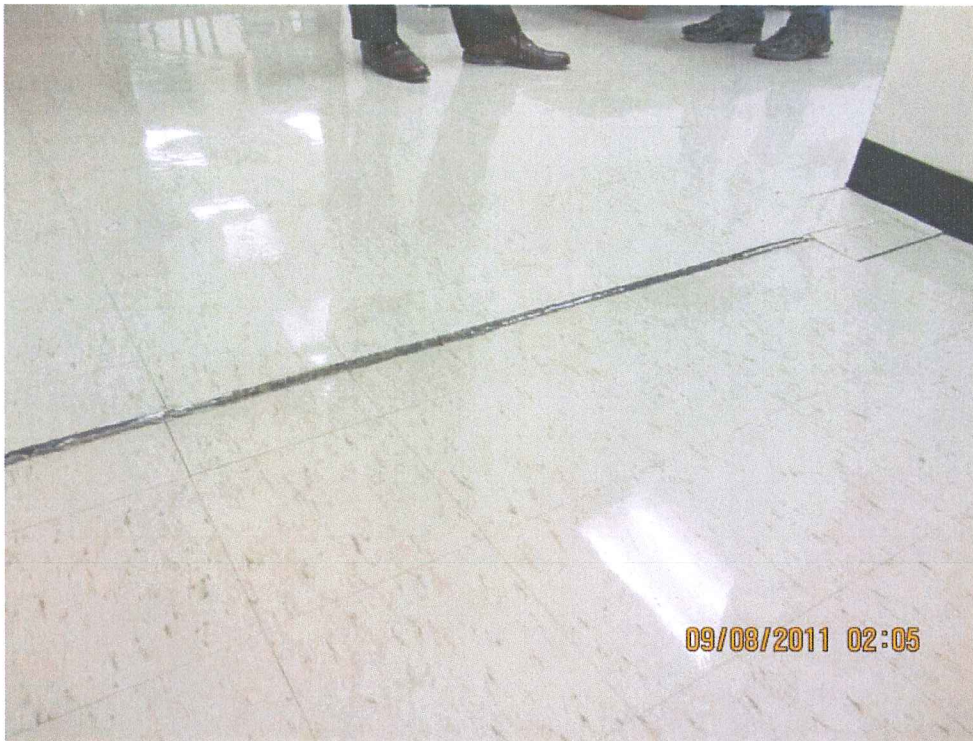
Photo #11: Movement and vertical separation in slab joint in classroom corridor on north side of the building.

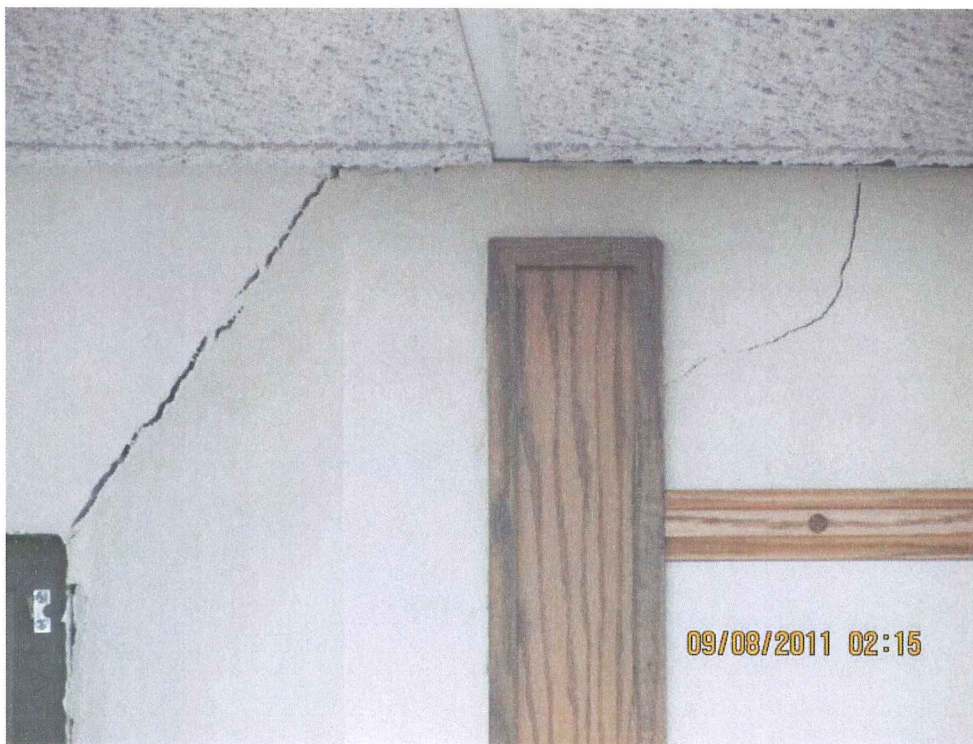
Photo #12: Cracking of interior wall finishes on west side of library.

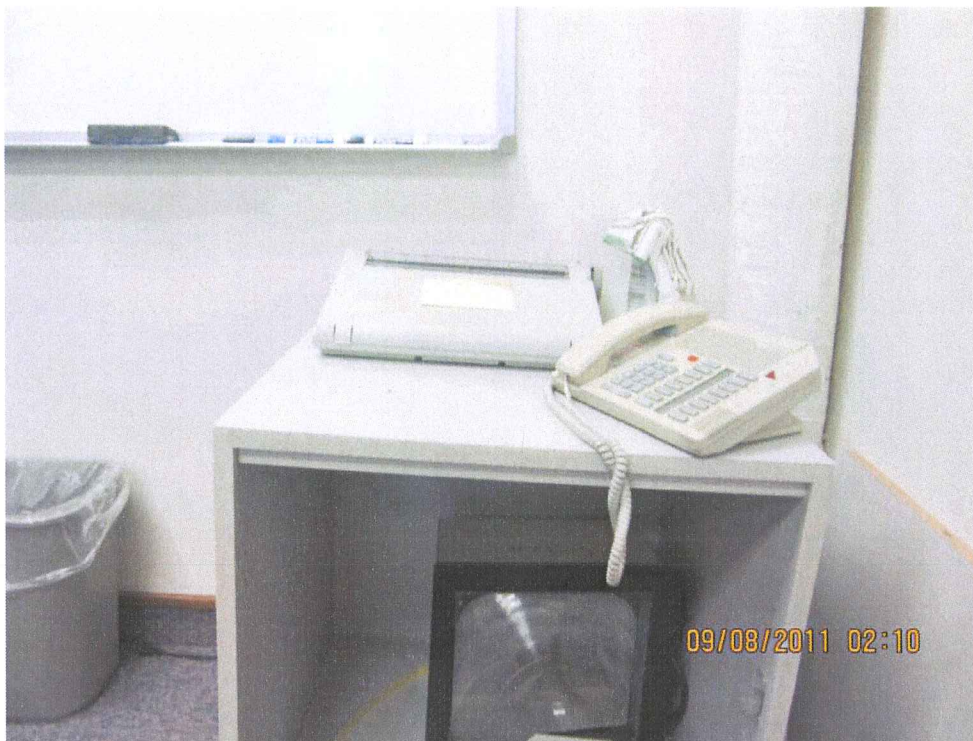
The main floor slab-on-grade is also showing significant to severe signs of crowning. This crowning in the floor slab is common throughout the entire building but is particularly noticeable along all of the perimeter main floor walls. The slab on grade in the library stack areas and perimeter rooms to the north and west of the stack area are severely crowned upward with the interior areas higher than the exterior. For example, the floor slab in Conference Room 101D is out of level by 2 9/16" over a 6 foot length perpendicular to the west wall of the room with the slab sloping downward sharply from the interior of the room west to the exterior wall. Also, the slab in the CCTV Typing Room is out of level by 1 7/8" over a 6 foot length perpendicular to the west wall of the room also sloping downward sharply from the interior of the room to the exterior wall. This slope is evident by the lean of counters and bookcases adjacent to the exterior wall in the attached photos (see attached **Photos #13 and #14**).

expansive soils. The interior slabs and the interior partition walls placed on them are relatively light and therefore highly effected by the expansive clay soil heave. This is evident by the buckling of finishes along the exterior walls (see attached **Photos #4, #7 and #10**). This differential movement is also evident in the severe slab slope downward toward the exterior walls in the rooms on the west side of the library stack area (see attached **Photos #13 and #14**).

Photo #13: Leaning counter due to sloping floor in CCTV Room on west side of building.

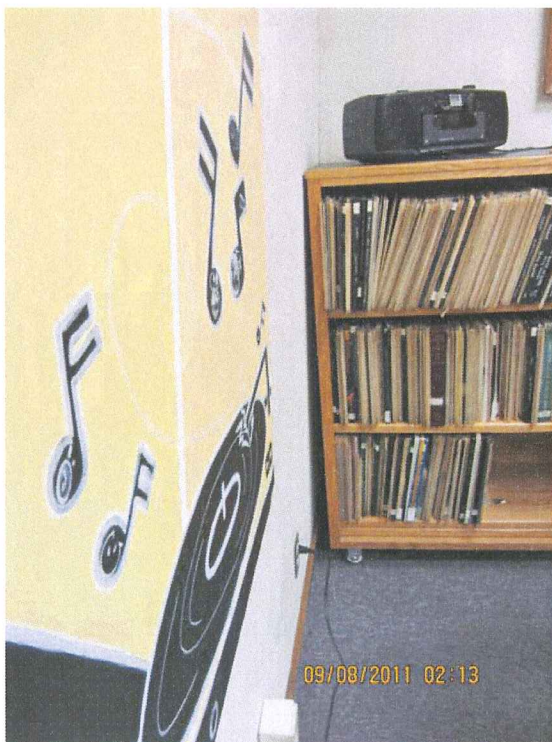
Photo #14: Leaning shelving unit in room on west exterior wall.

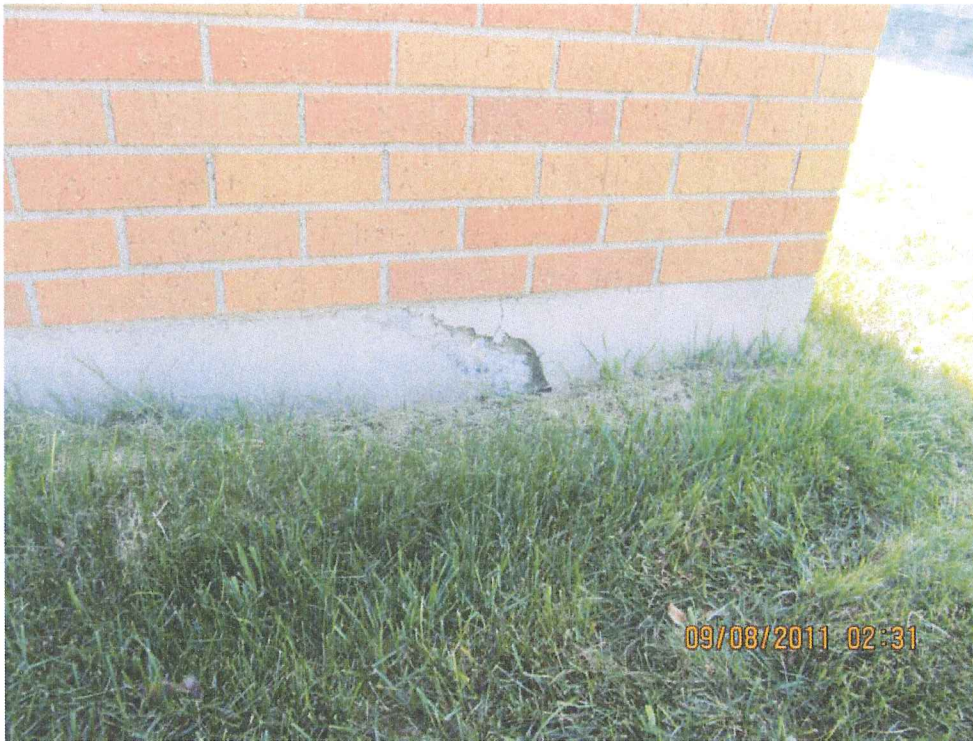
There is some evidence of movement in the exterior walls of the building which is visible from the building exterior such as cracks in the top of the foundation wall along the west side of the building (see attached **Photo #15**).

Photo #15: Signs of distress in the foundation wall on the west side of the building.

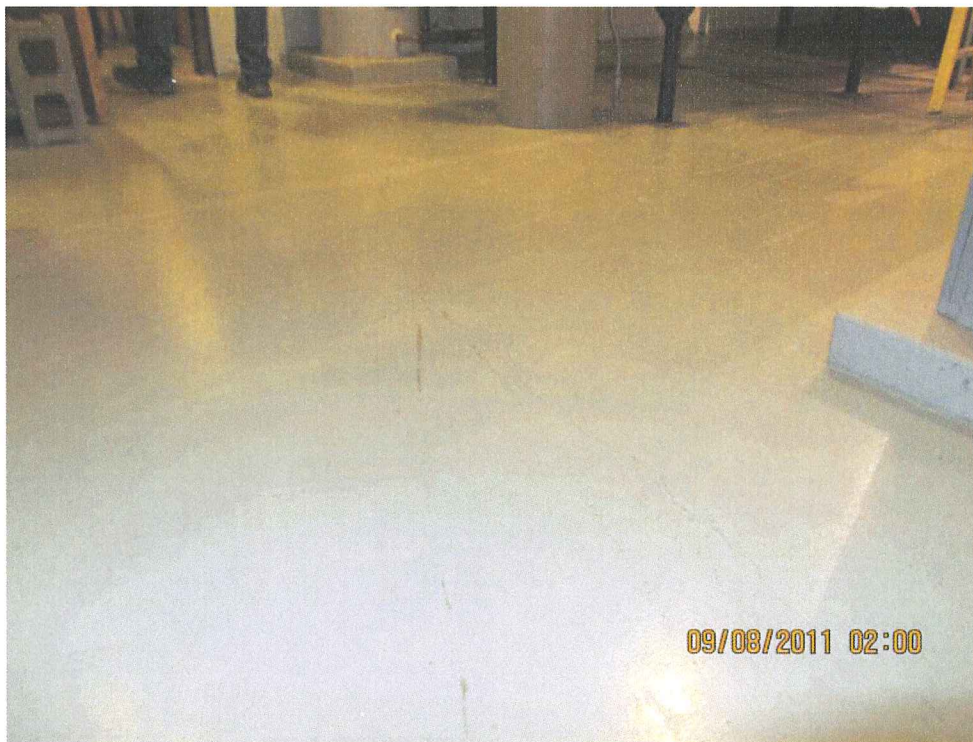
The interior slabs-on-grade in both the basement and on the main floor are showing significant to severe signs of crowning. There are numerous cracks in the exposed concrete slabs of the basement (see attached **Photos #16 and #17**). These cracks are relatively random in nature but appear to be more prevalent in the interior of the building footprint and radiate outward toward the exterior walls. The floor slabs also appear to be humped or crowned upward on the interior of the building relative to the building perimeter.

The exposed slabs in the basement mechanical and archive rooms are crowned or humped upward on the interior of the building relative to the exterior wall lines with crack patterns indicative of the effects of swelling or heave associated with highly expansive clay soils (see attached **Photos #16 and #17**).

Photo #16: Hump and cracking in the basement floor slab.

We recommend performing a soils investigation including soil sampling and testing to determine the remaining swell potential of the existing subgrade soils. This potential is based on the current moisture content present. If the existing soils can take on more moisture the added moisture will result in further expansion. The expansive soils can also be tested to determine the potential swell pressures and movement they can induce on the building foundations. Based on this information the building foundations can be further evaluated to determine the general effect this may have on building movement. Also, based on the possible amount of foundation movement, in particular differential movement, the building structure can be further evaluated for potential distress and the possibility for failure in extreme cases.

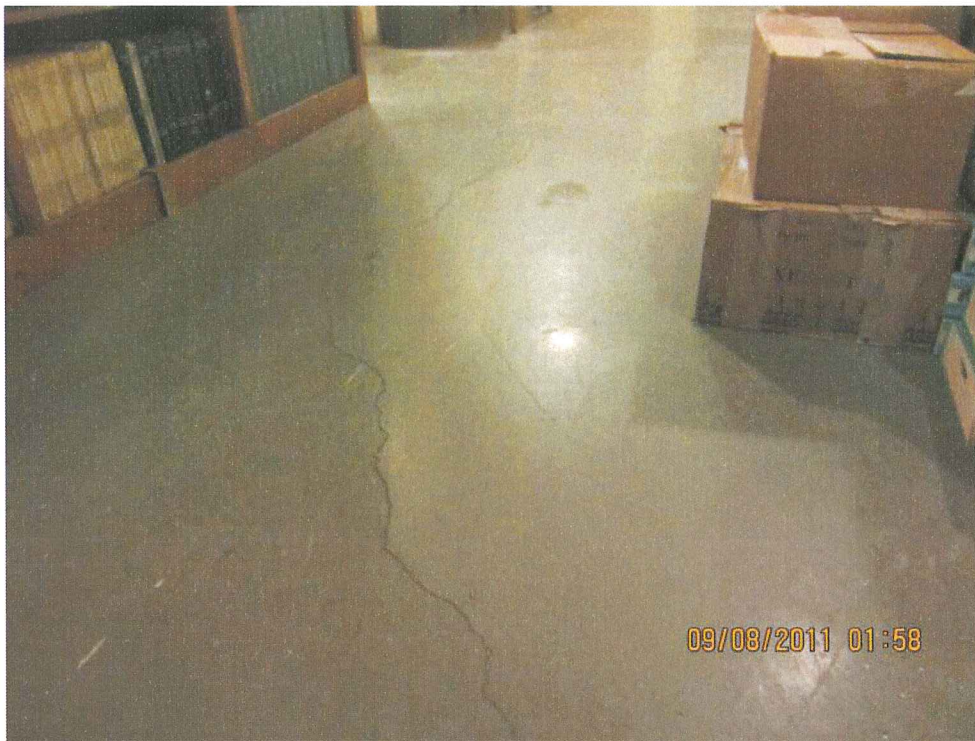
Photo #17: Hump and cracking in the basement floor slab.
