ICON
ARCHITECTURAL GROUP

**FACILITY ASSESSMENT FOR
NORTH DAKOTA YOUTH CORRECTIONAL CENTER
PHYSICAL PLANT**

Mandan, ND | July 2024

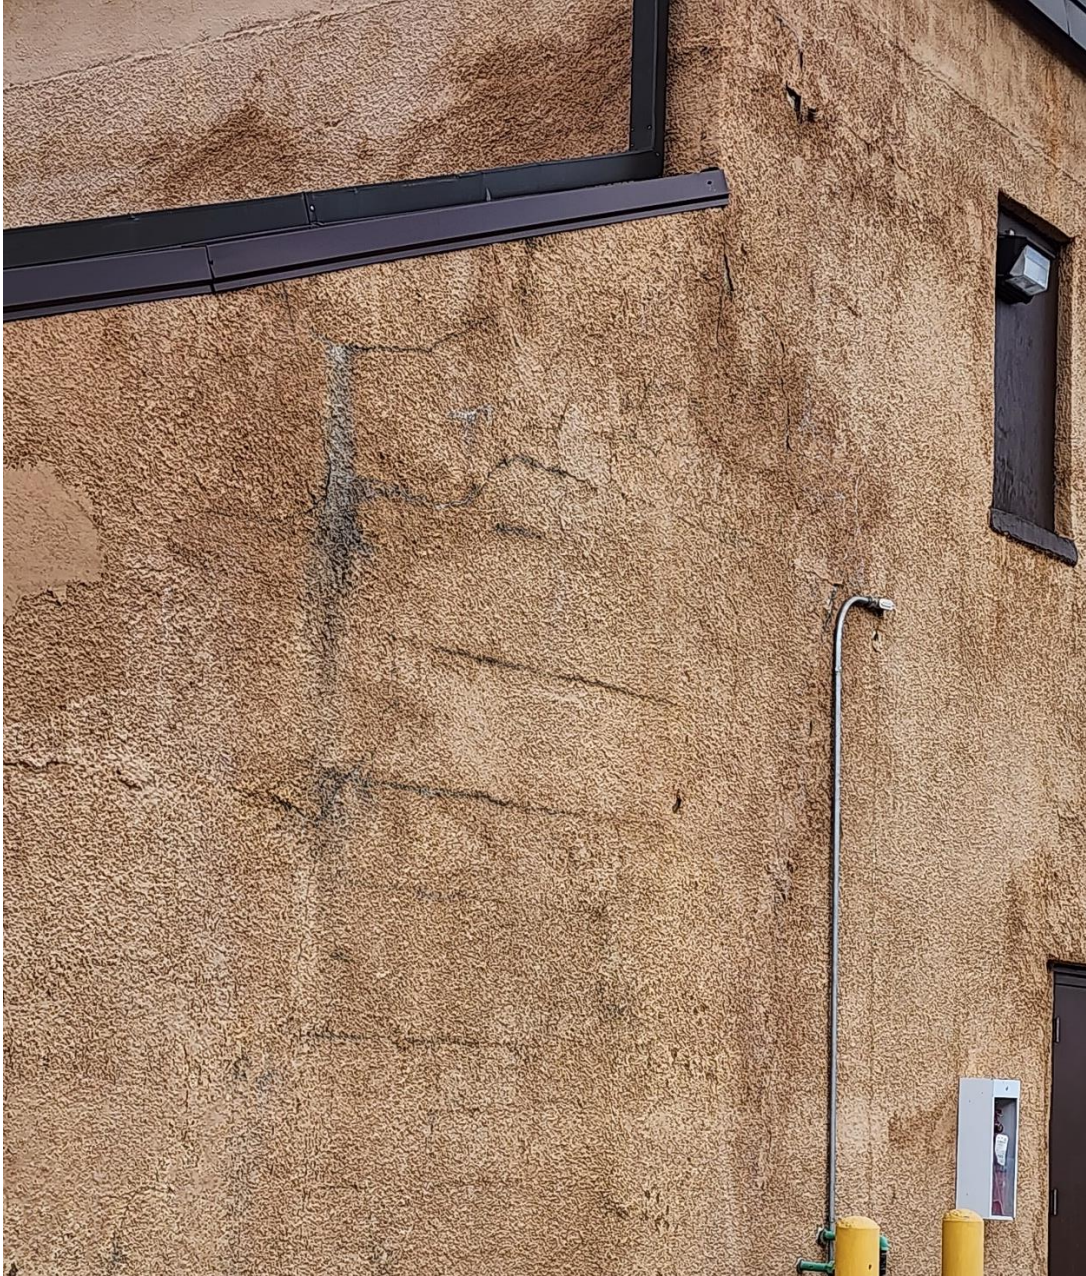
(Photo: 20240216_143818)

Exterior EIFS in poor condition.

Extensive cracking and evidence of water infiltration causing material failure.

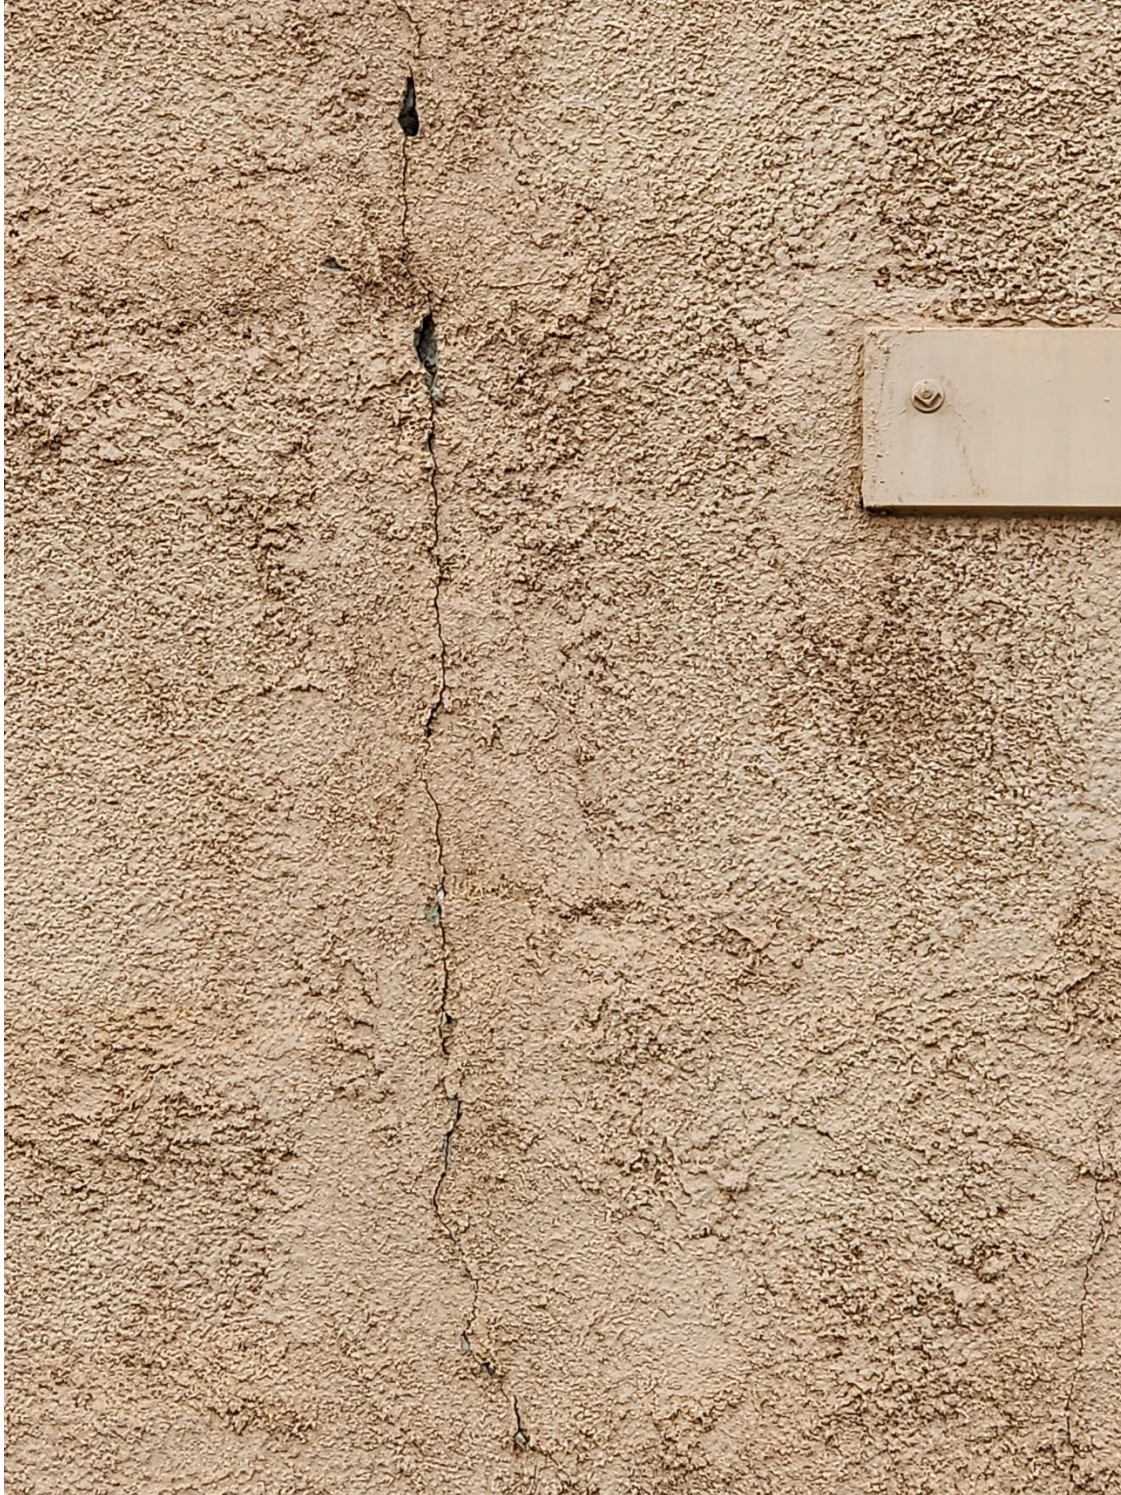
Exterior EIFS in poor condition.
Extensive cracking and evidence of water infiltration causing material failure.
(Photo: 20240216_143856)

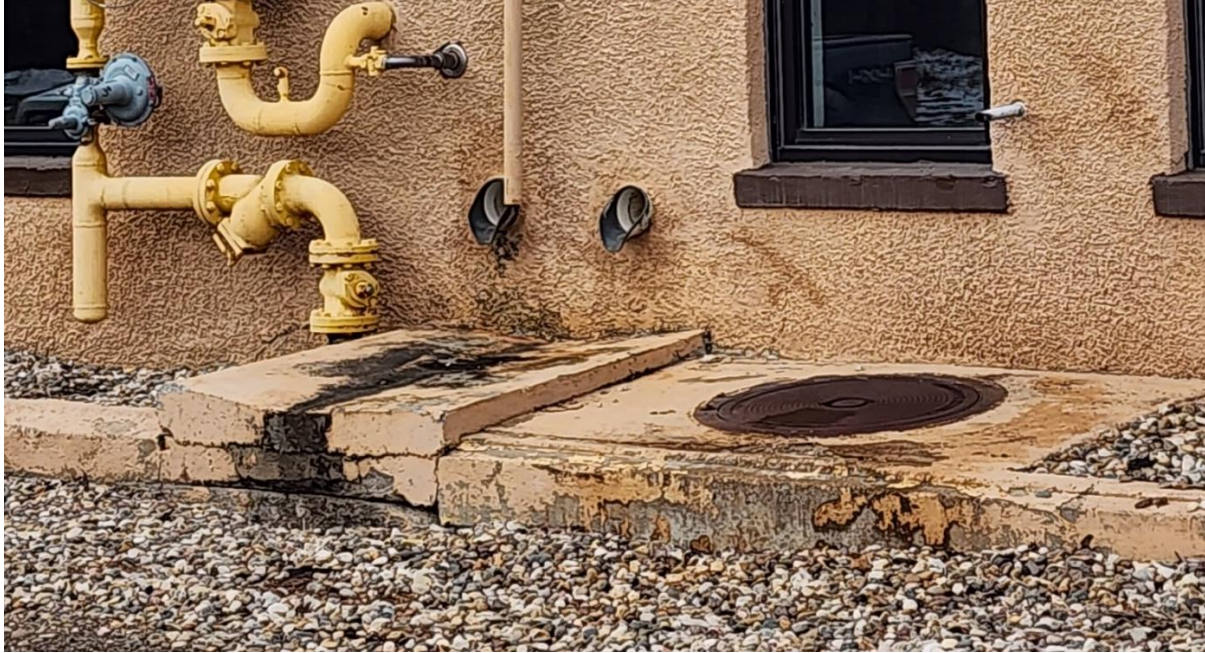
Exterior drainage along wall and foundation in poor condition.
Evidence of water infiltration.
(Photo: 20240216_1440009)

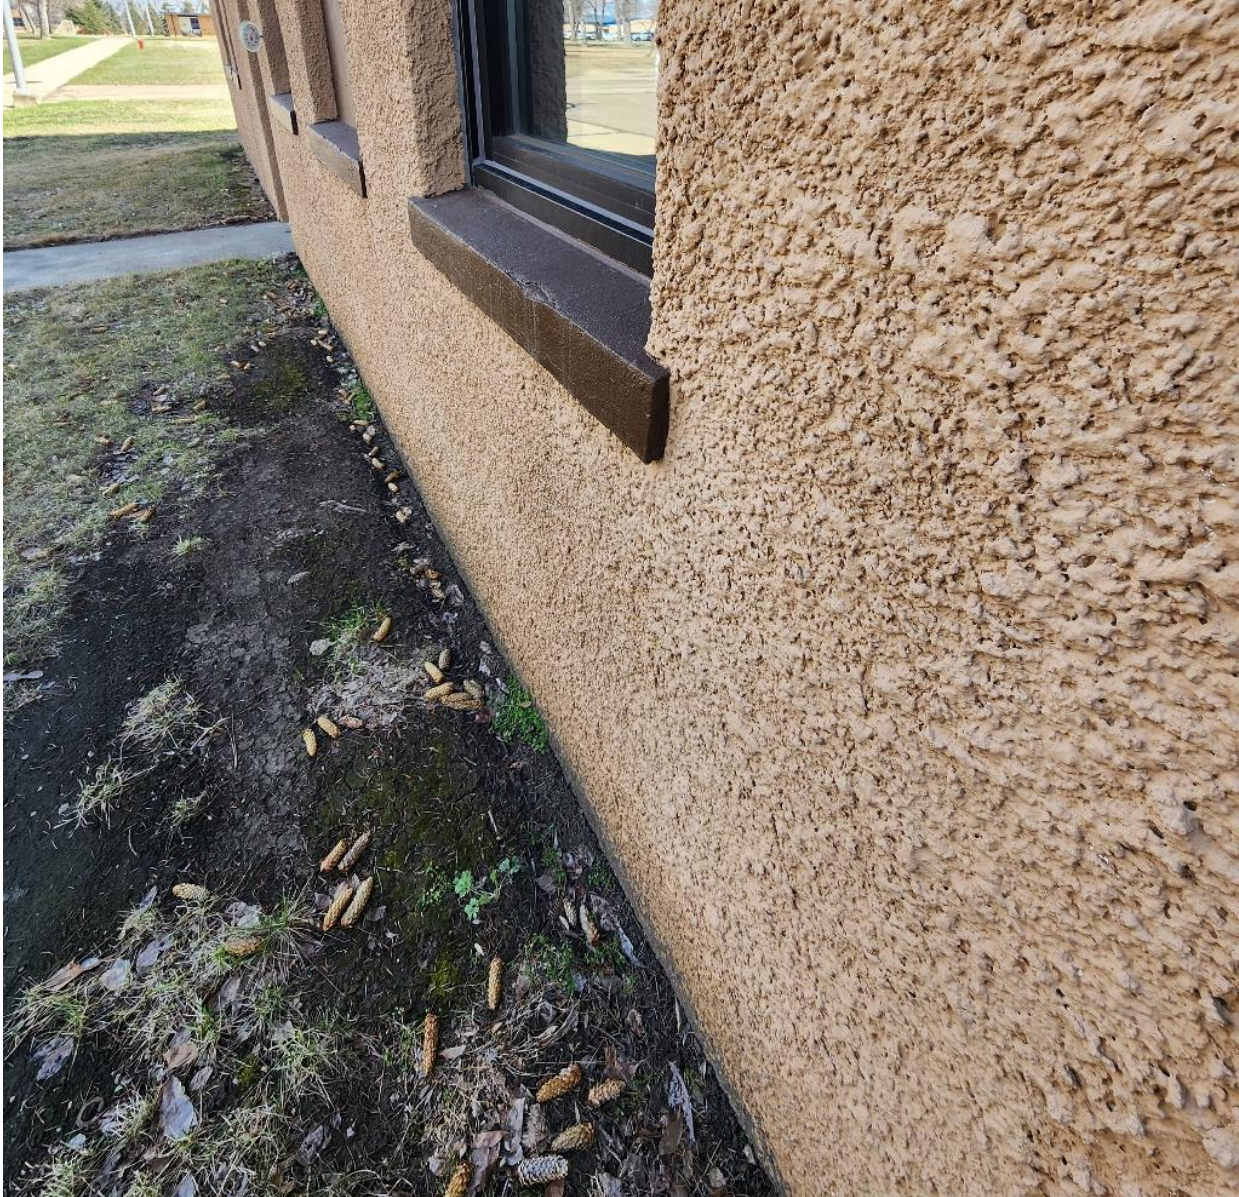
Exterior drainage along the wall and foundation in poor condition.
Evidence of water sitting along the foundation wall.
(Photo: 20240411_145949)

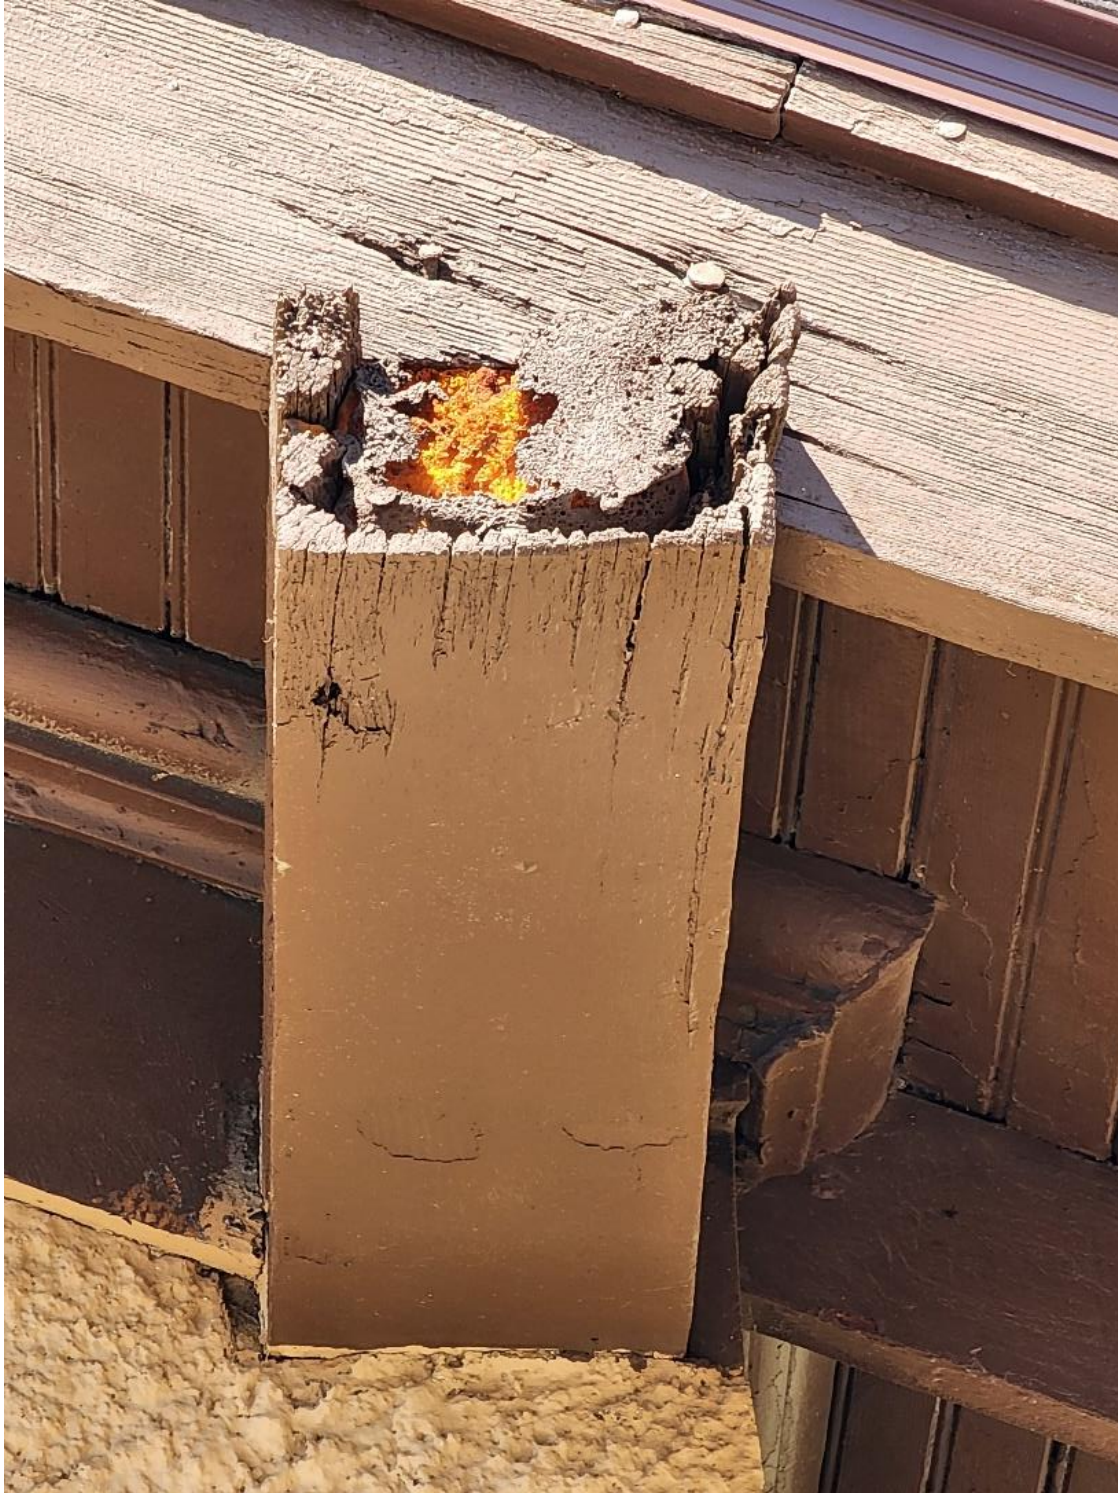
(Photo: 20240411_150158)

Exposed wood framing, including structural beams, are showing signs of decay and rotting. Structural failure has not occurred but is impending with the visibly poor condition of the wood beams.

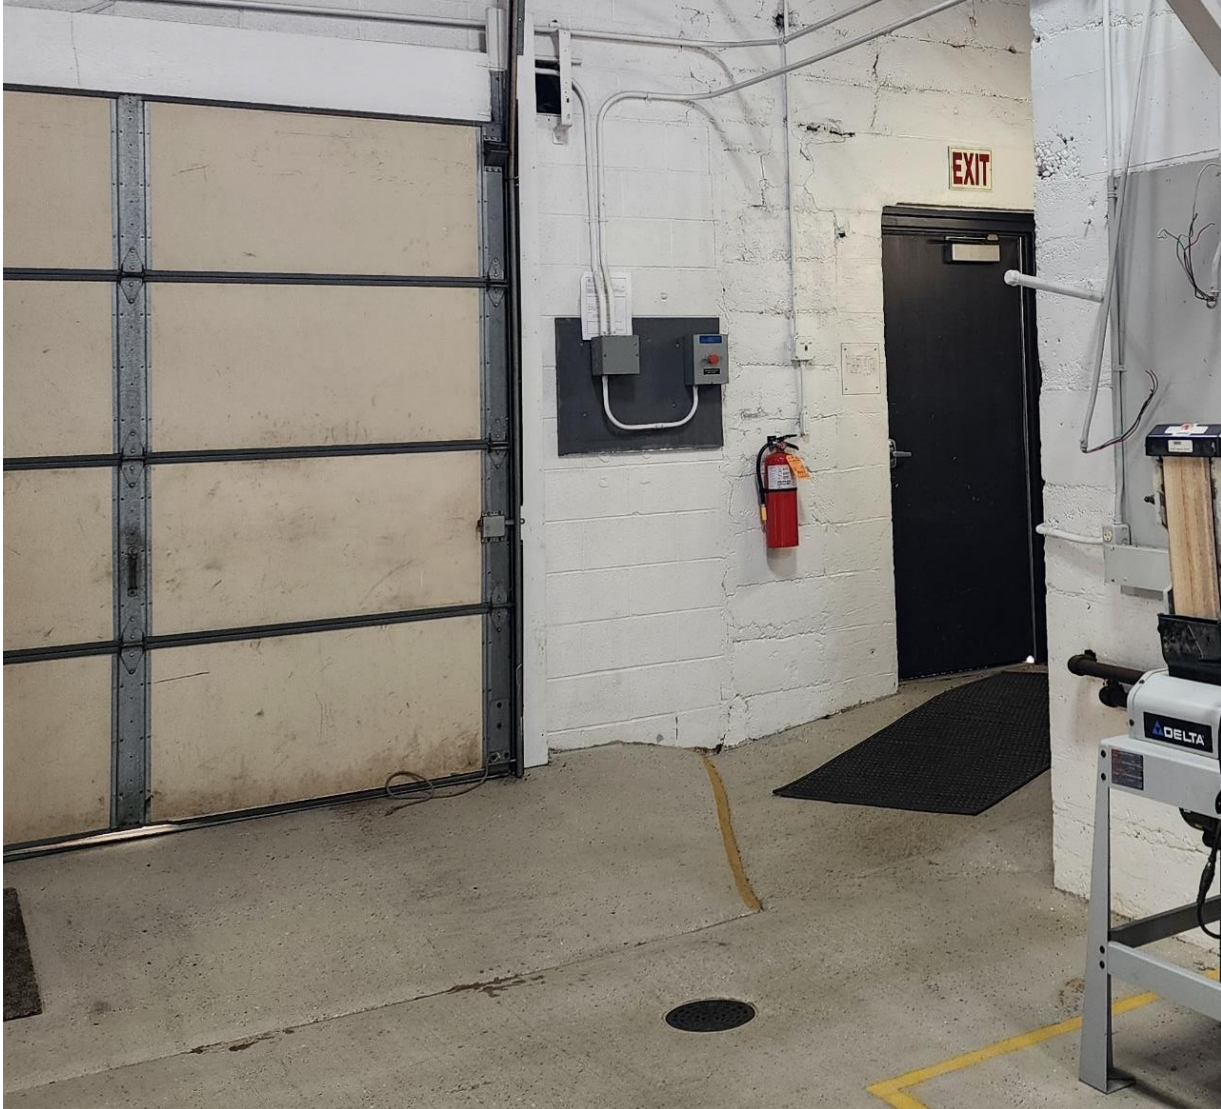
(Photo: 20240216_140711)

Uneven floor conditions not meeting ADA requirements.

Poor condition of interior CMU walls.

Daylight evident at doors.

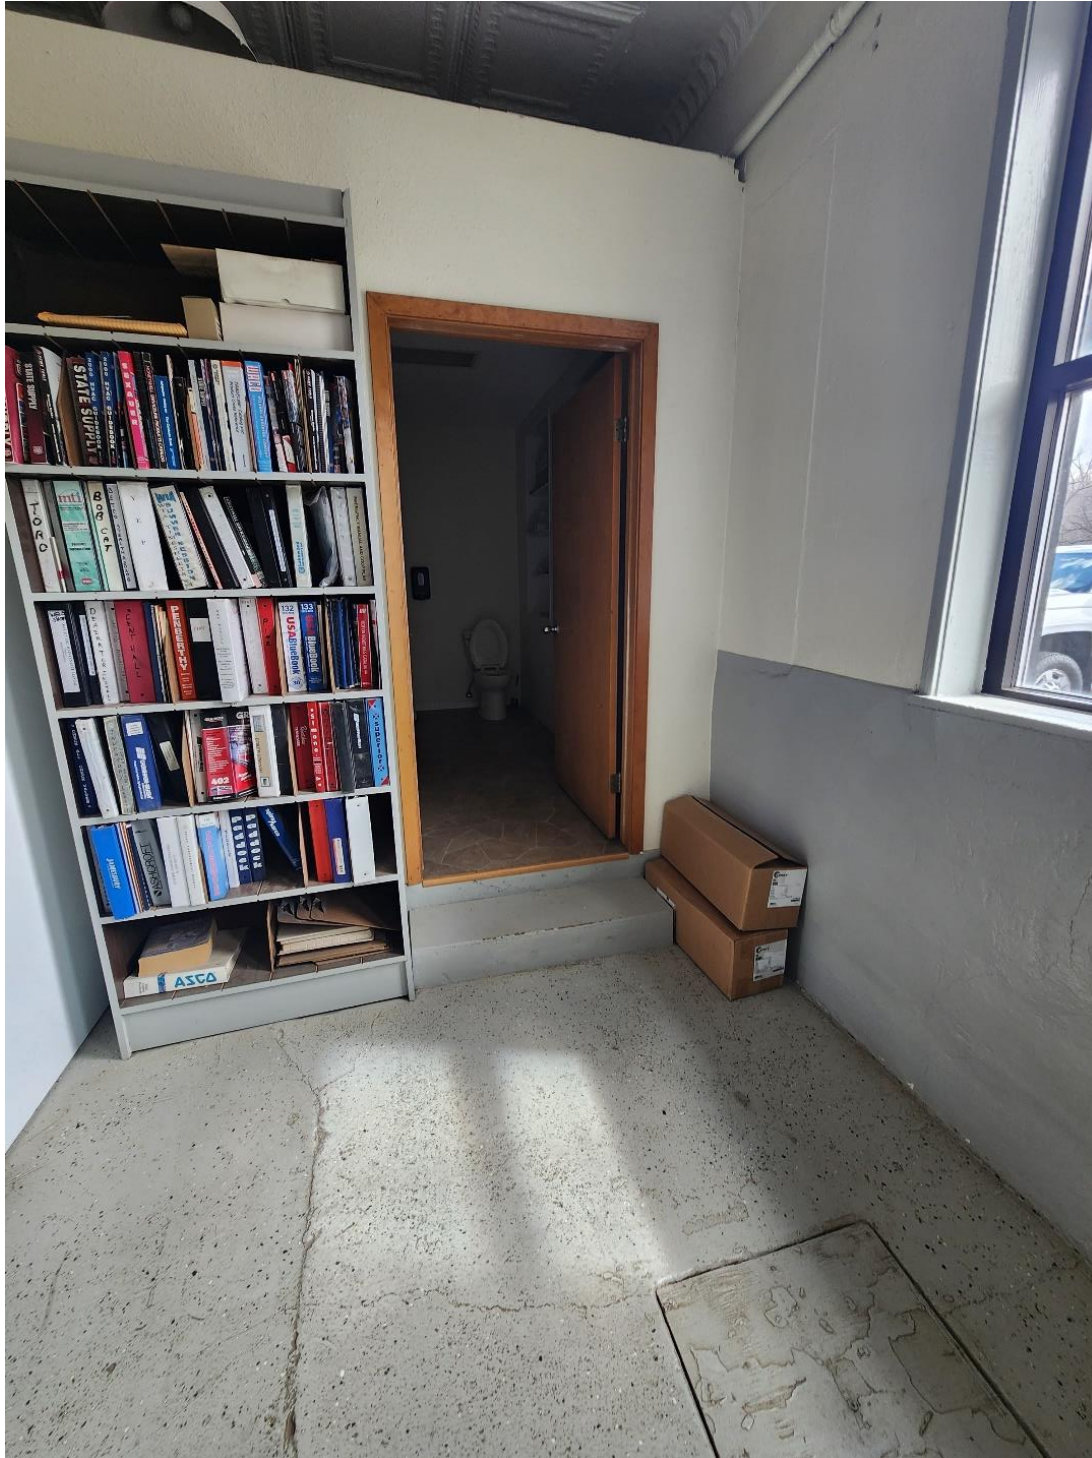
Restroom access does not meet ADA requirements.
Wall does not extend to bottom of roof structure above.
Extensive floor slab cracking
(Photo: 20240216_142755)

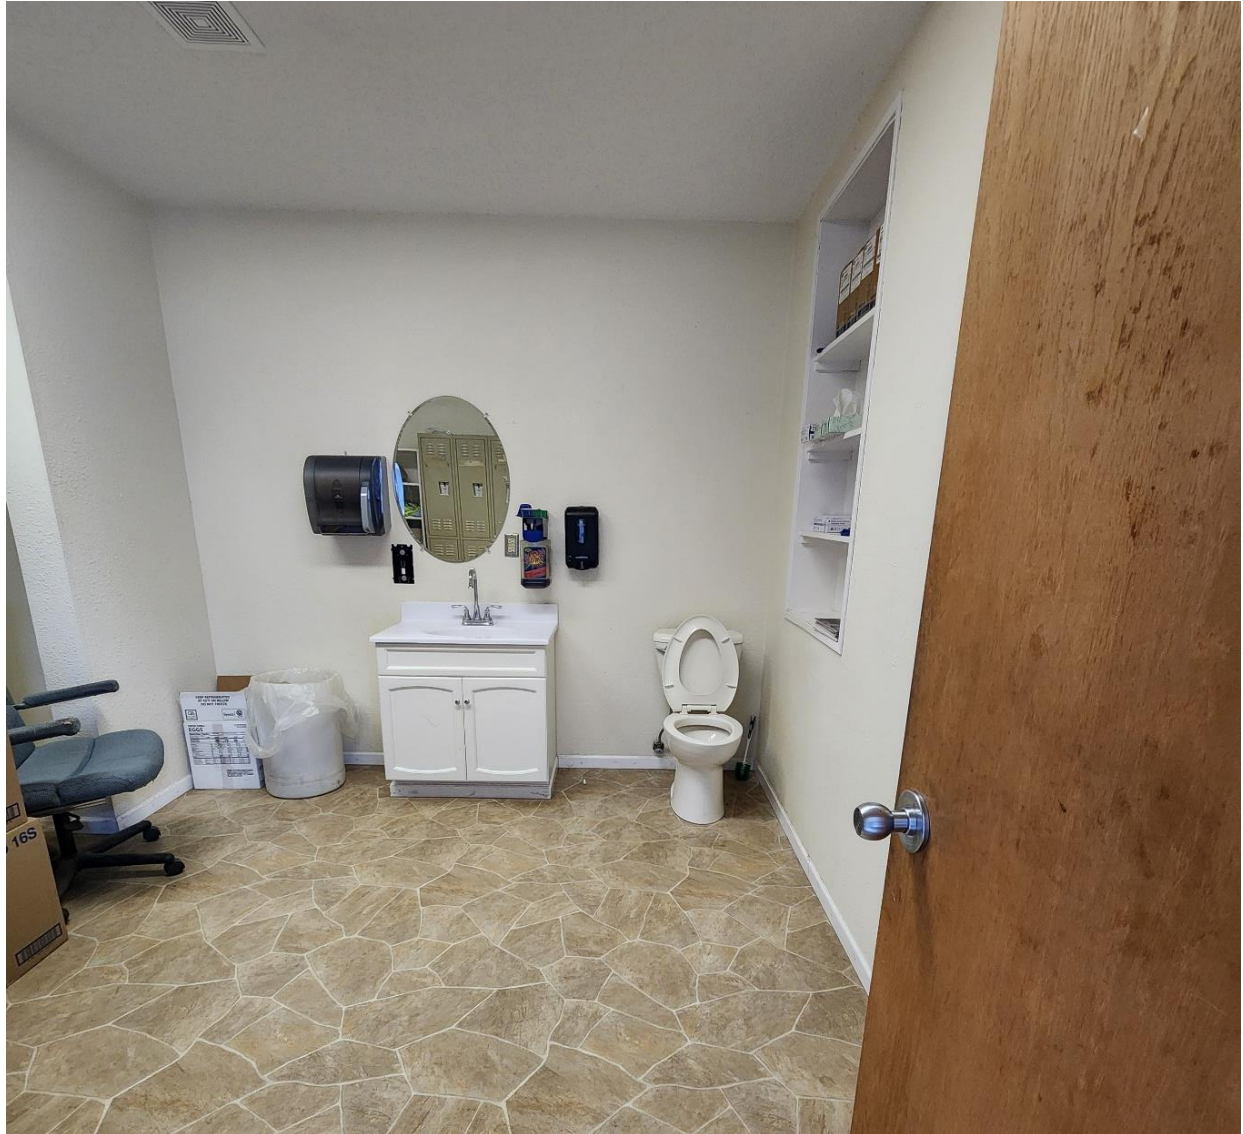
Restroom fixtures do not meet ADA requirements.
No grab bars as required by ADA.
Door hardware does not meet ADA requirements.
(Photo: 20240411_142814)

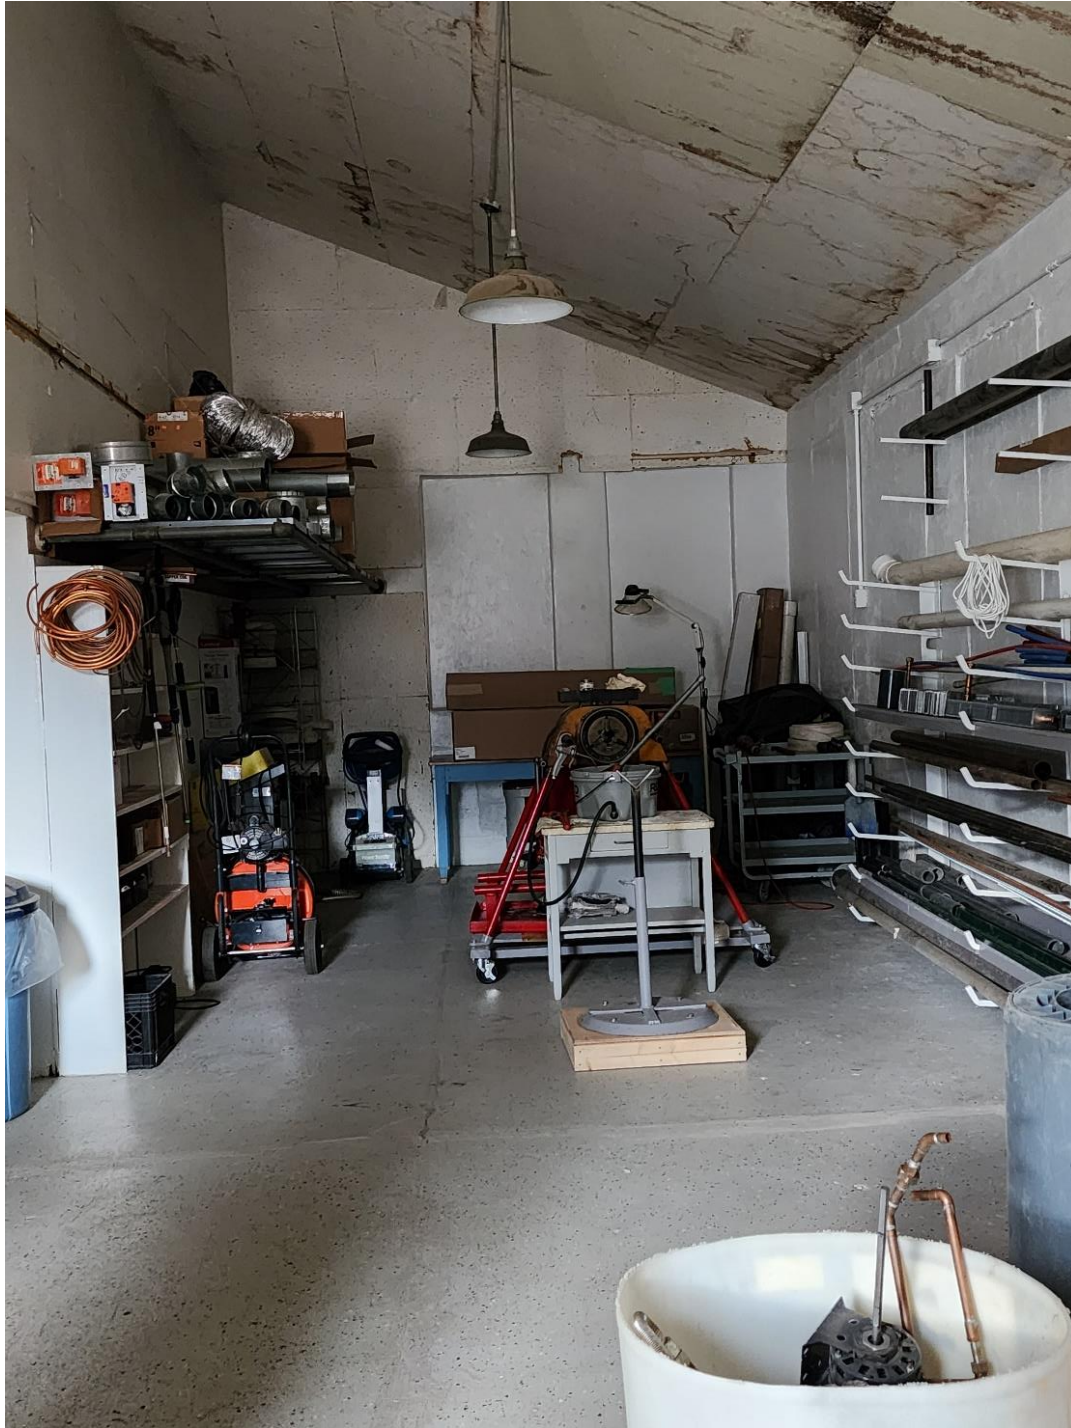
Improper ceiling material and installation.
Extensive water damage on ceiling.
Evidence of mold – not tested.
No fire suppression.
(Photo: 20240216_142237)

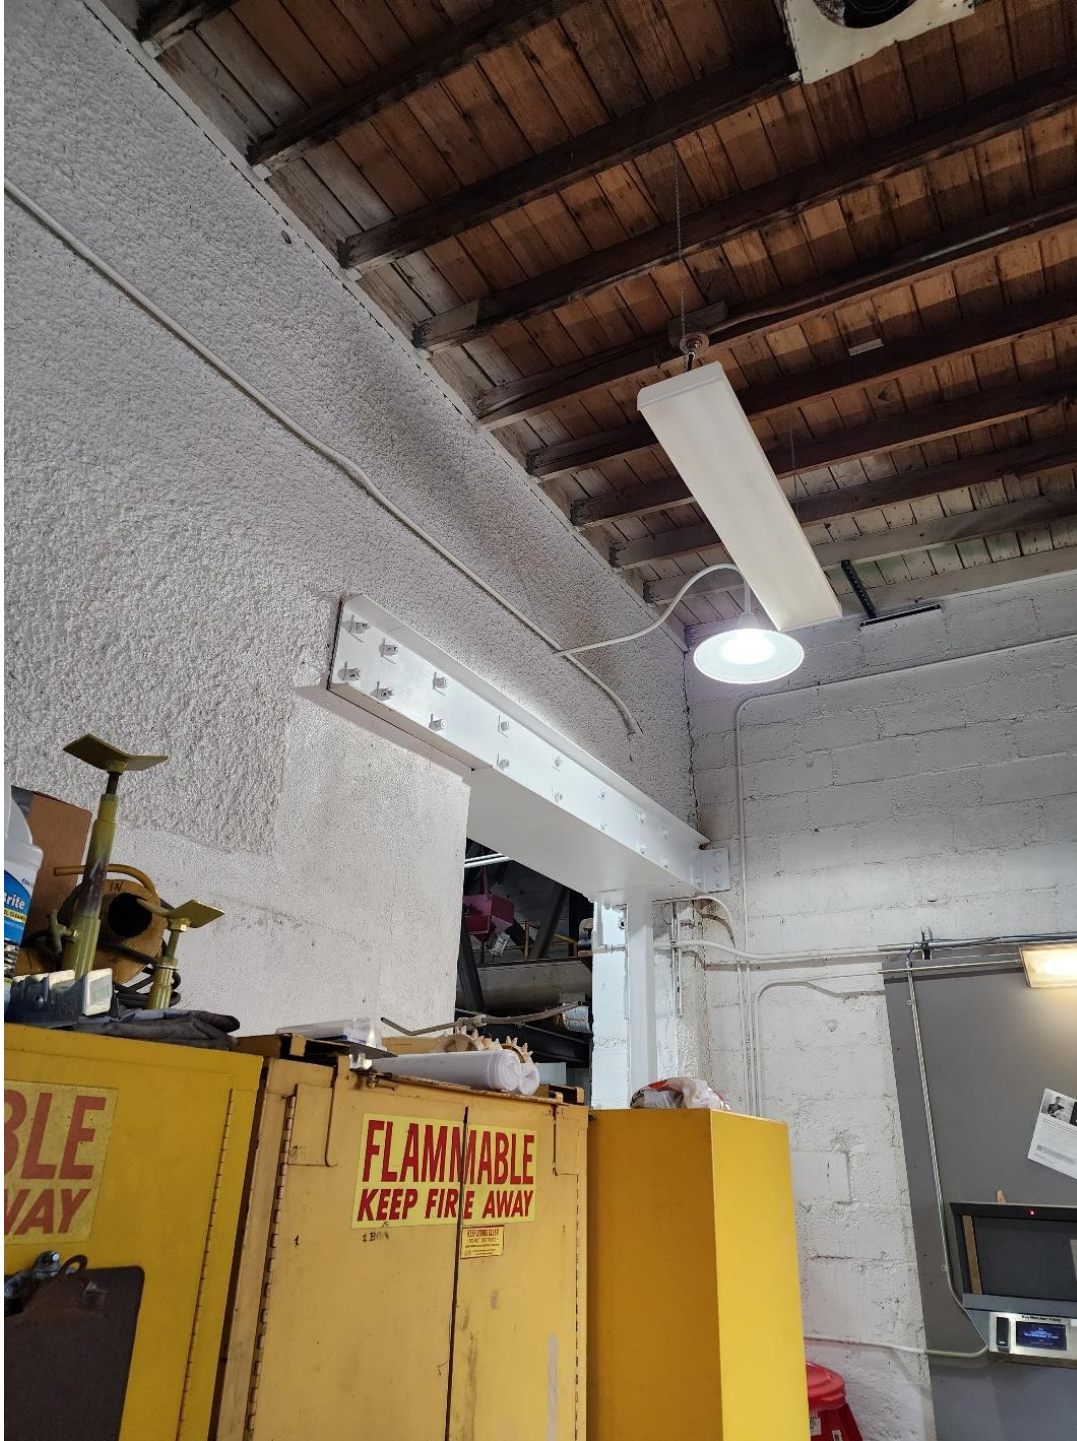
Unprotected ceiling structure.
Interior walls in poor condition.
No fire suppression.
(Photo: 20240216_141519)

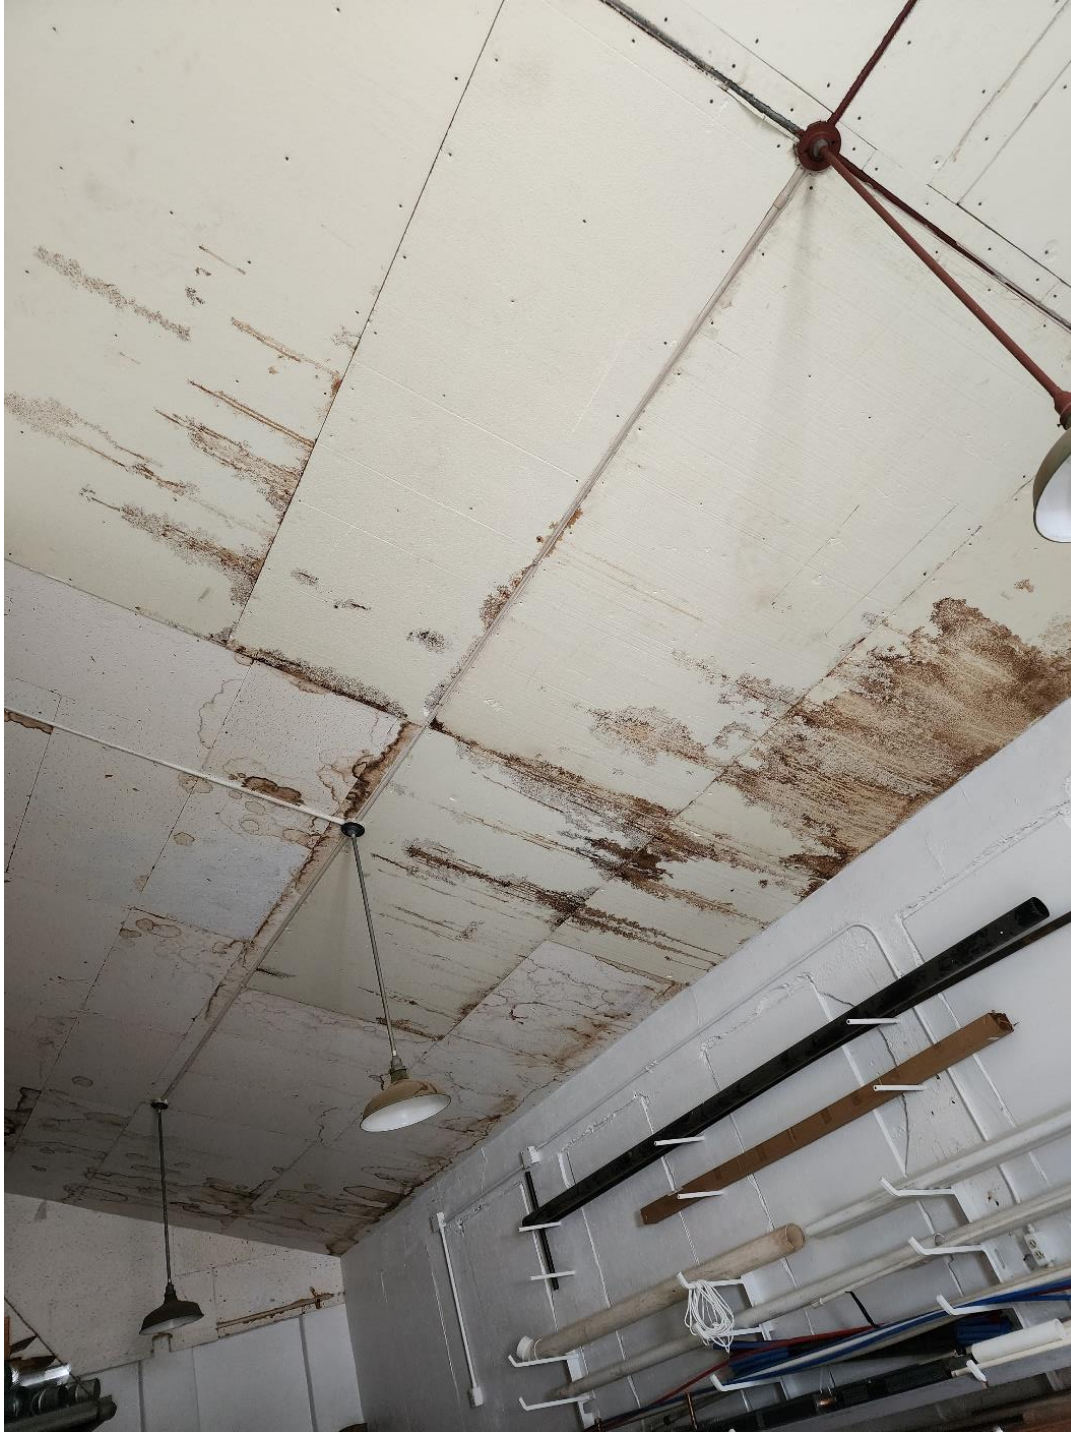
Extensive water damage on ceiling.
Evidence of mold – not tested.
No fire suppression.
(Photo: 20240216_142137)

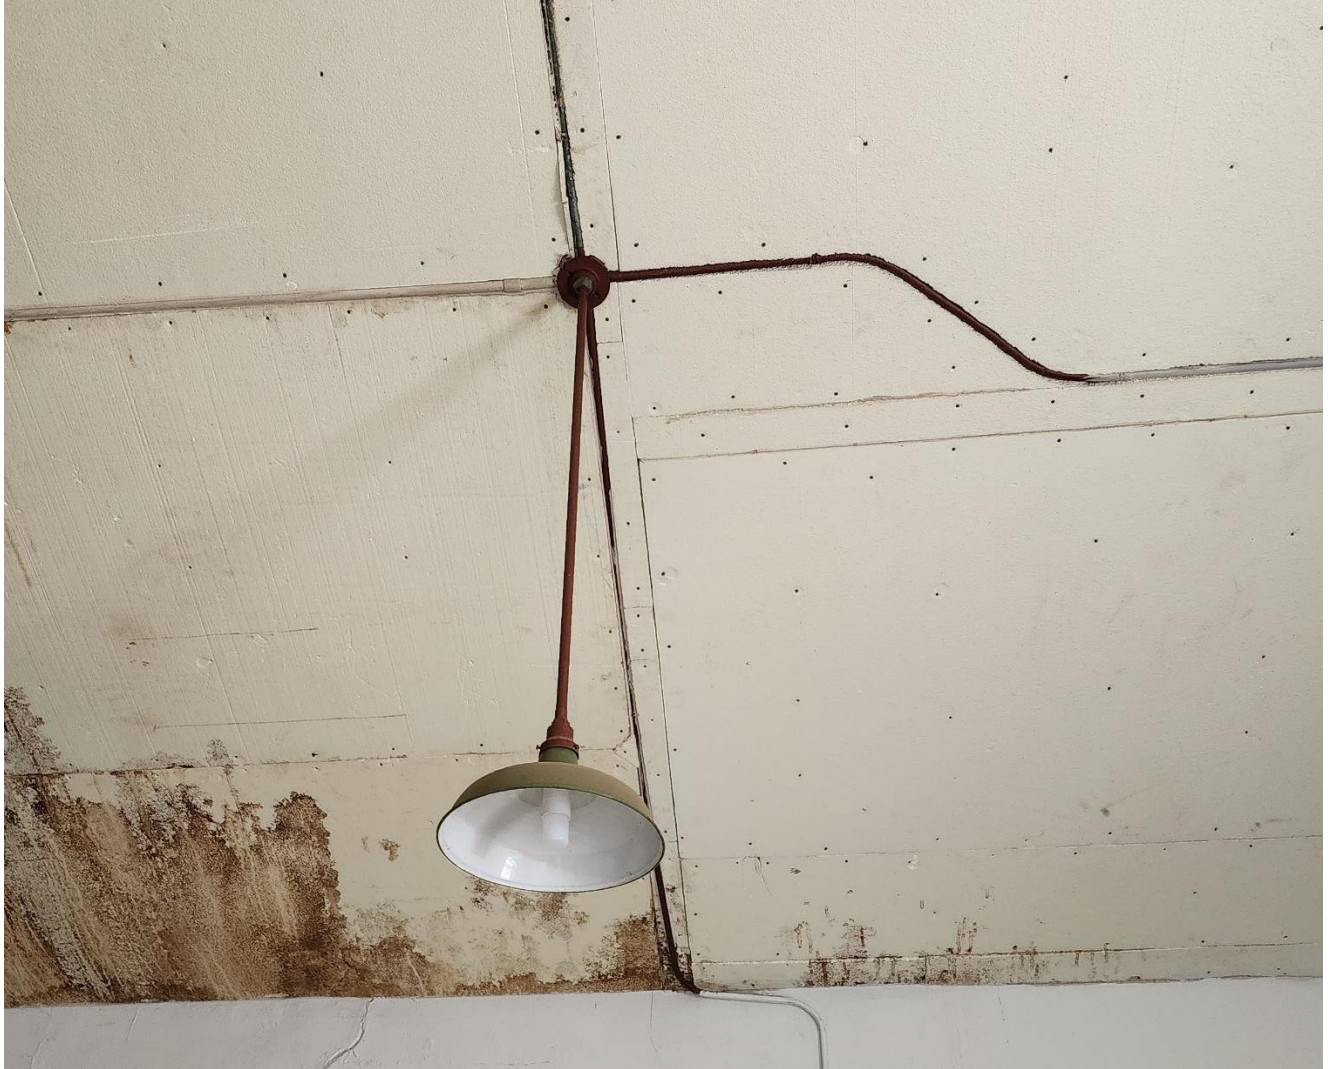
Extensive water damage on ceiling.
Evidence of mold – not tested.
Electrical conduit showing signs of water damage and rusting.
Lighting has not been updated.
(Photo: 20240216_142139)

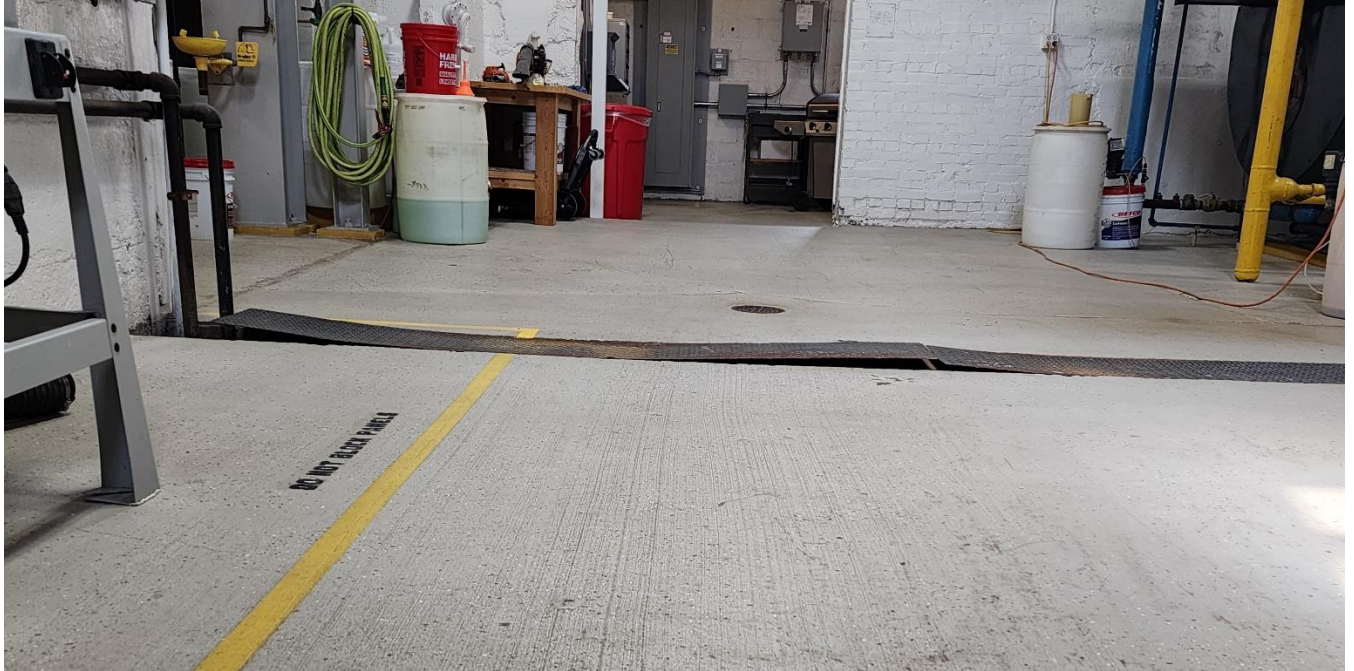
Bent trench drain covers within interior floor slab – potential tripping hazards.
(Photo: 20240411_141837)

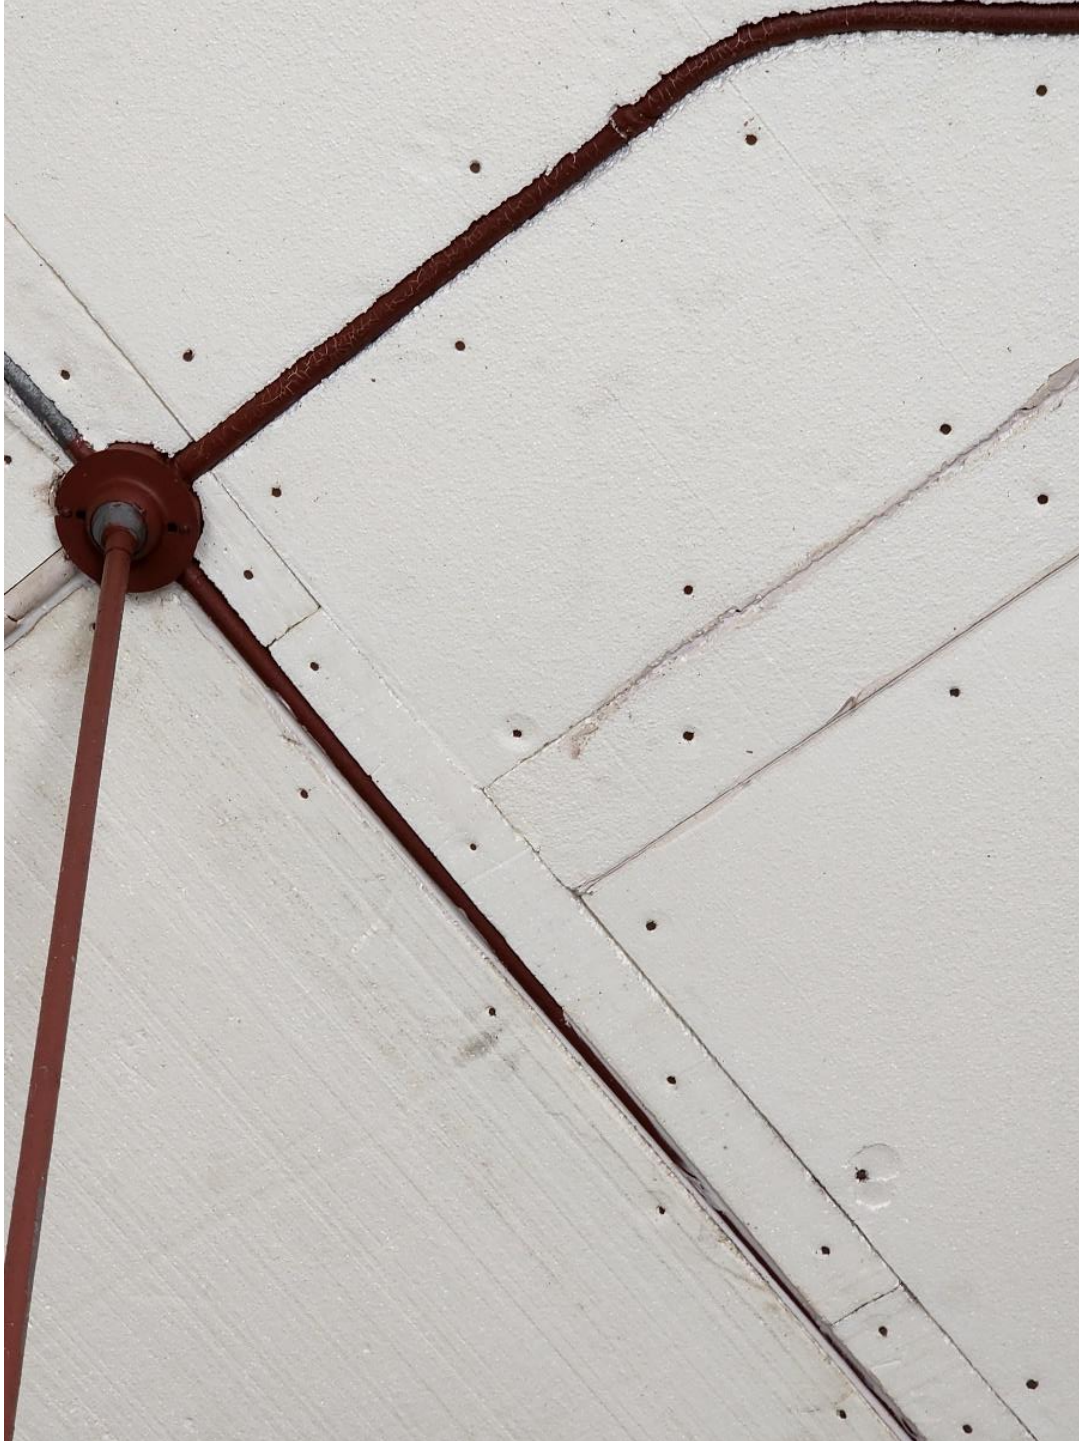
Nonstandard ceiling material.
Electrical conduit showing signs of water damage and rusting.
Lighting has not been upgraded.
(Photo: 20240216_142219)

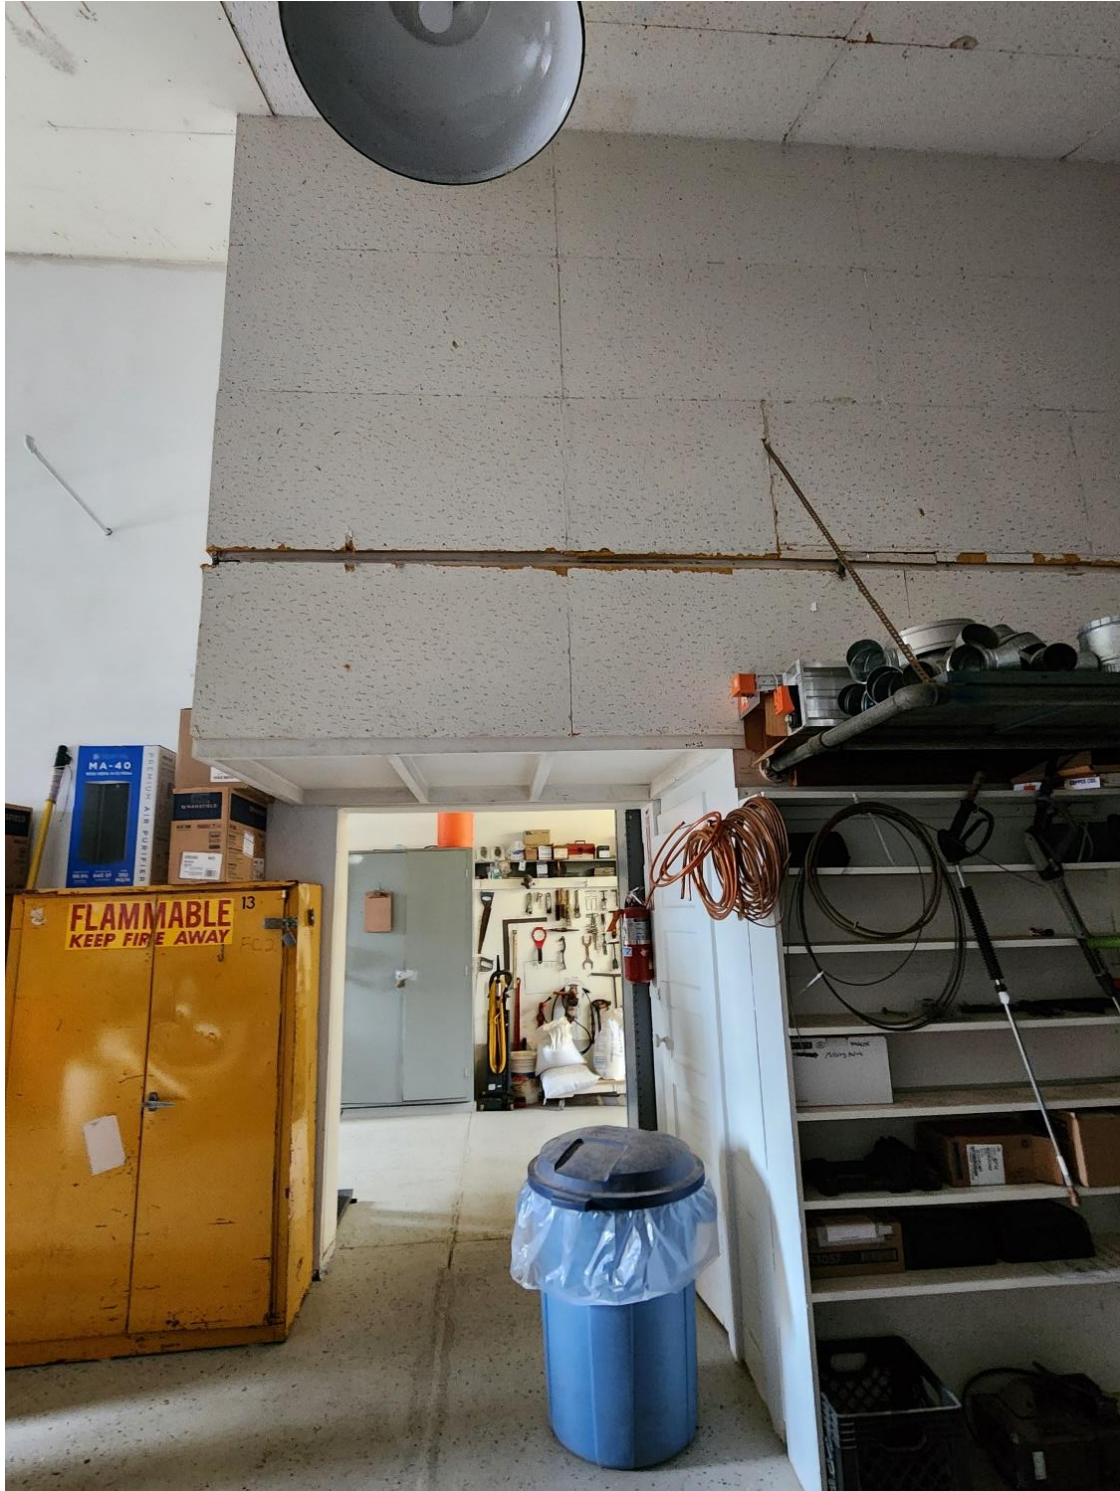
Minimum head clearance not met under stair.
(Photo: 20240216_142452)
