ICON
ARCHITECTURAL GROUP

**FACILITY ASSESSMENT FOR
NORTH DAKOTA YOUTH CORRECTIONAL CENTER
PHYSICAL PLANT**

Mandan, ND | July 2024

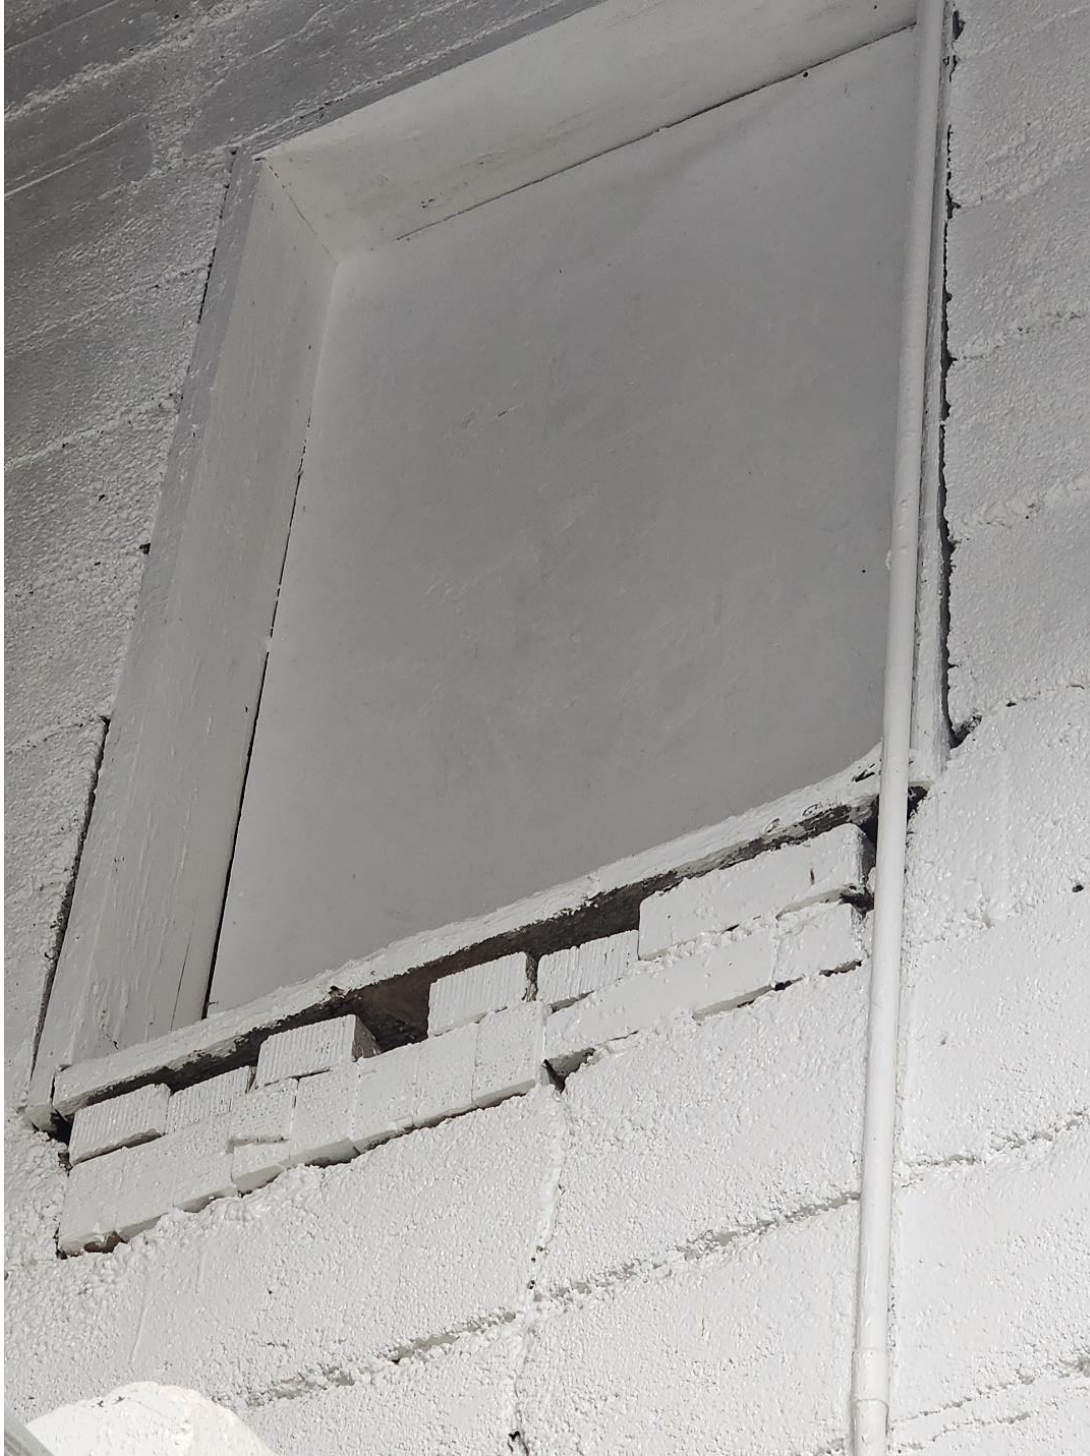
Window jambs and sills in poor condition and non-standard construction methods.
Location of water and pest infiltration.
(Photo: 20240411_135835)

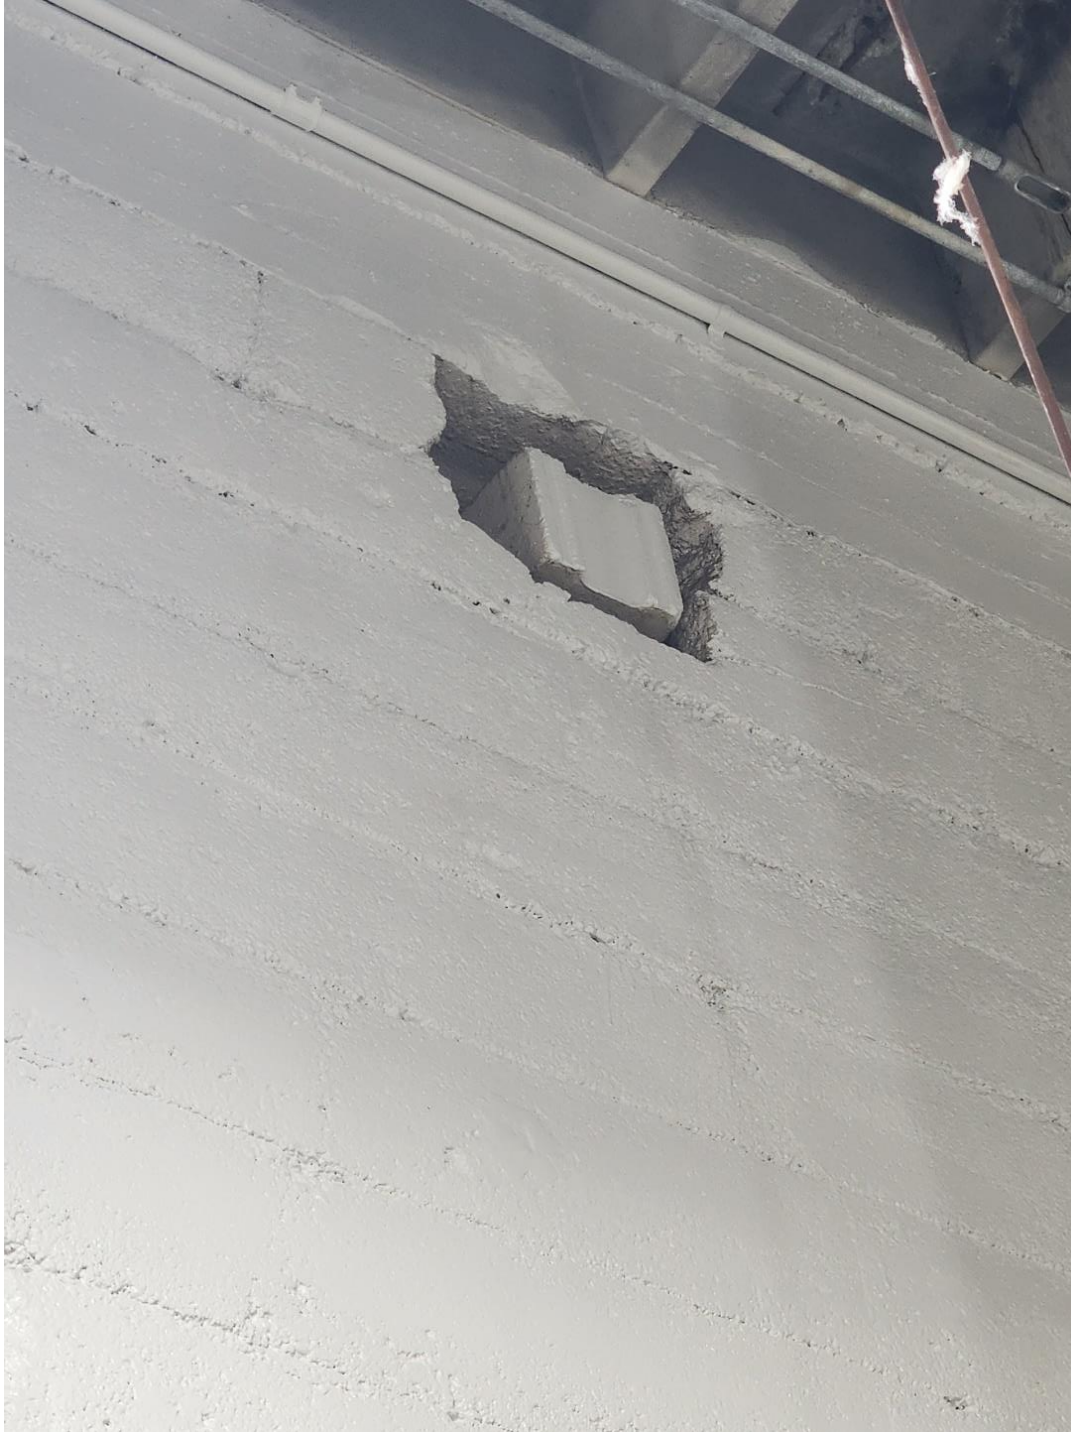
Wall penetrations infilled with non-standard construction methods.
Non-rated ceiling assembly as required by building code.
Location of water and pest infiltration.
(Photo: 20240411_135834)

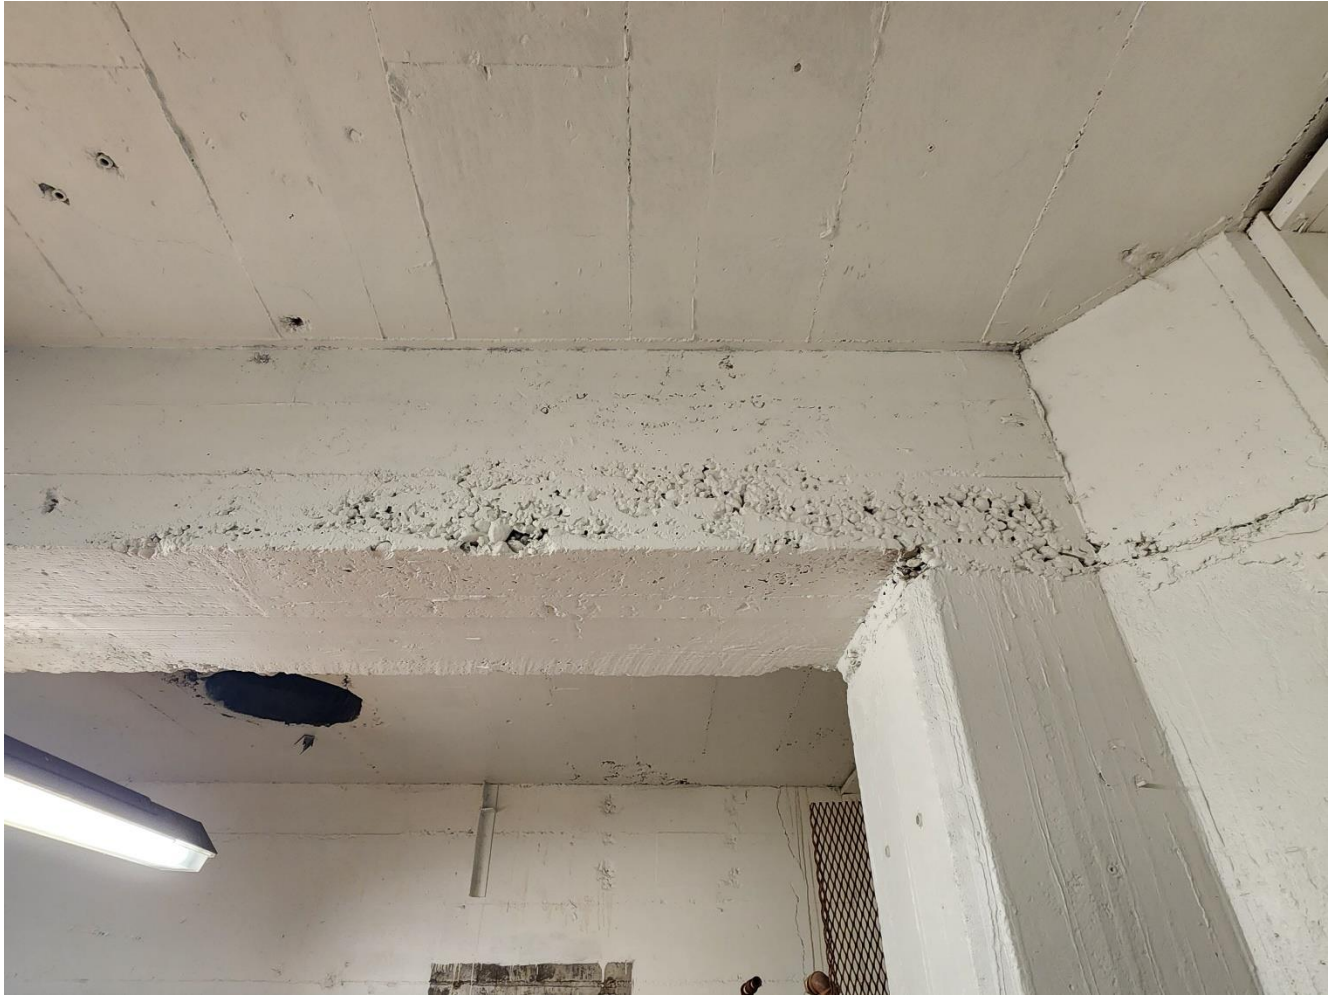
(Photo: 20240411_141552)

Ceiling penetrations not properly capped and protected.

There is visible evidence of concrete spalling and cracking which leads to exposure of concrete reinforcement, and a decrease in strength and load-carrying capacity of the members.

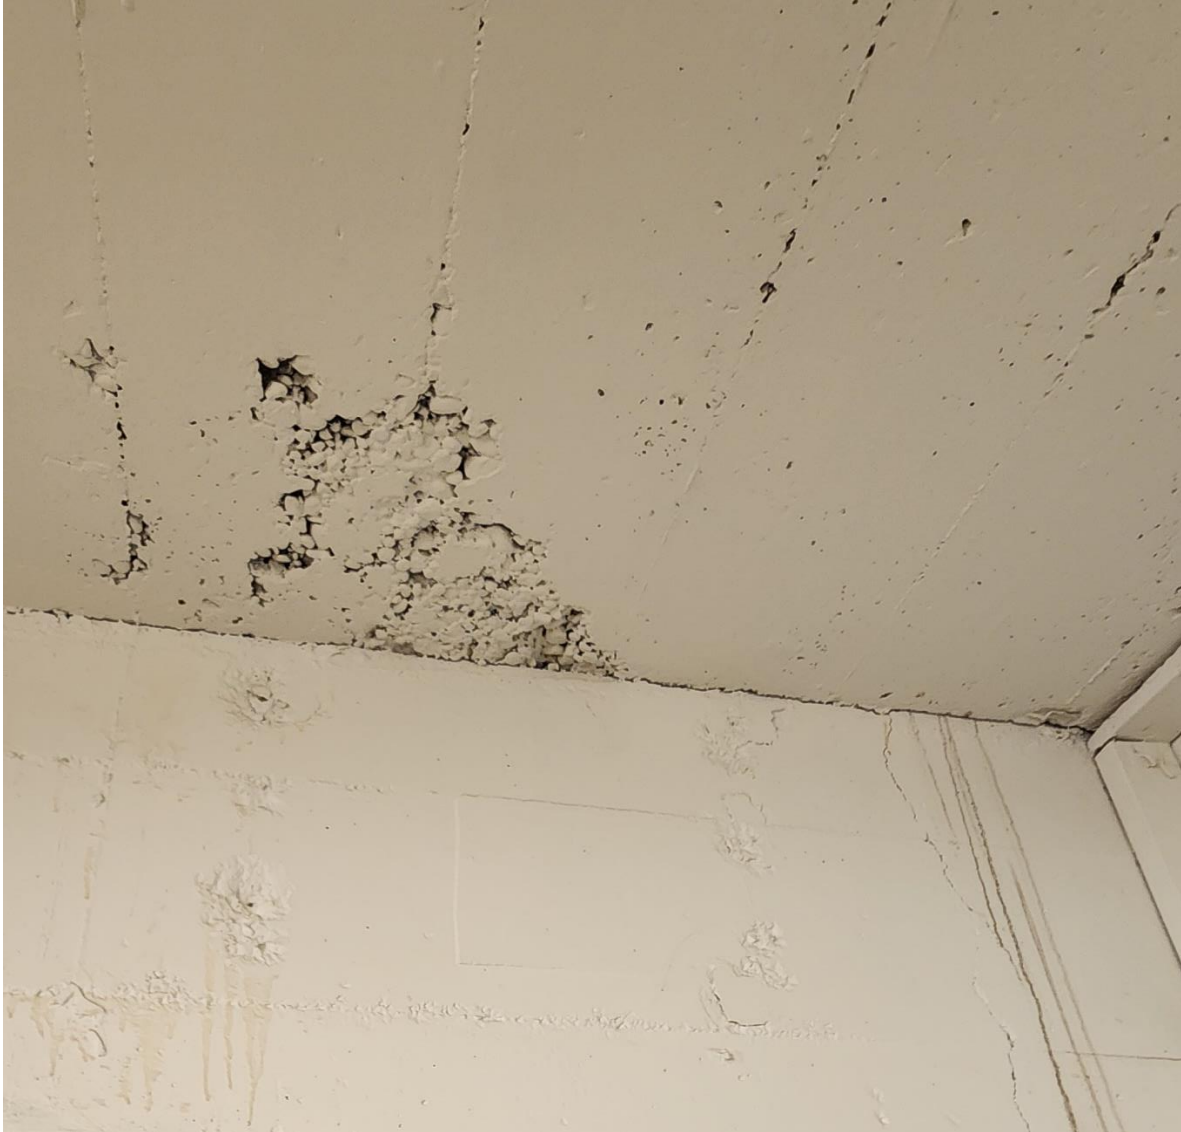
(Photo: 20240411_141604)

There is visible evidence of concrete spalling and cracking which leads to exposure of concrete reinforcement, and a decrease in strength and load-carrying capacity of the members.

Evidence of water infiltration.

Cracking at ceiling/wall connection.

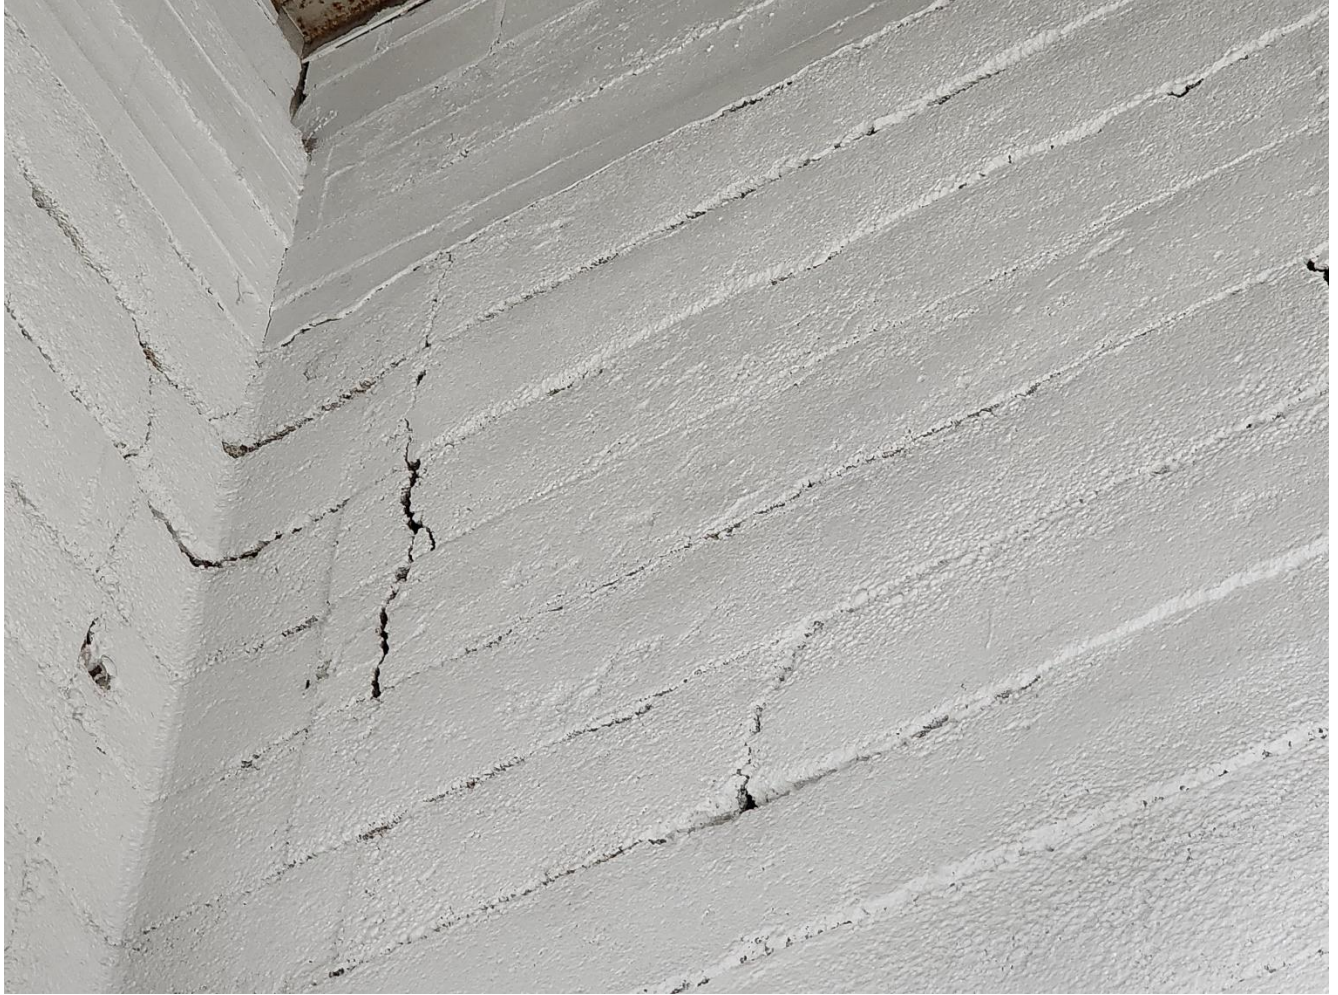
There is visible evidence of concrete spalling and cracking which leads to exposure of concrete reinforcement, and a decrease in strength and load-carrying capacity of the members.
(Photo: 20240411_141708)

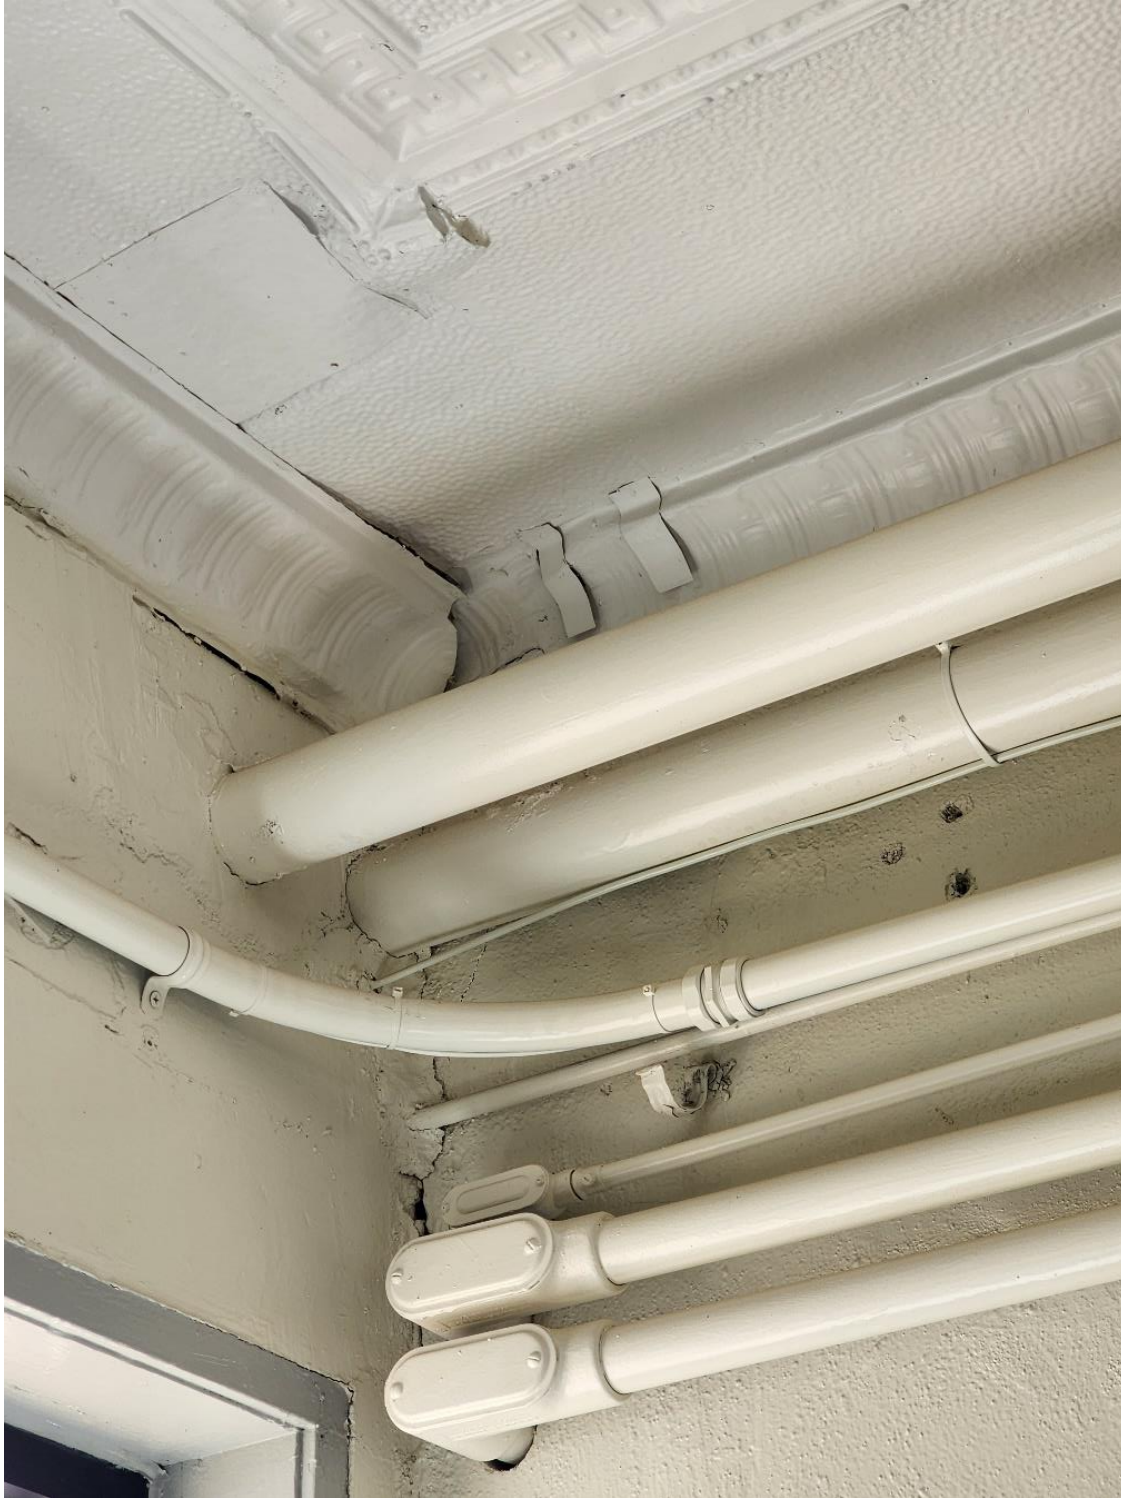
Wall penetrations not sealed.
Finish material failure.
(Photo: 20240411_145007)

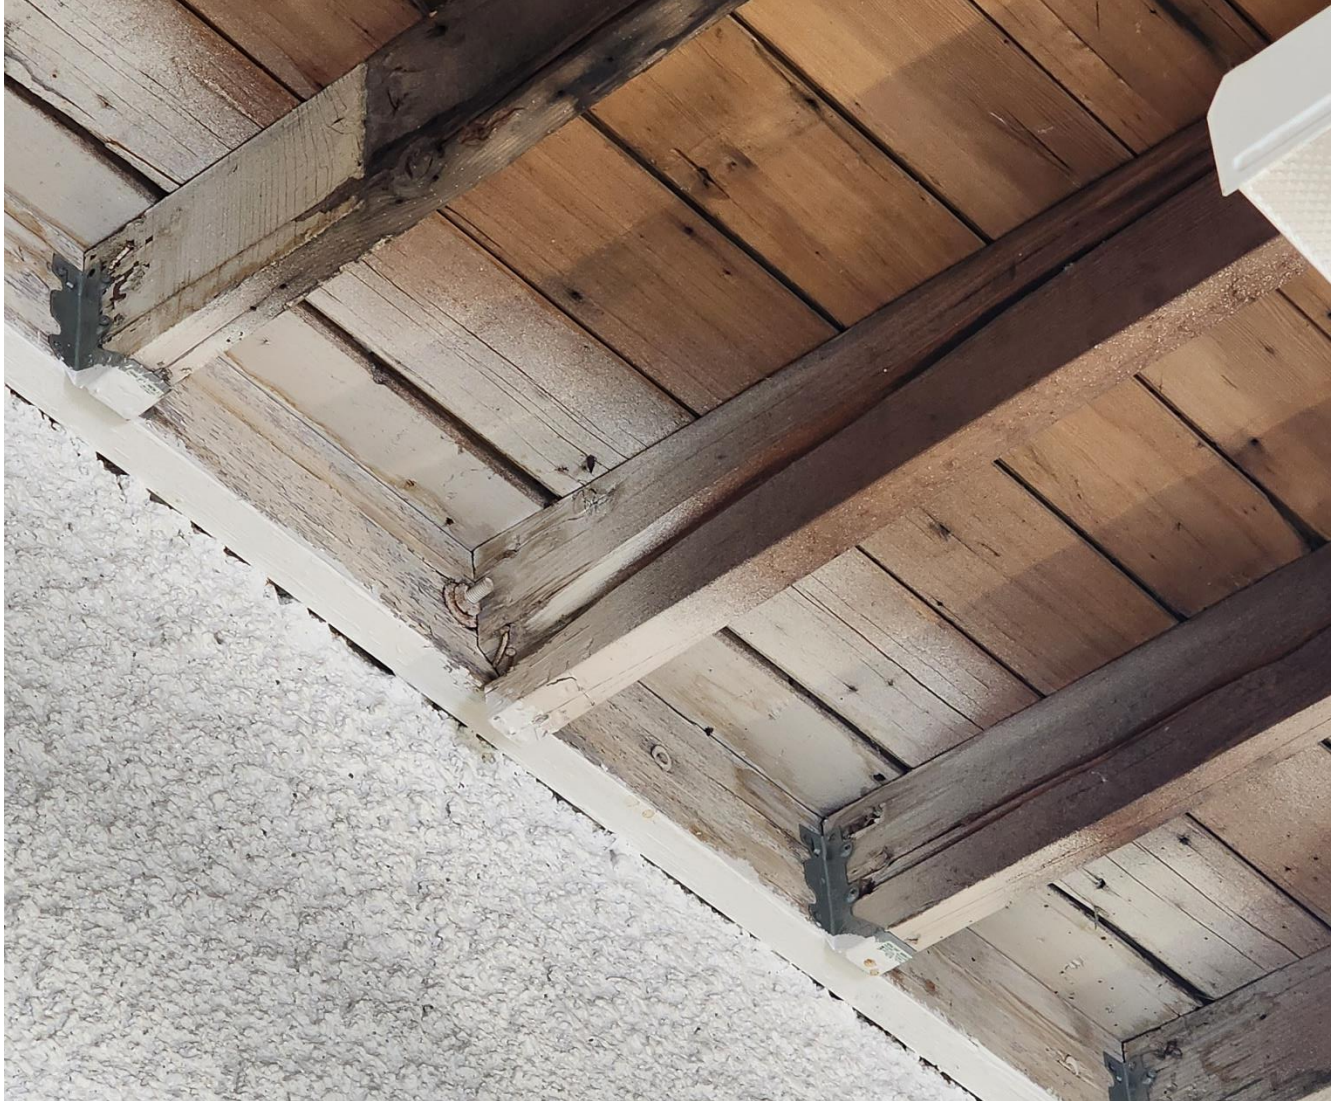
(Photo: 20240411_142546)

The ceiling joists of the Storage Room are cracked and failing. Joist hangers have been installed, but the joists themselves are still damaged and should be reinforced. There is the potential for roof failure as snow drifts onto this low roof from the higher Boiler area.

Non-protected ceiling assembly.

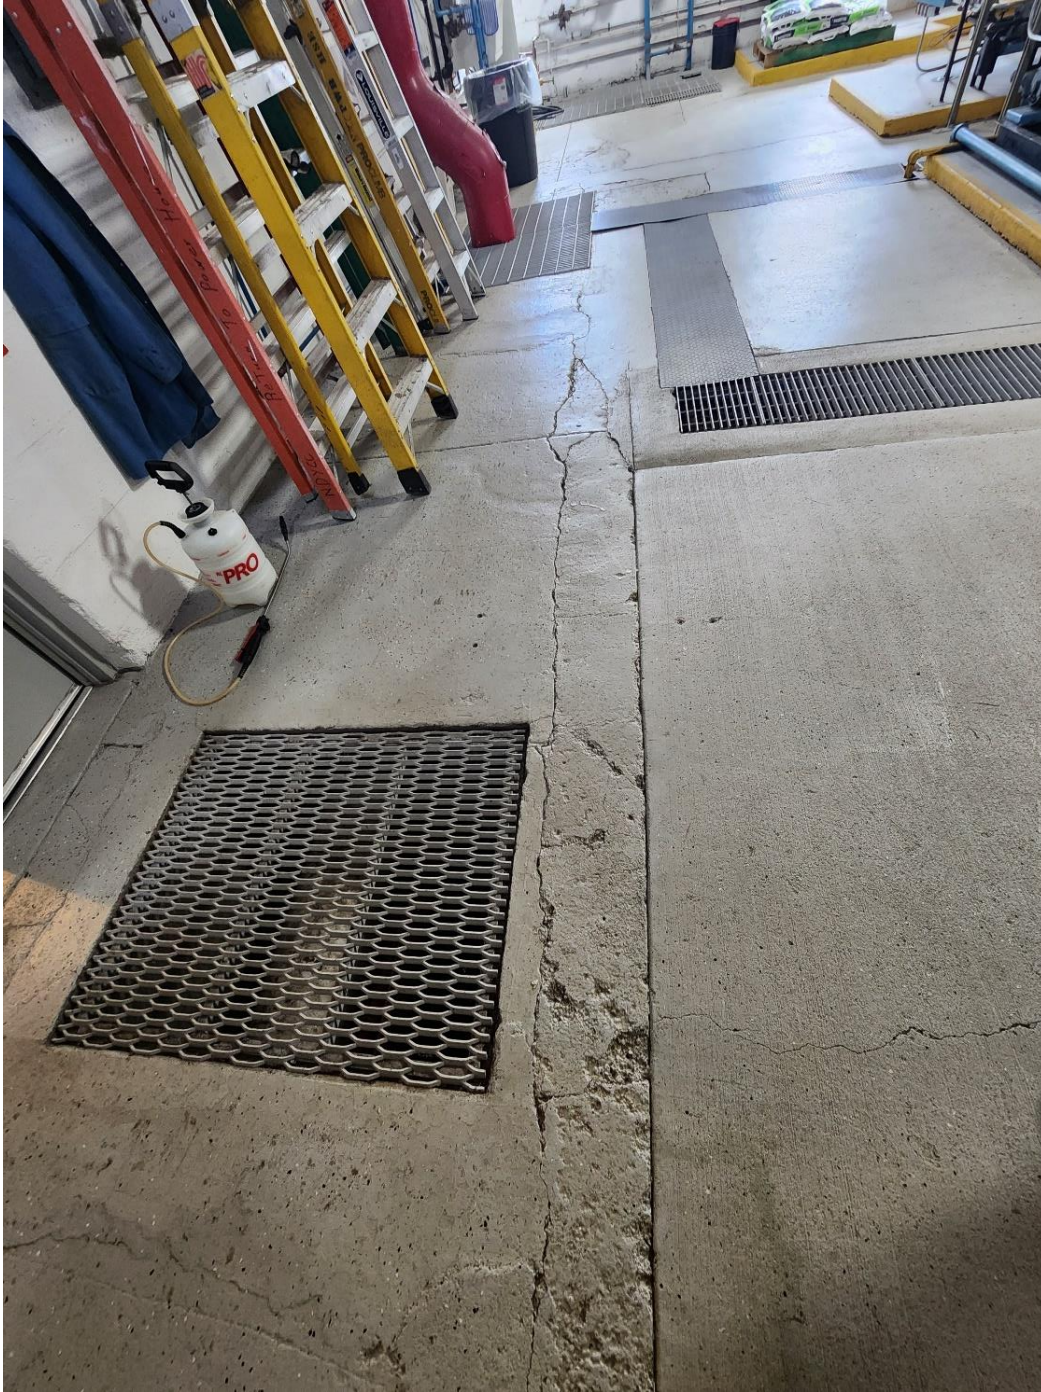
Floor slab cracking indicates settlement and differential movement between areas of the building. Some areas of the floor slabs are structural slabs over mechanical tunnels, and not slabs on grade. Cracking of these slabs could lead to water infiltration, reinforcement exposure, and failure of the slab. The cracking also creates potential trip hazards in the floor slab. (Photo: 20240411_142636)

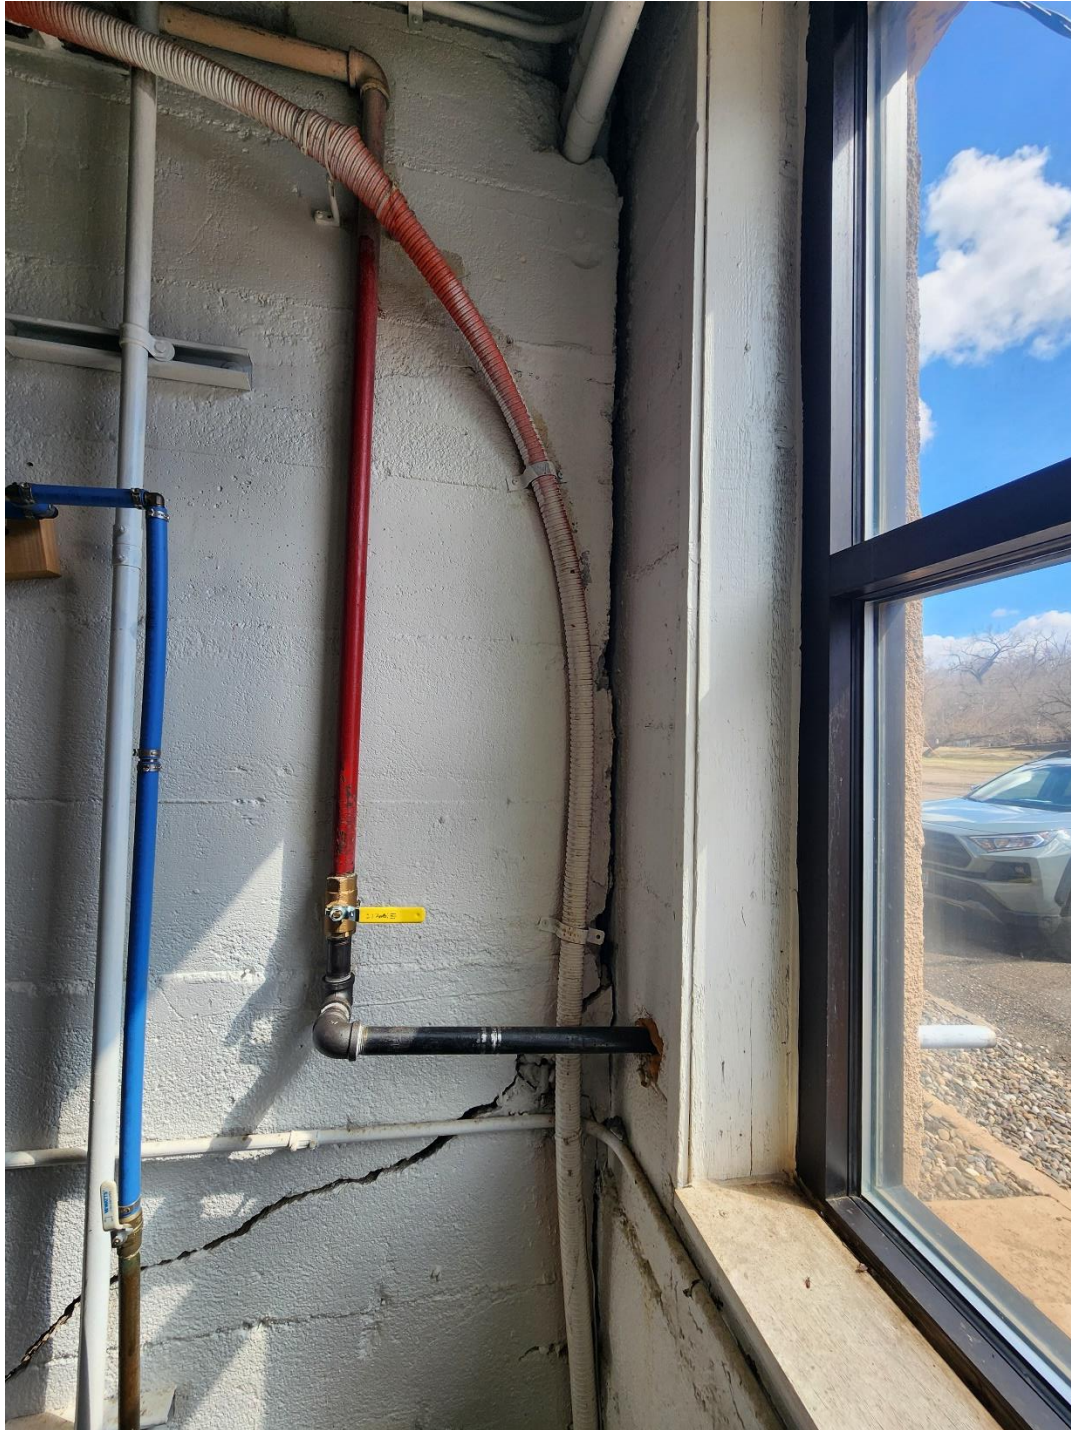
Interior wall and exterior wall pulling away from each other, with a 1" wide gap. Large diagonal crack that extends through the wall, located at the bottom of the north-south interior wall between the Heating Plant Office and Boilers. Both the crack and the gap are indicative of excessive building settlement. Wall penetrations not properly protected. (Photo: 20240411_145052)

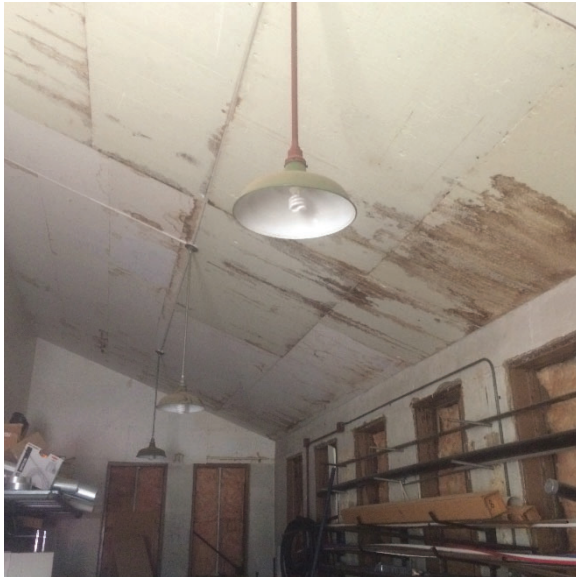
Plumbing Storage

- The existing roof framing was not visible in the main plumbing storage area due to the finished ceiling. The ceiling showed visible signs of water damage, including sagging and discoloration. It is unknown what condition the framing is in, but it is most likely water damaged with possible mold and fungi growth.

Water damage to ceiling. Ceiling to be removed to verify structural condition of roof framing.

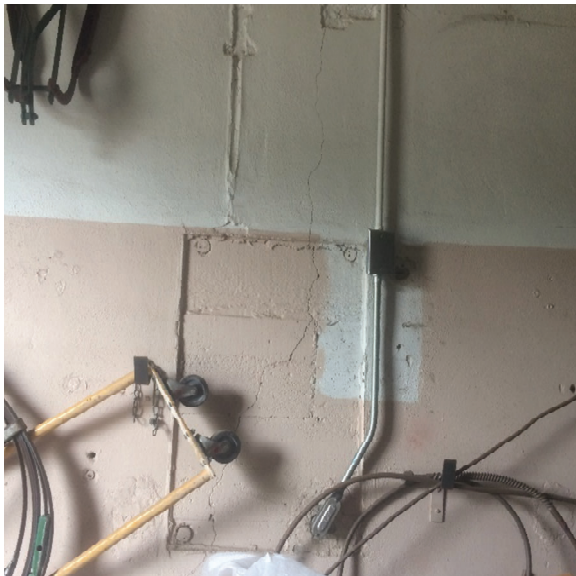
Visible crack in interior wall to be monitored.

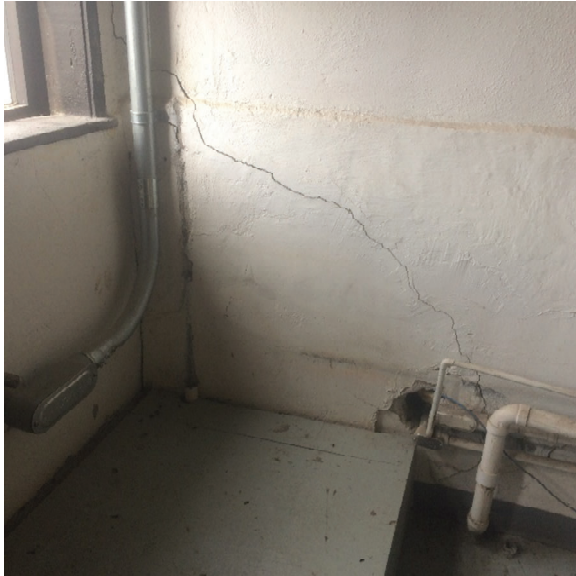
Plumbing Shop & Heating Plant Office

Crack in interior concrete wall between Heating Plant Office and Boilers to be monitored.

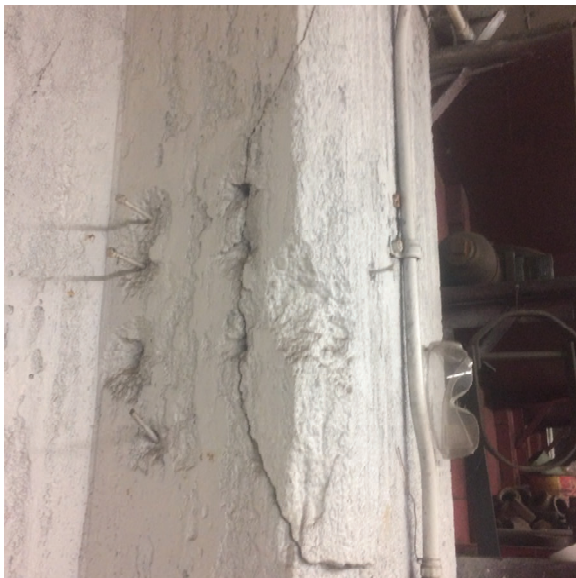
Storage

Visible crack in concrete pier below concrete roof beam to be monitored. Note the indentations of previously installed anchors in the crack line.

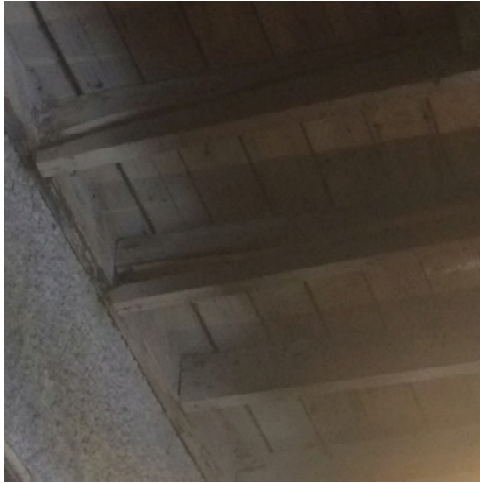
Tools

Failed and cracked 2x6 roof joists that need to be repaired and / or replaced.

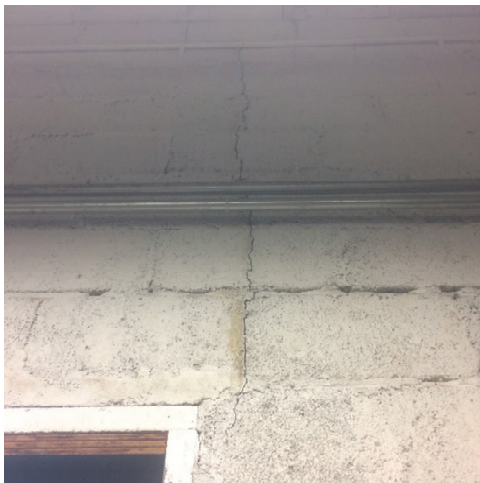
Vertical crack in wall at window corner, most likely due to a lack of control joints in the CMU wall.

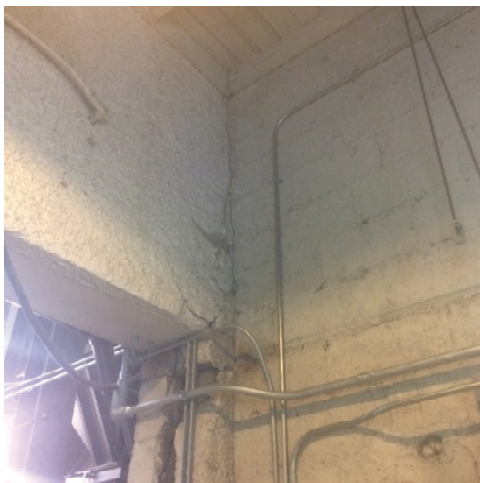
Cracked and damaged bearing at opening in wall between Tools and Boilers to be repaired – see the Boilers section for additional information.

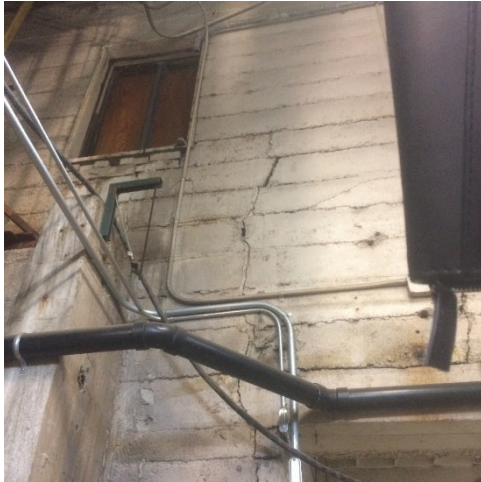
Large vertical crack in wall at corner of existing wall opening between Boilers and Tools. Opening to be repaired by installing new steel beam lintel.

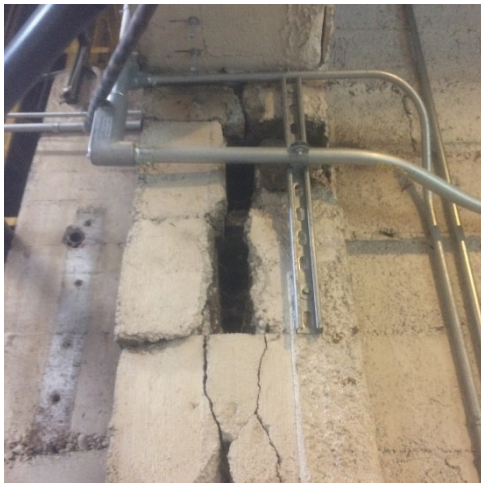
Cracked and broken concrete at bearing of existing wall opening between Boilers and Tools to be rebuilt and repaired – wall section view.

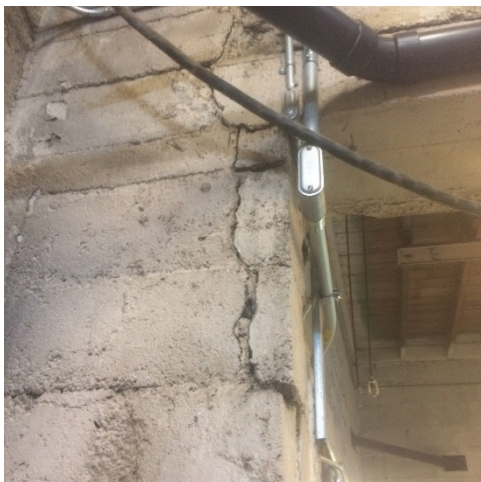
Cracked and broken concrete at bearing of existing wall opening between Boilers and Tools to be rebuilt and repaired – wall elevation view.

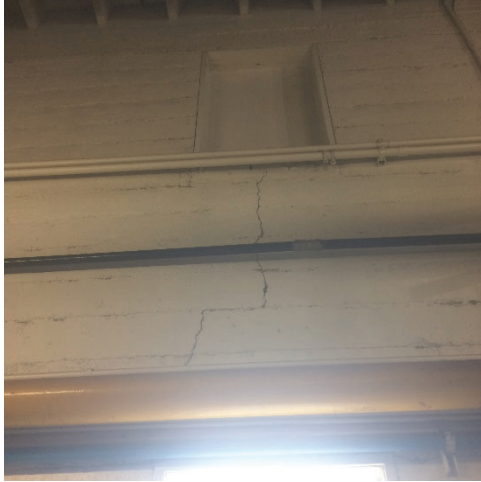
Boilers (continued)

Typical wall cracking around window and door openings.

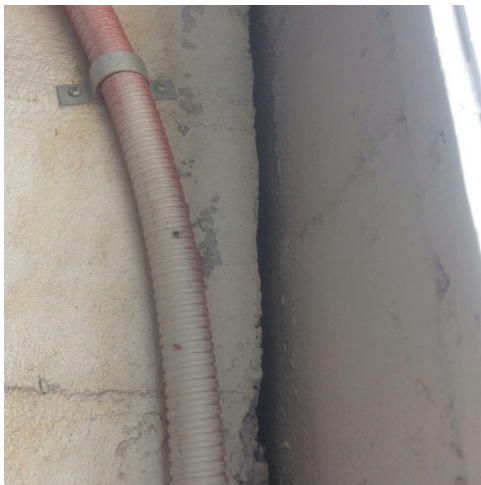
Gap between interior concrete wall and south exterior wall to be monitored.

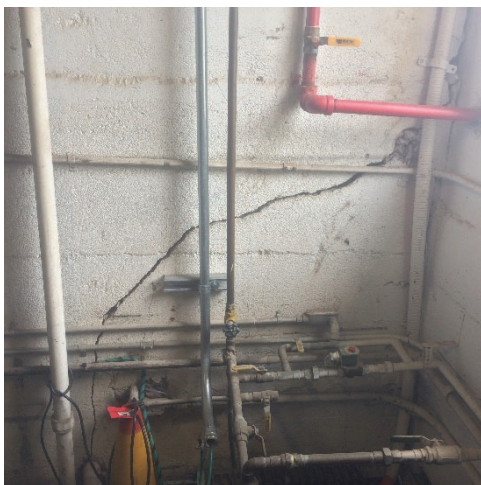
Diagonal crack in interior concrete wall that needs to be monitored.
