Architecture
Interior Design
Landscape Architecture
Engineering

222 N Second St, Suite 101
Minneapolis, MN 55401
Telephone: 612.339.3752
Facsimile: 612.339.6212
www.bkvgroup.com
EOE

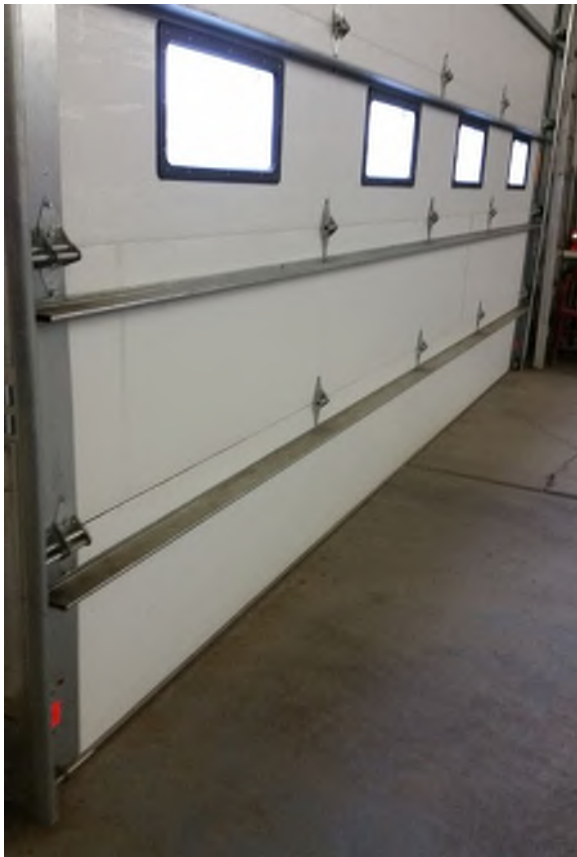
No photo-eyes on bay doors, creating pinning/ crushing hazard

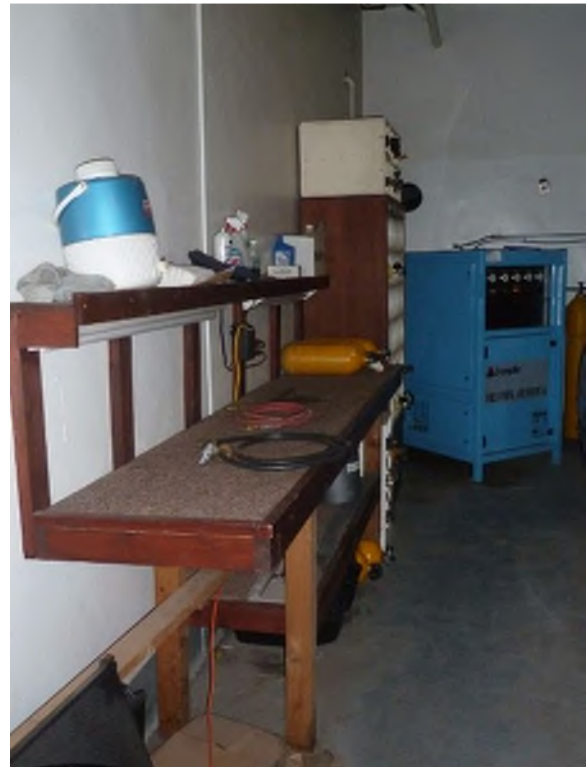
SCBA repair and cleaning area takes place in dirty environment

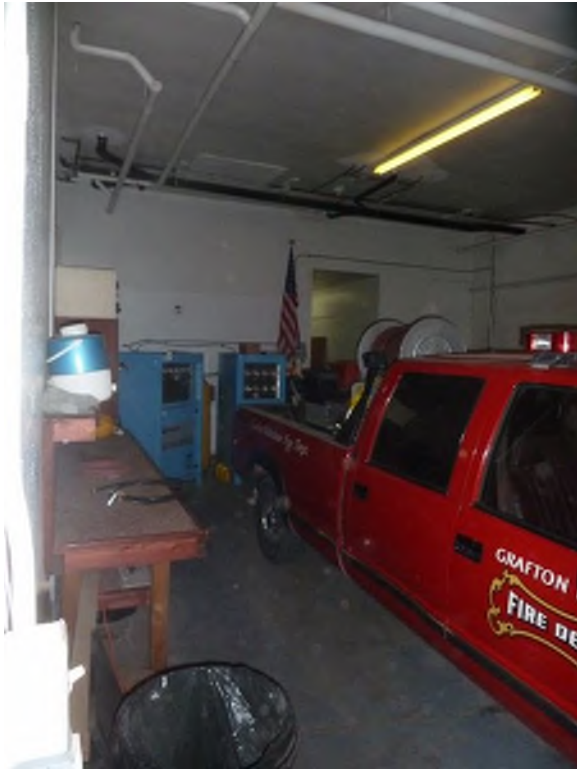
No exhaust removal system in maintenance bay

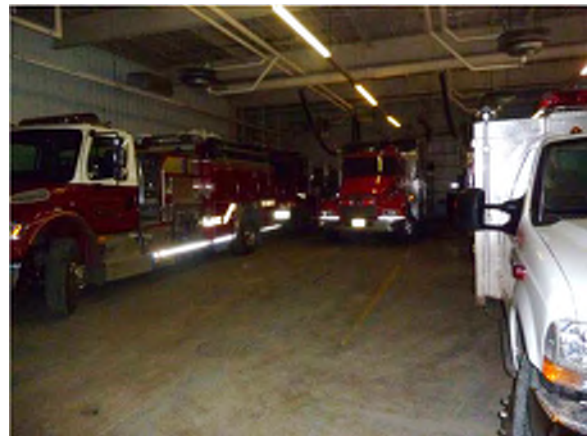
Limited floor drains and insufficient slope results in pooling water and slip hazards

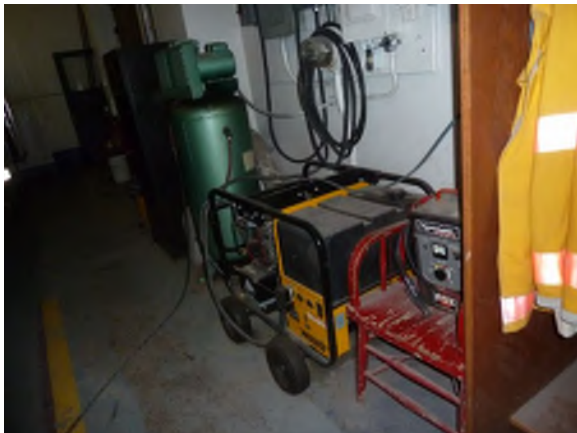
Equipment stored in front of electrical panels

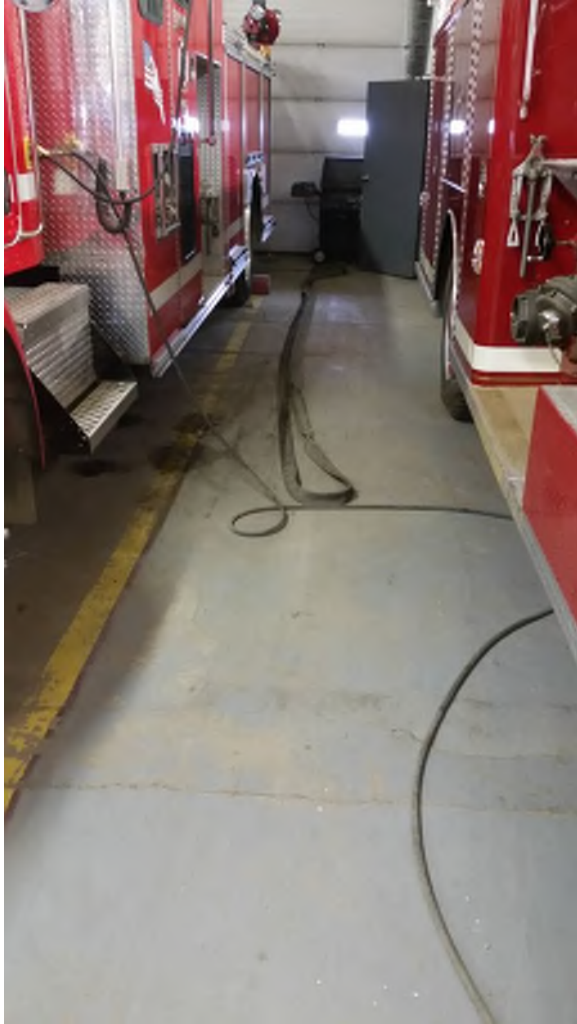
Shore lines laying on floor create tripping hazard

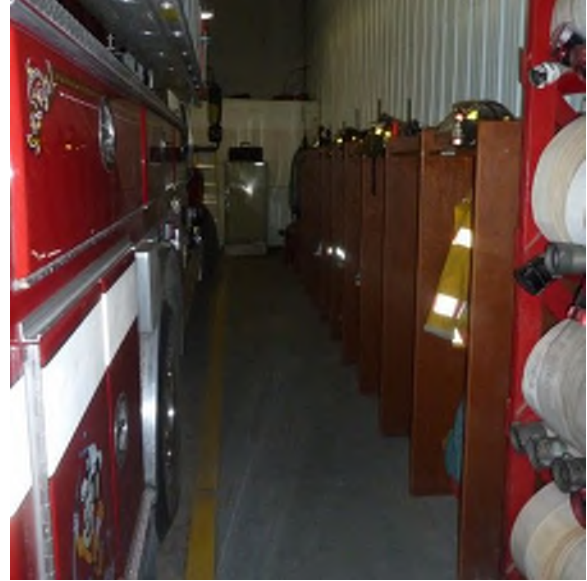
Turnout gear stored on bay walls too close to apparatus. Solid panels at gear lockers restrict evaporative drying of turnout gear

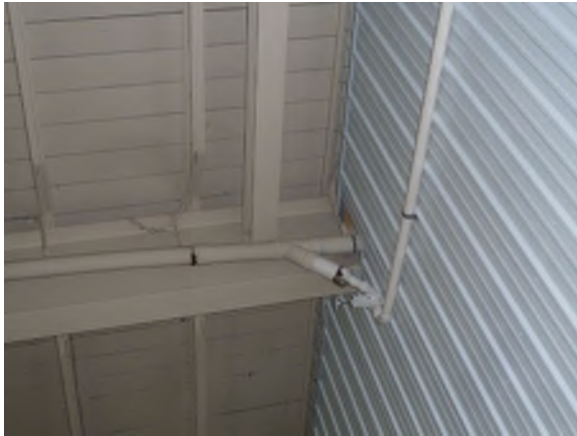
Roof due to be replaced next year

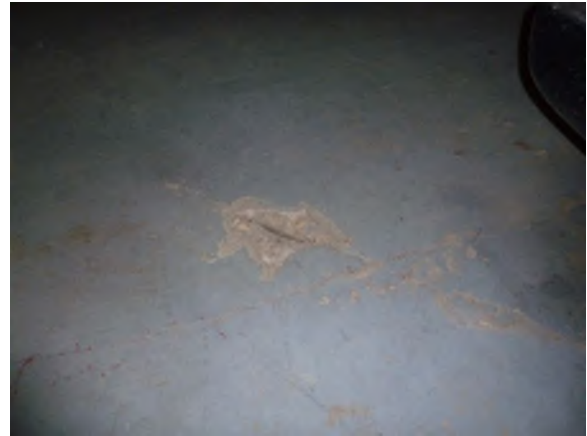
Cracks in floor, some down to rebar

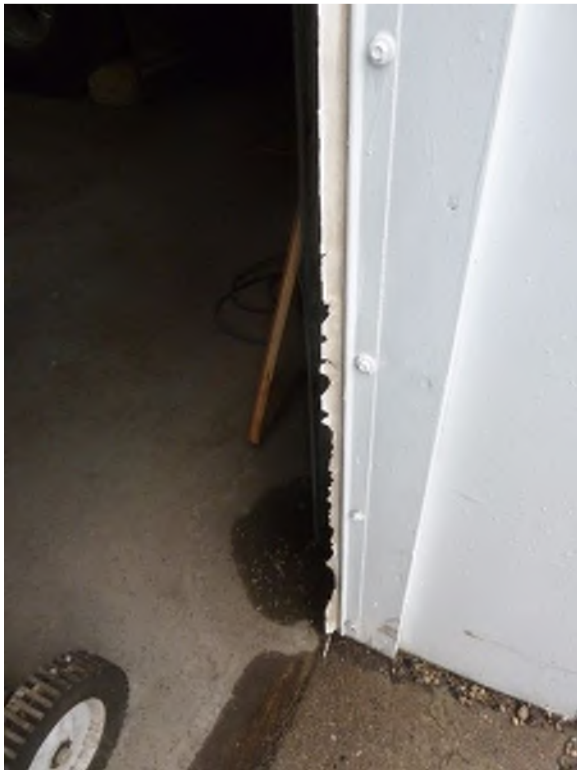
Weatherstripping at rear apparatus door needs replacement

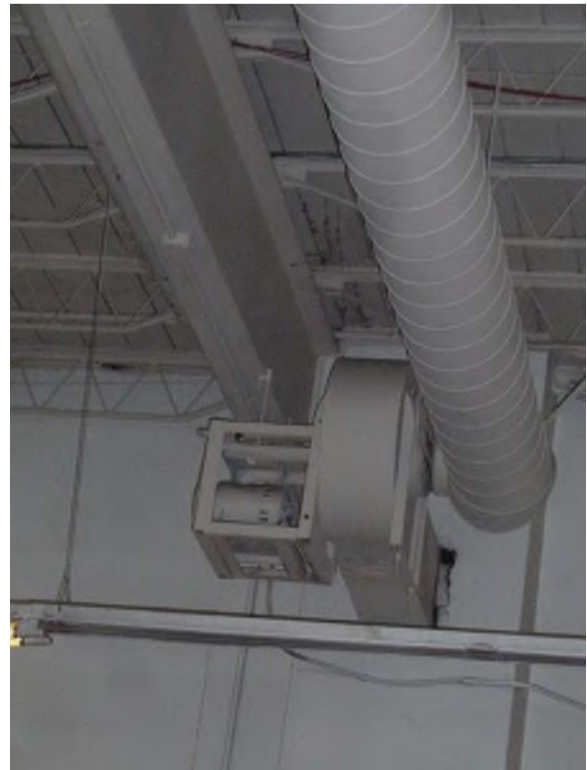
Mechanical exhaust system motor needs maintenance

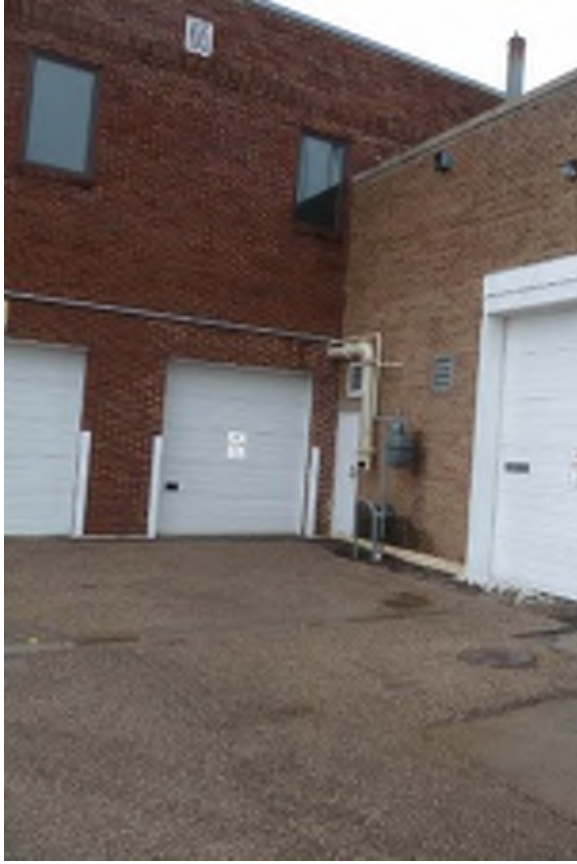
Client reported leak under window of Firemen's Hall

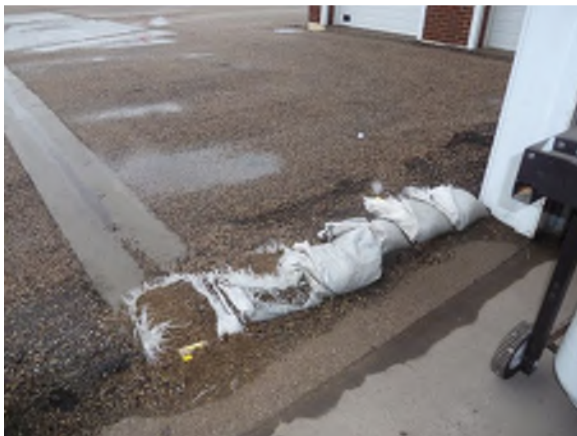
Grading at rear apparatus door slopes towards building

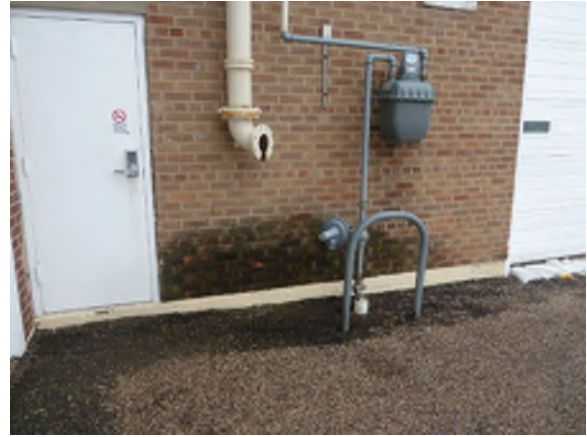
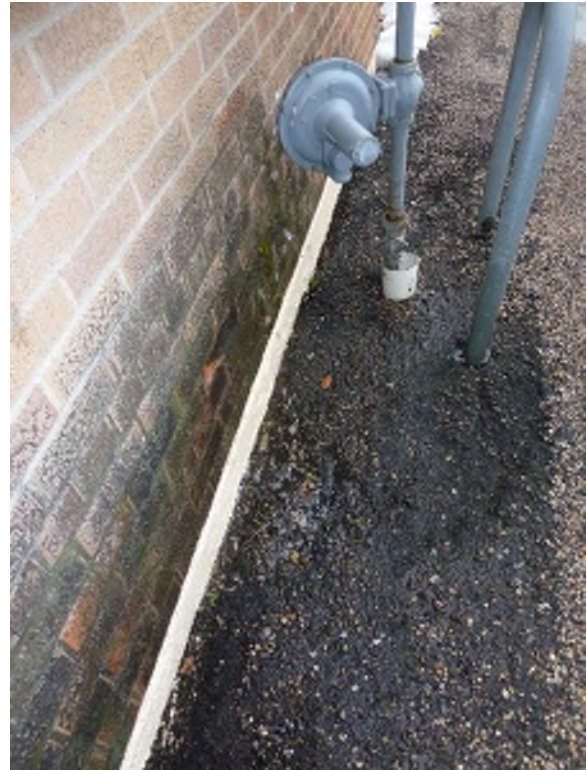
Roof drain discharges water at building wall, creating environment for molds and lichen and causing brick to spall and deteriorate

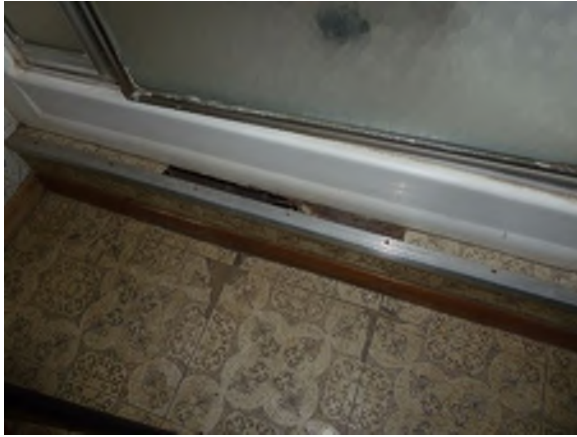
Wood framing below shower pan not protected from moisture and shows evidence of disintegration

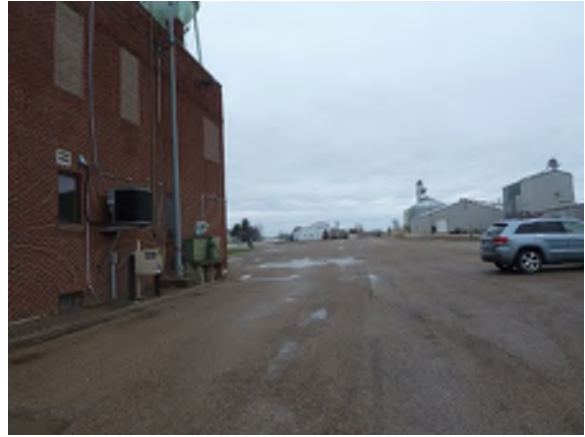
Asphalt past the end of its useful service life. Exhibiting potholes, cracks, disintegrating top layer

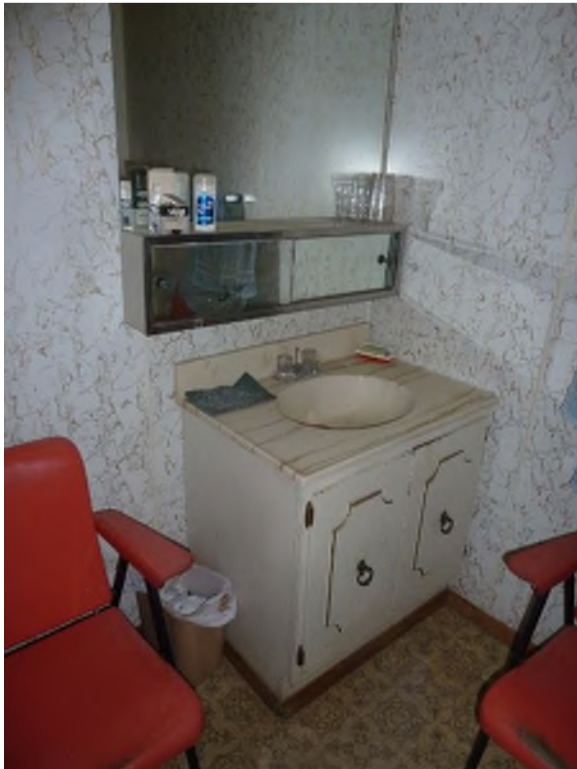
Fixtures and finishes in toilet room past the end of their useful life

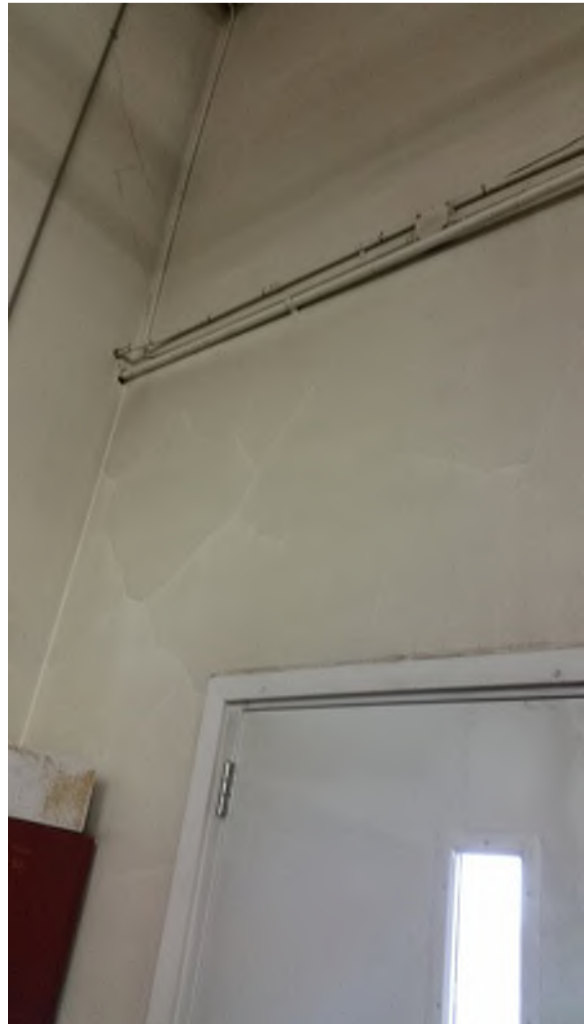
Plaster cracking and falling off interior walls

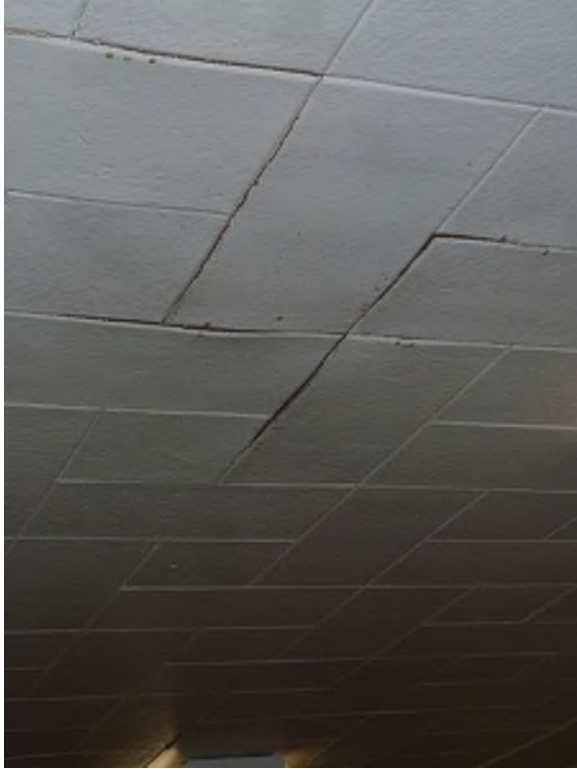
Ceiling tiles loose at Firemen's Hall

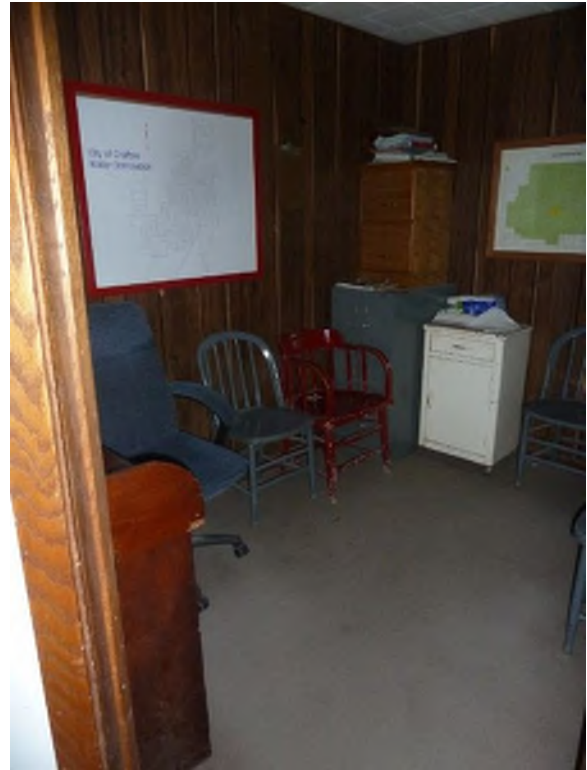
Carpet at Watch Office past the end of its useful service life

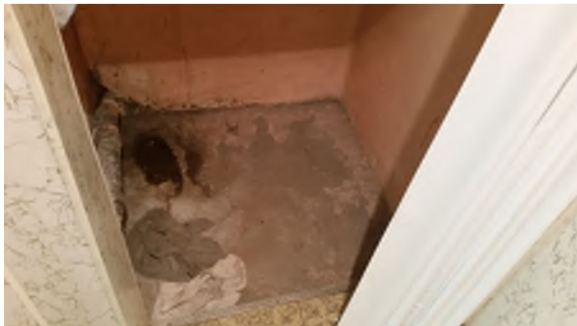
Shower area degraded to the point of uselessness

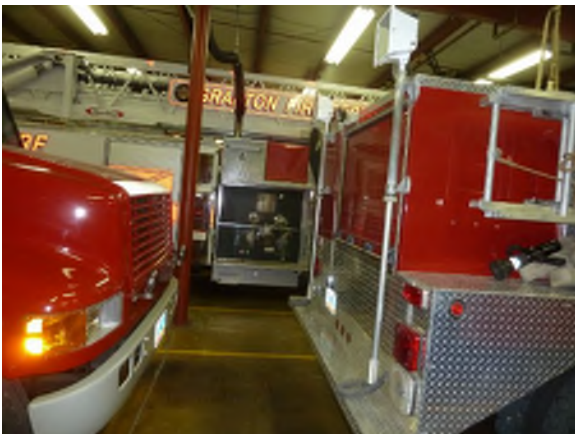
Center column in apparatus bay creates pinning/ crushing hazard by backing apparatus

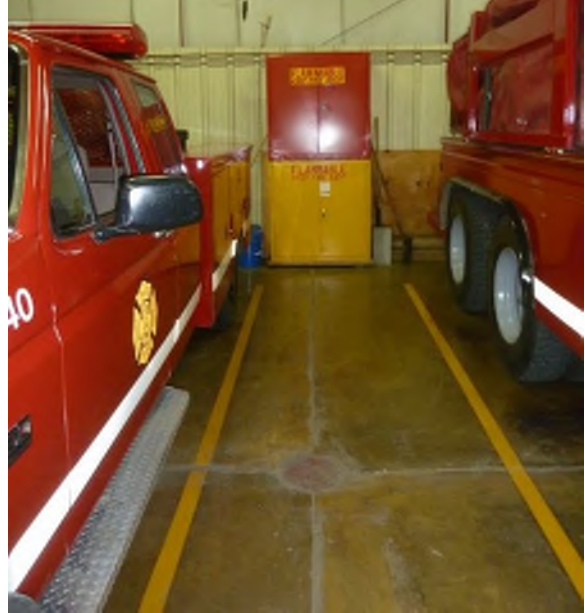
Limited floor drains and insufficient slope results in pooling water and slip hazards

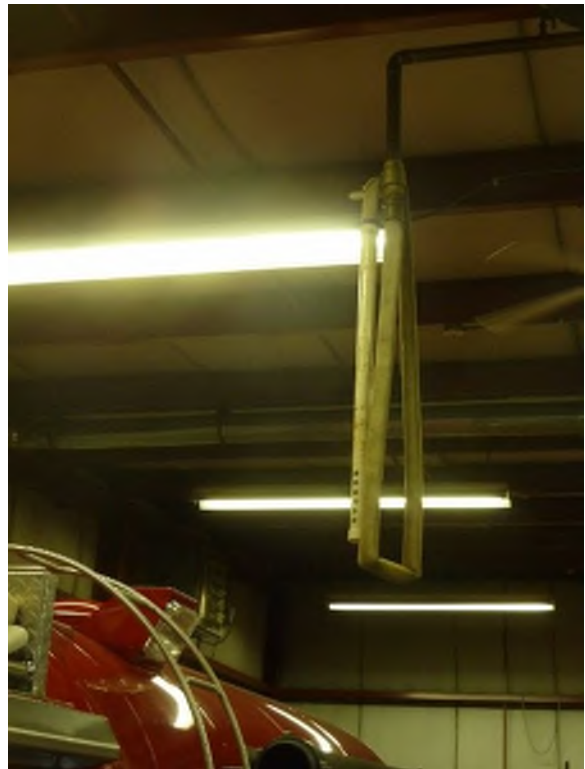
Overhead truck fill requires climbing on apparatus to operate

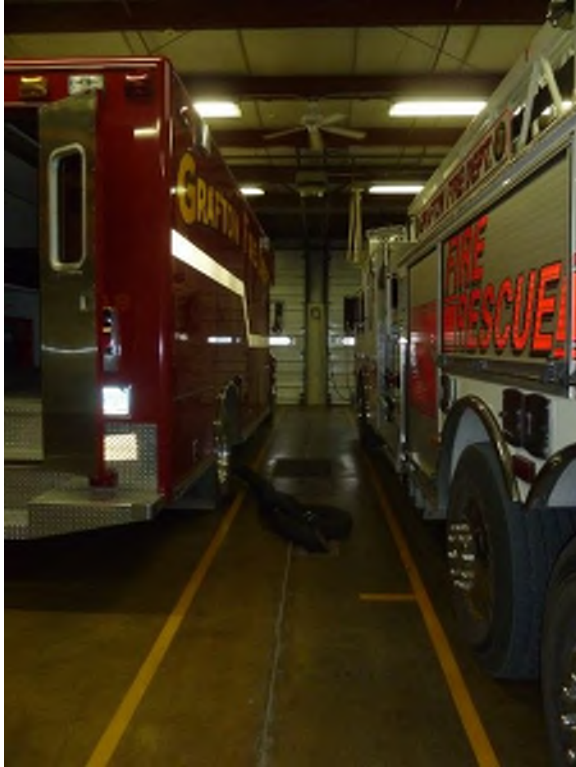
Underslab exhaust hose creates a tripping hazard

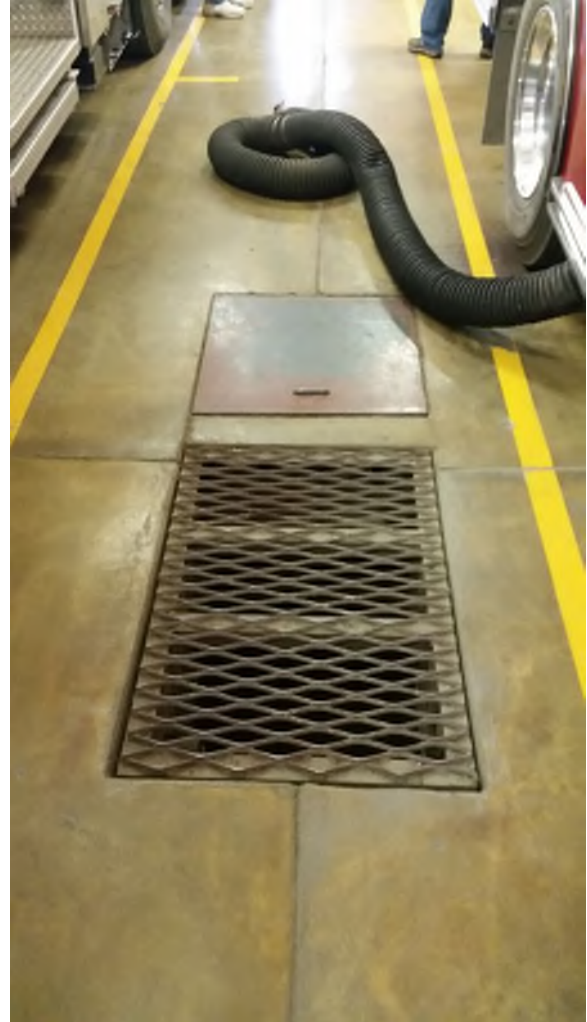
Oil pit grating not flush with surrounding concrete, creating a trip hazard

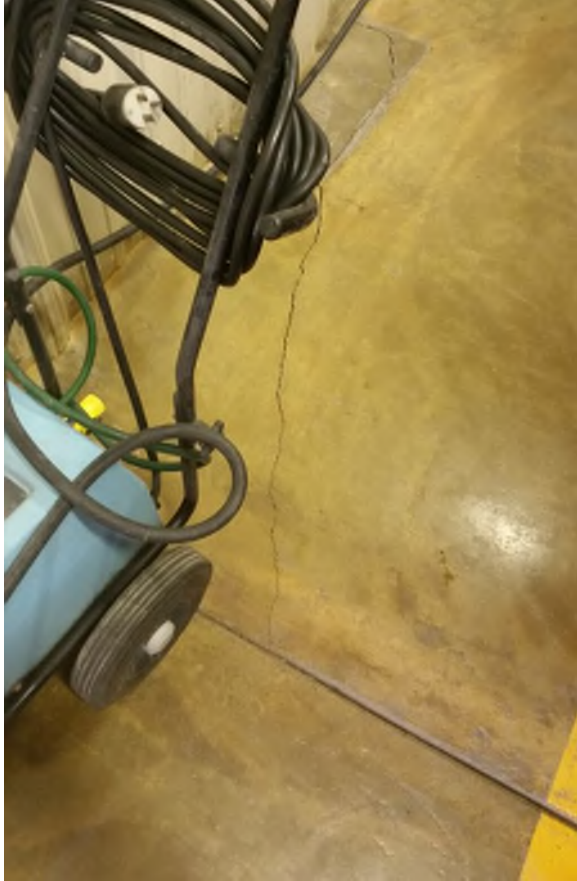
Concrete has cracked and settled in apparatus bays, creating trip hazard at joints

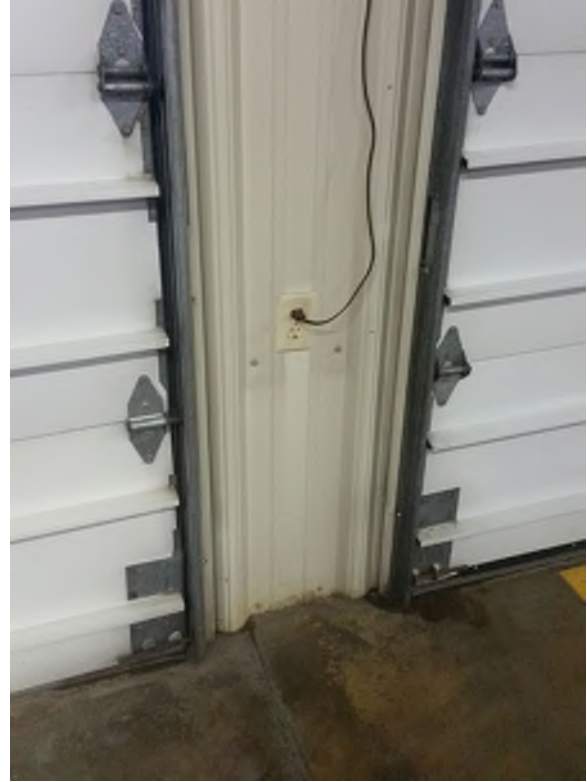
No photo-eyes on bay doors, creating pinning/ crushing hazard

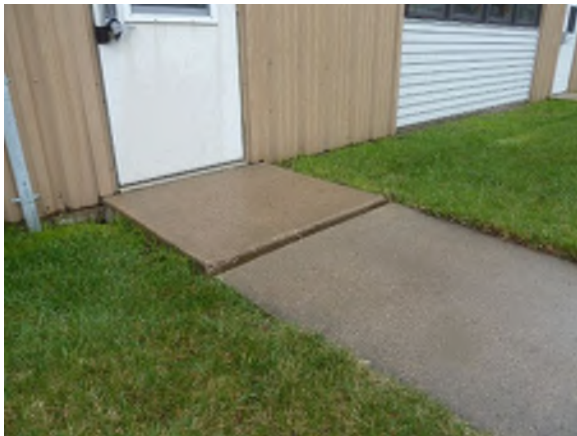
Sidewalks heaving/ settling compared to stoops, creating trip hazard

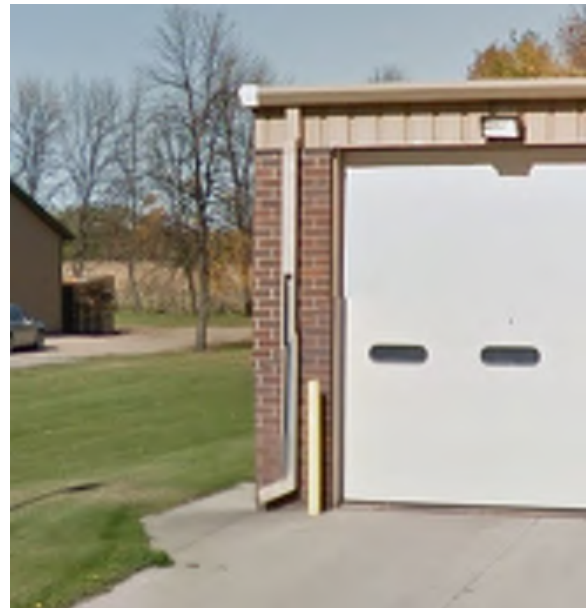
Southwest downspout discharges across sidewalk, creating potential for ice formation

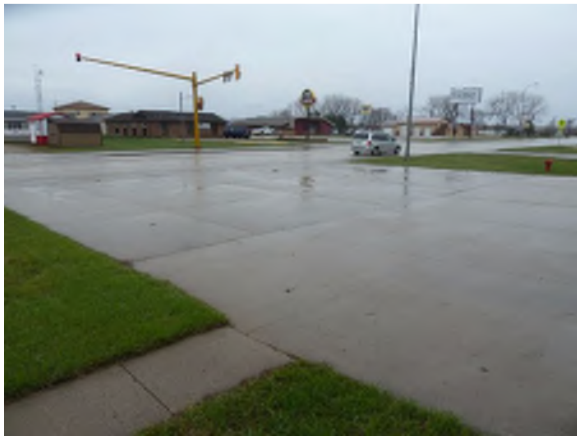
Apparatus apron is too flat, creating water ponding issues that may freeze and create slippery conditions for apparatus exiting

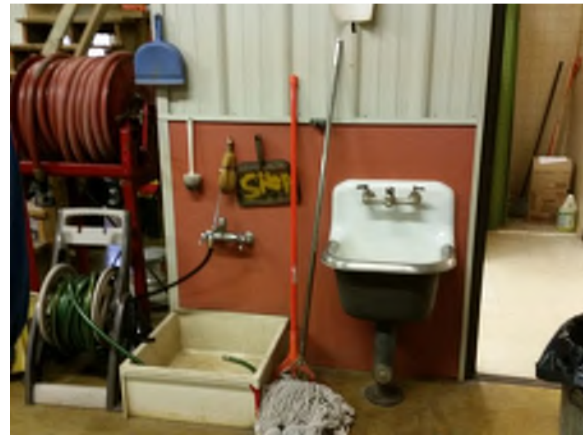
Insufficient decontamination space for SBCA masks and equipment

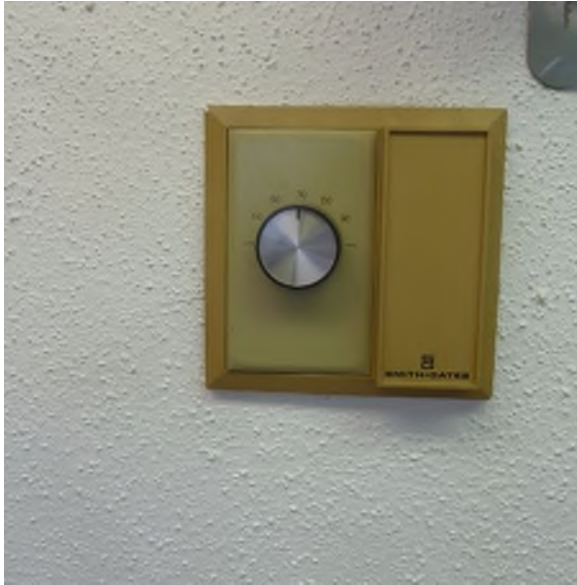
Client reports that in-floor radiant heat system broken

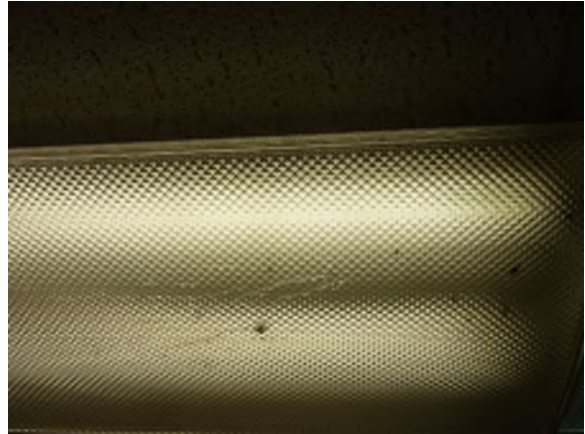
Cracked light fixture lens in watch office

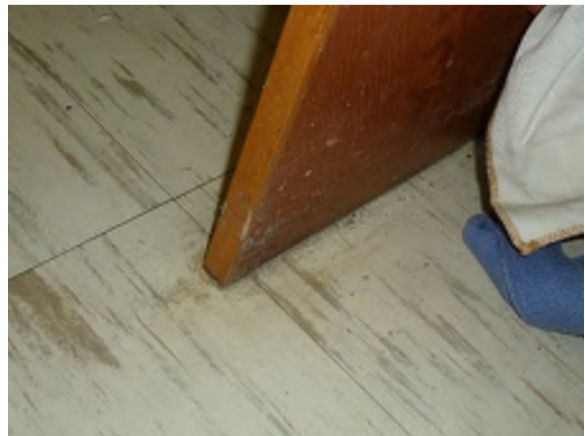
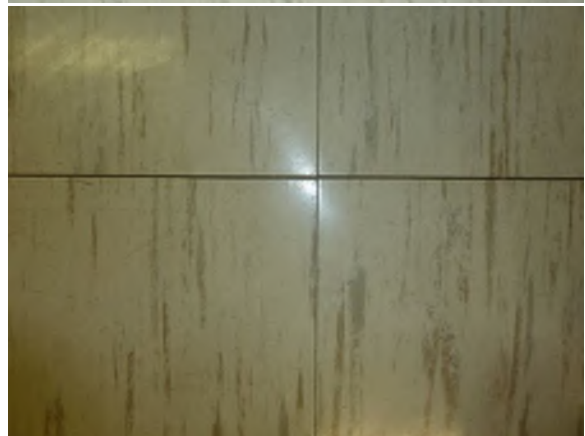
VCT showing signs of distress with gapping at joints and crushing at turnout locker partitions, nearing end of useful service life

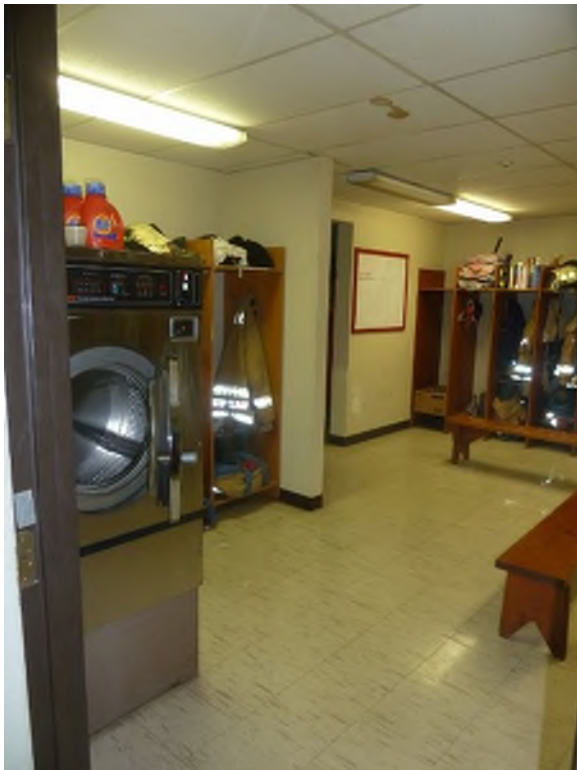
Evidence of roof leaks at ceiling tiles. Client reports having repaired roof several times.

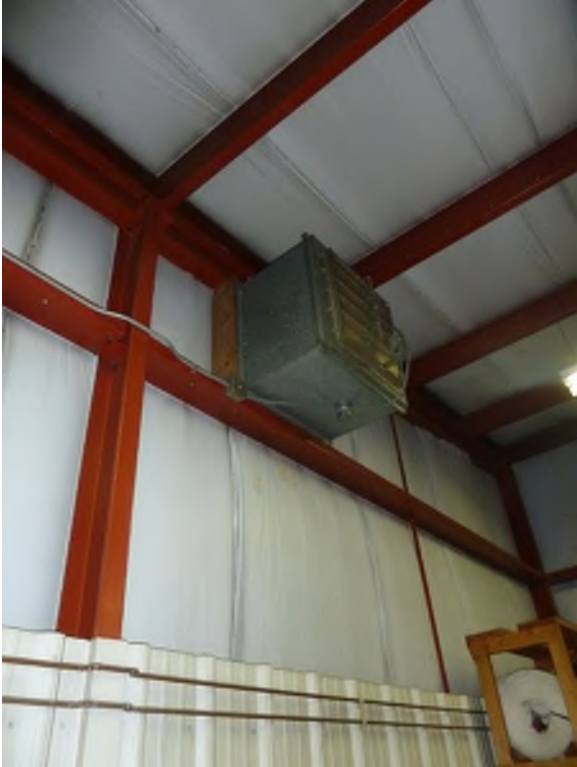
Exhaust fan needs maintenance, rebalancing

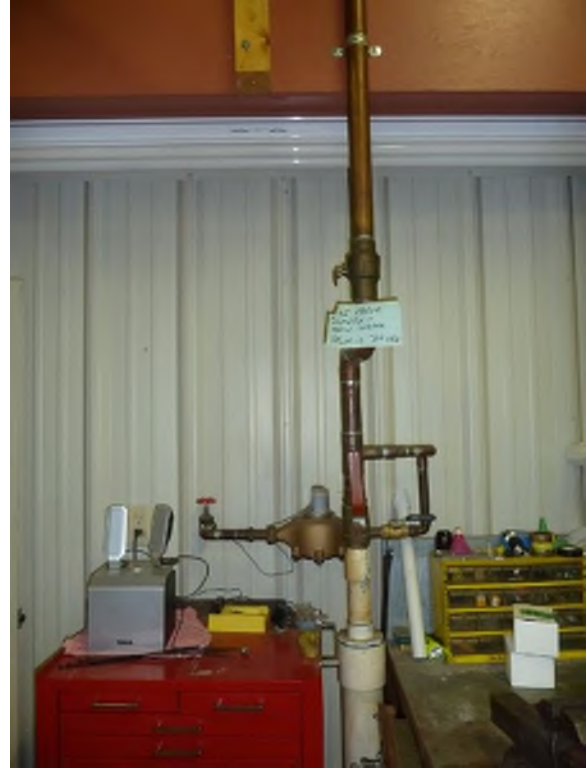
Water valve broken at street, creates water hammer problems inside building

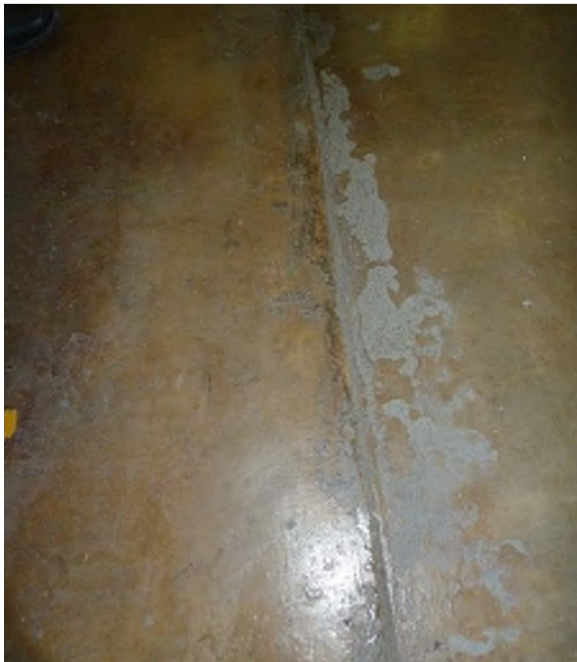
Concrete floor in apparatus bay showing signs of deterioration

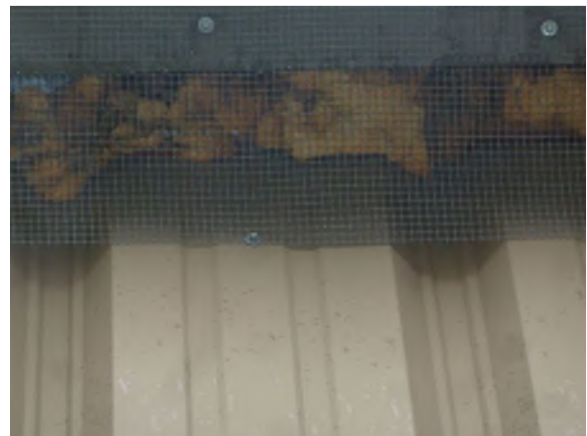
Spray foam insulation exposed on exterior

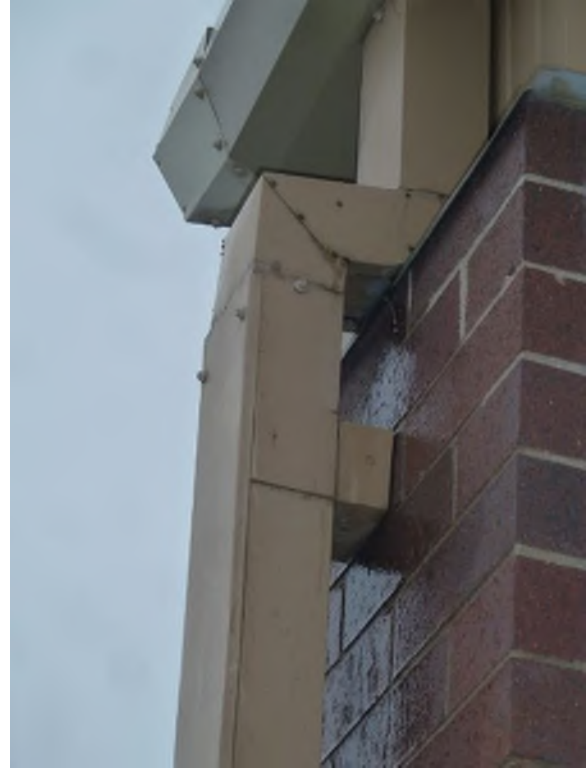
Southwest downspout damaged and leaking down face of building

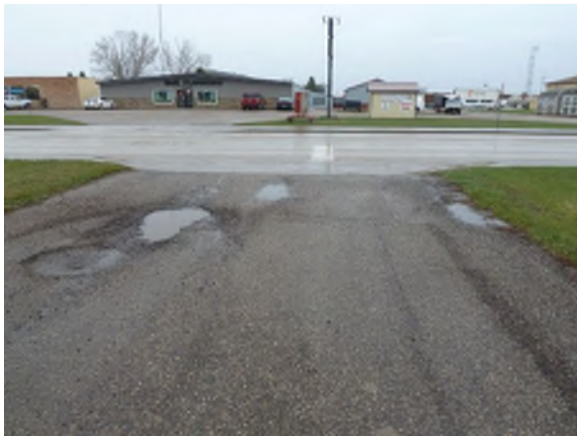
Asphalt at parking lot past the end of its useful service life. Exhibiting potholes, cracks, disintegrating top layer

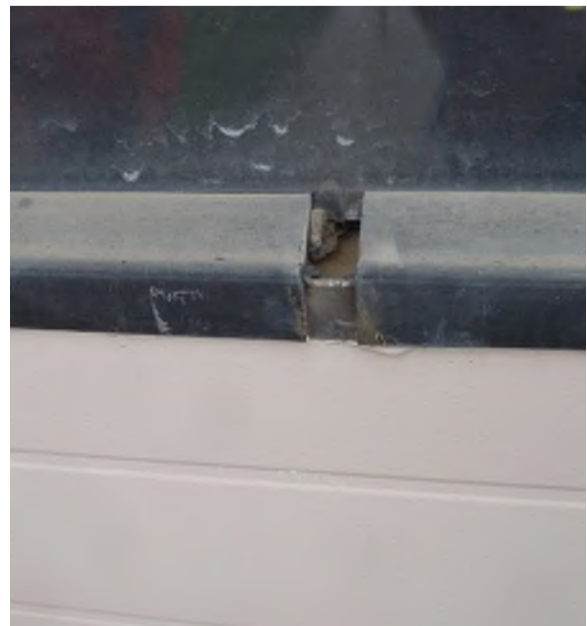
Glazing panels in sectional overhead doors have large gaps at seals

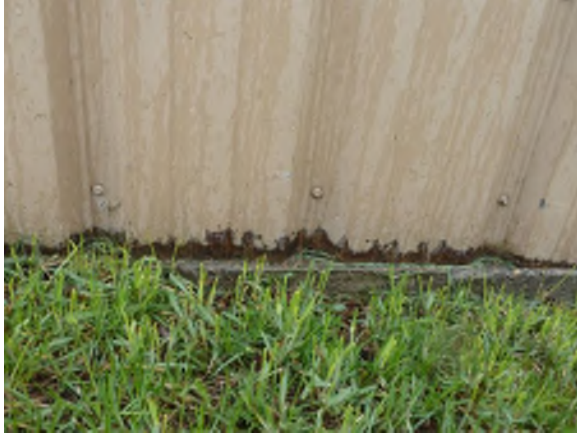
Bottom of metal wall panels beginning to deteriorate

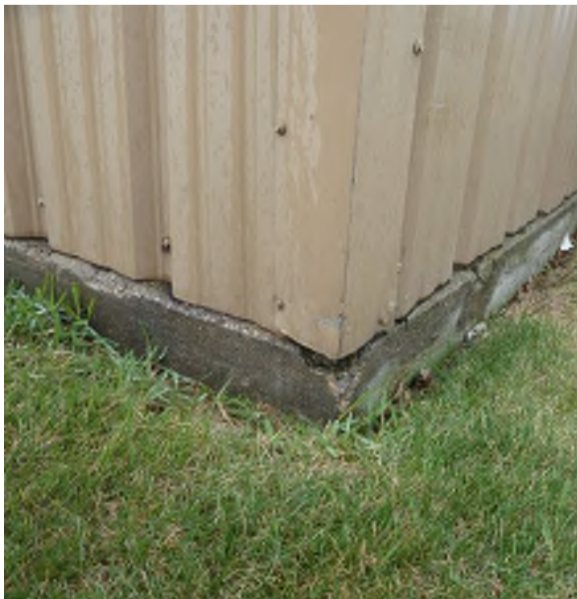
Spalling at concrete footing wall at northeast corner of building

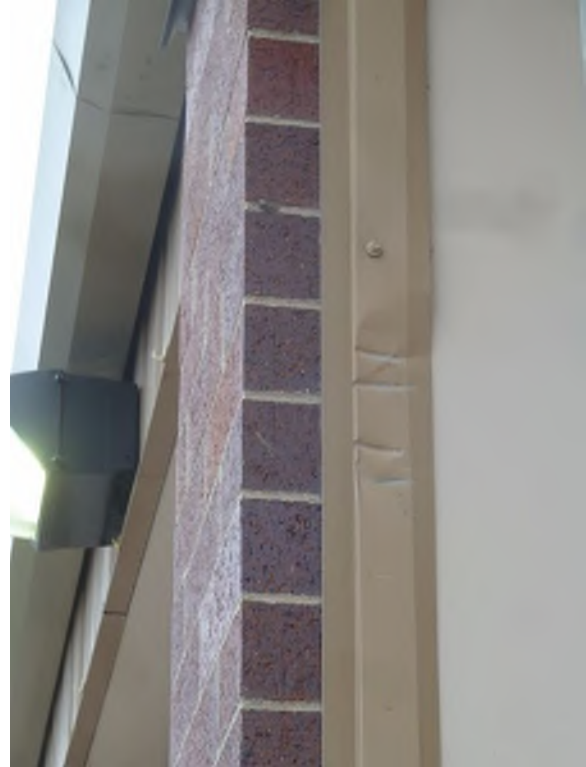
The west side of apparatus door closest to the office is damaged

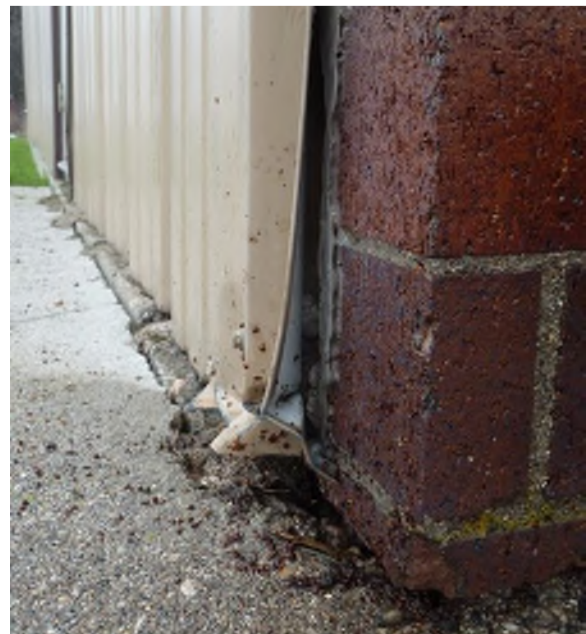
No visible flashing at base of wall condition - allowing water into wall system

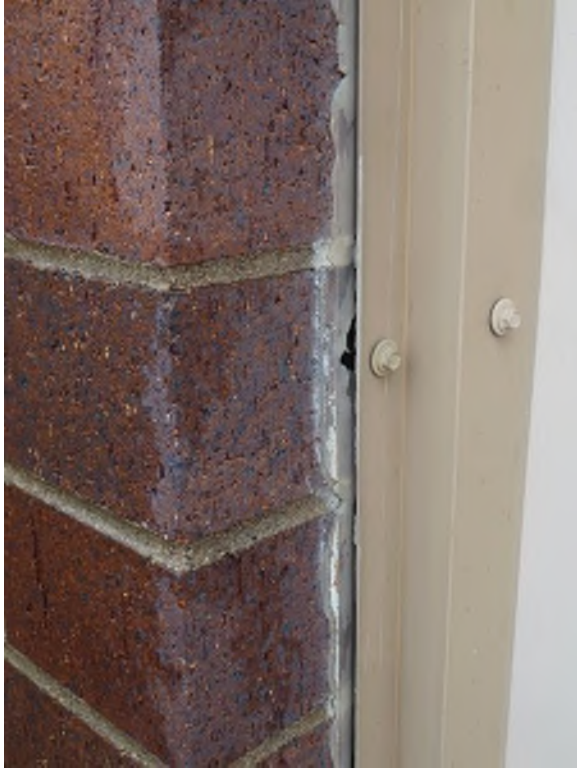
Sealant failing at all locations – needs to be re-caulked

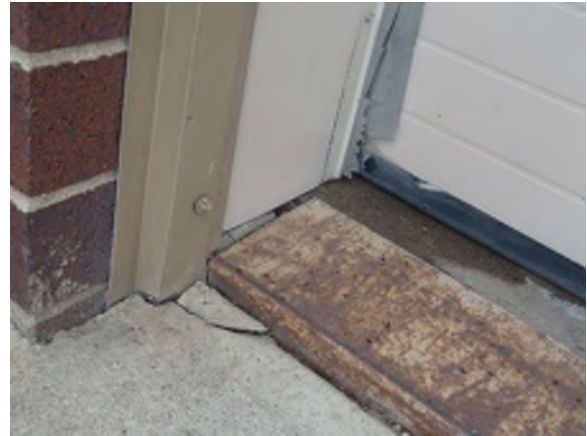
Weatherstripping at overhead doors damaged and needs replacement

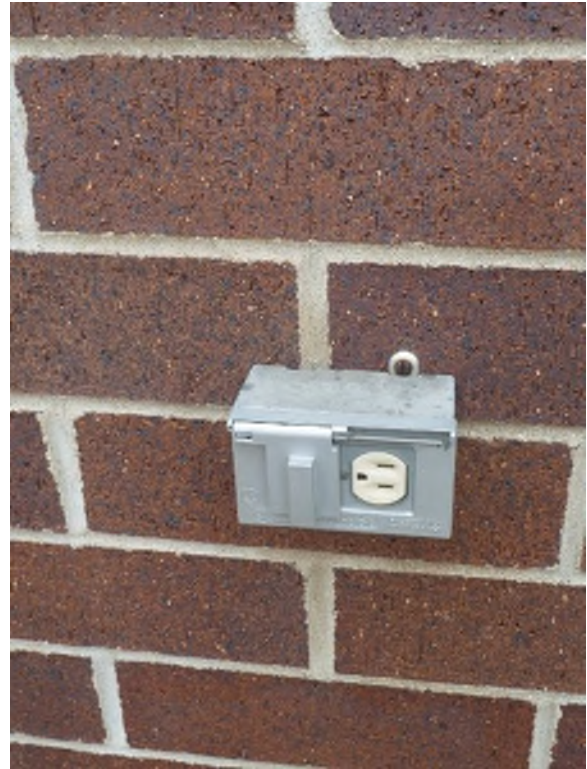
Exterior electrical outlet missing weather protection cover

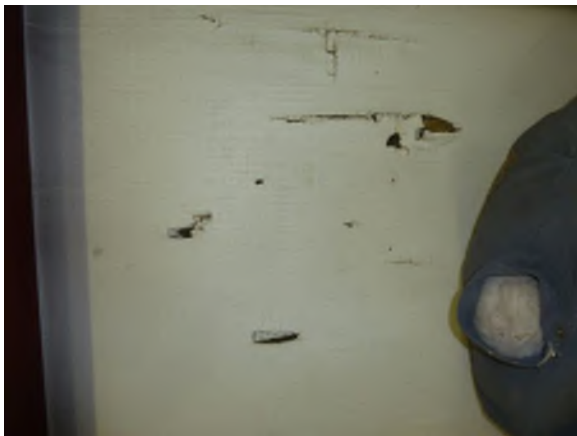
Frequent tears in vapor barrier at ceiling/walls throughout facility allows moisture into batt insulation, rendering it much less efficient at resisting heat transfer

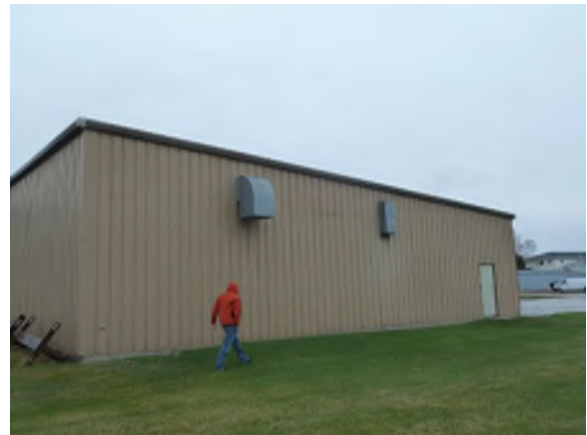
No make-up-air for exhaust system requires exterior doors to be propped open when exhaust is operating

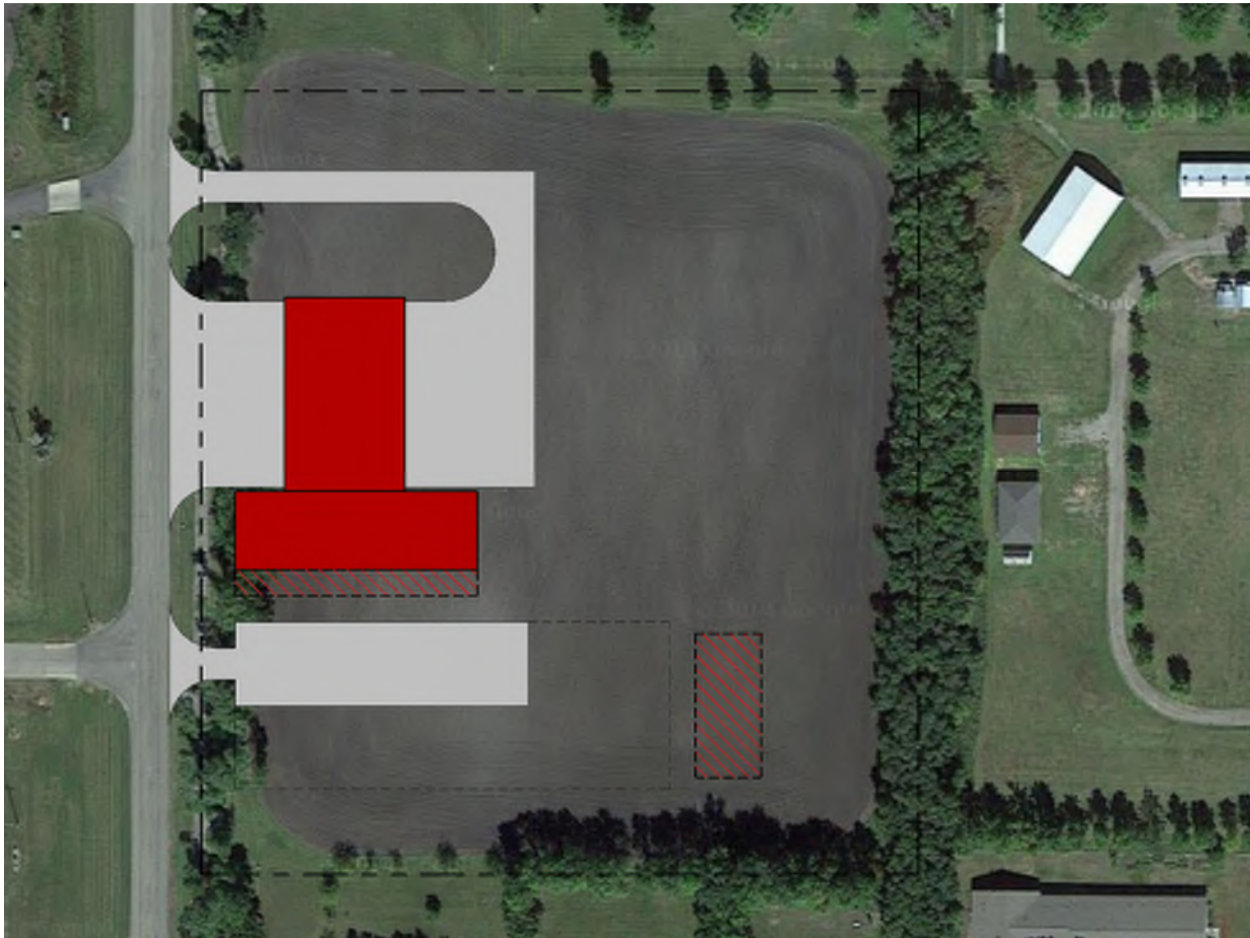
While it is not within the scope of this study to determine the optimal location of a new fire station, BKV Group did examine some potential options. One potential site that BKV Group has been made aware of is on State-owned property along School Road. The parcel is directly north of Station 102 and backs up to Heritage Village. The site appears to be very near the flood elevation but the building pad could be elevated with material removed for stormwater detention.

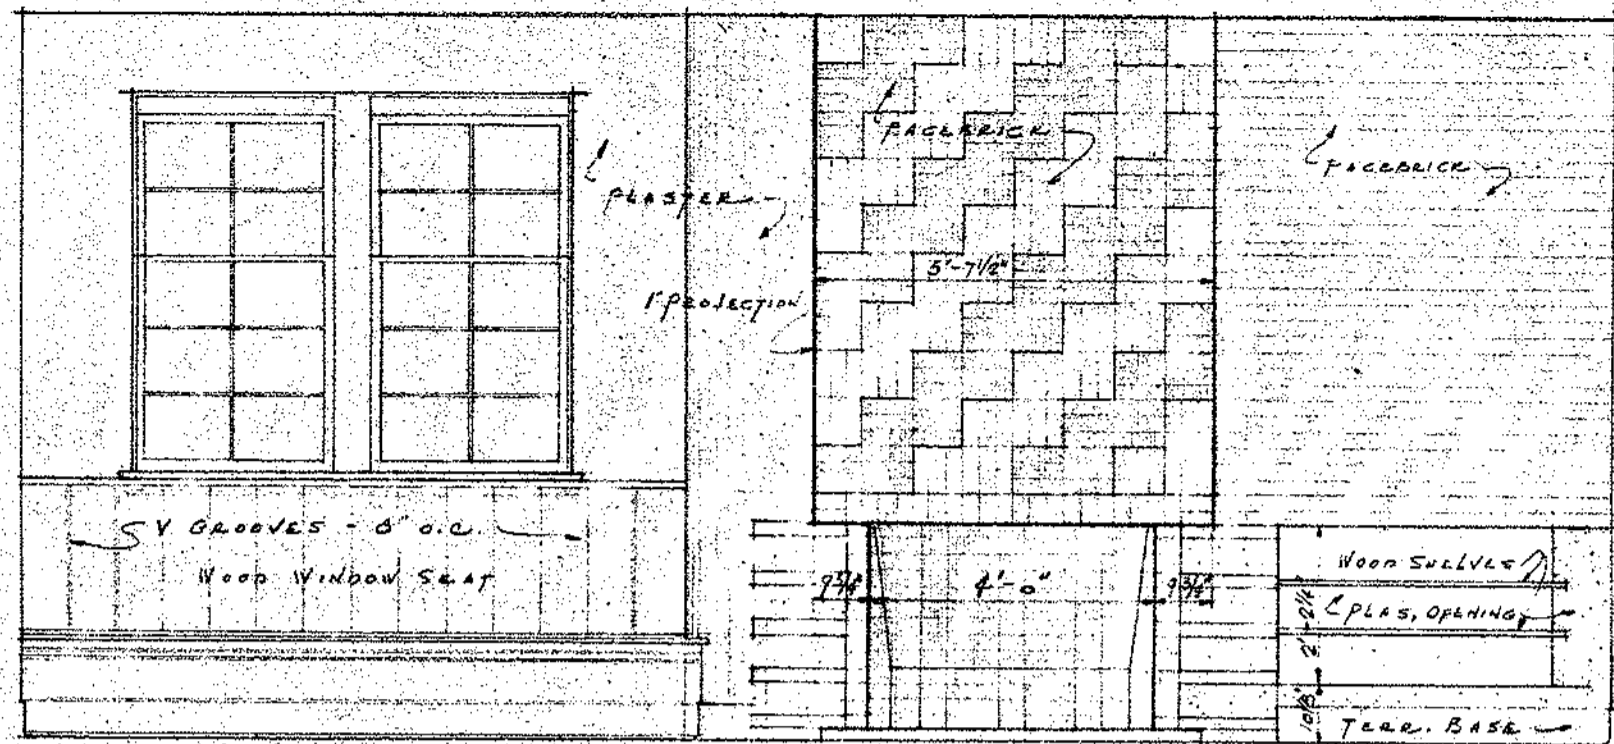
ELEVATION No. 1/4" = 1'-0"
