Architecture
Interior Design
Landscape Architecture
Engineering

222 N Second St, Suite 101
Minneapolis, MN 55401
Telephone: 612.339.3752
Facsimile: 612.339.6212
www.bkvgroup.com
EOE

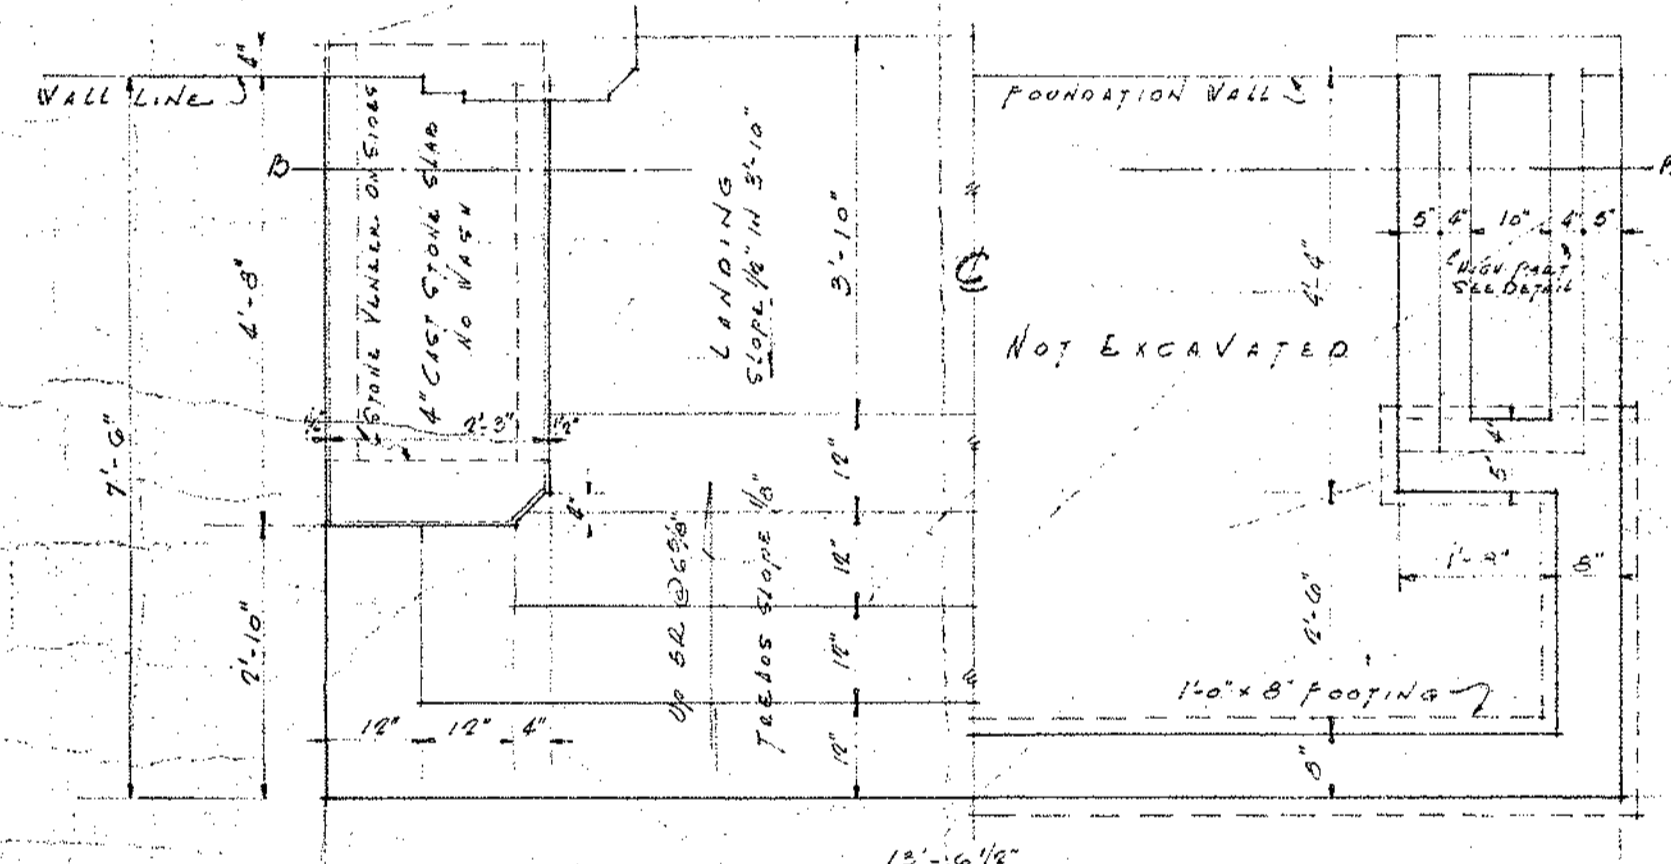
° PART TOP VIEW PLAN °

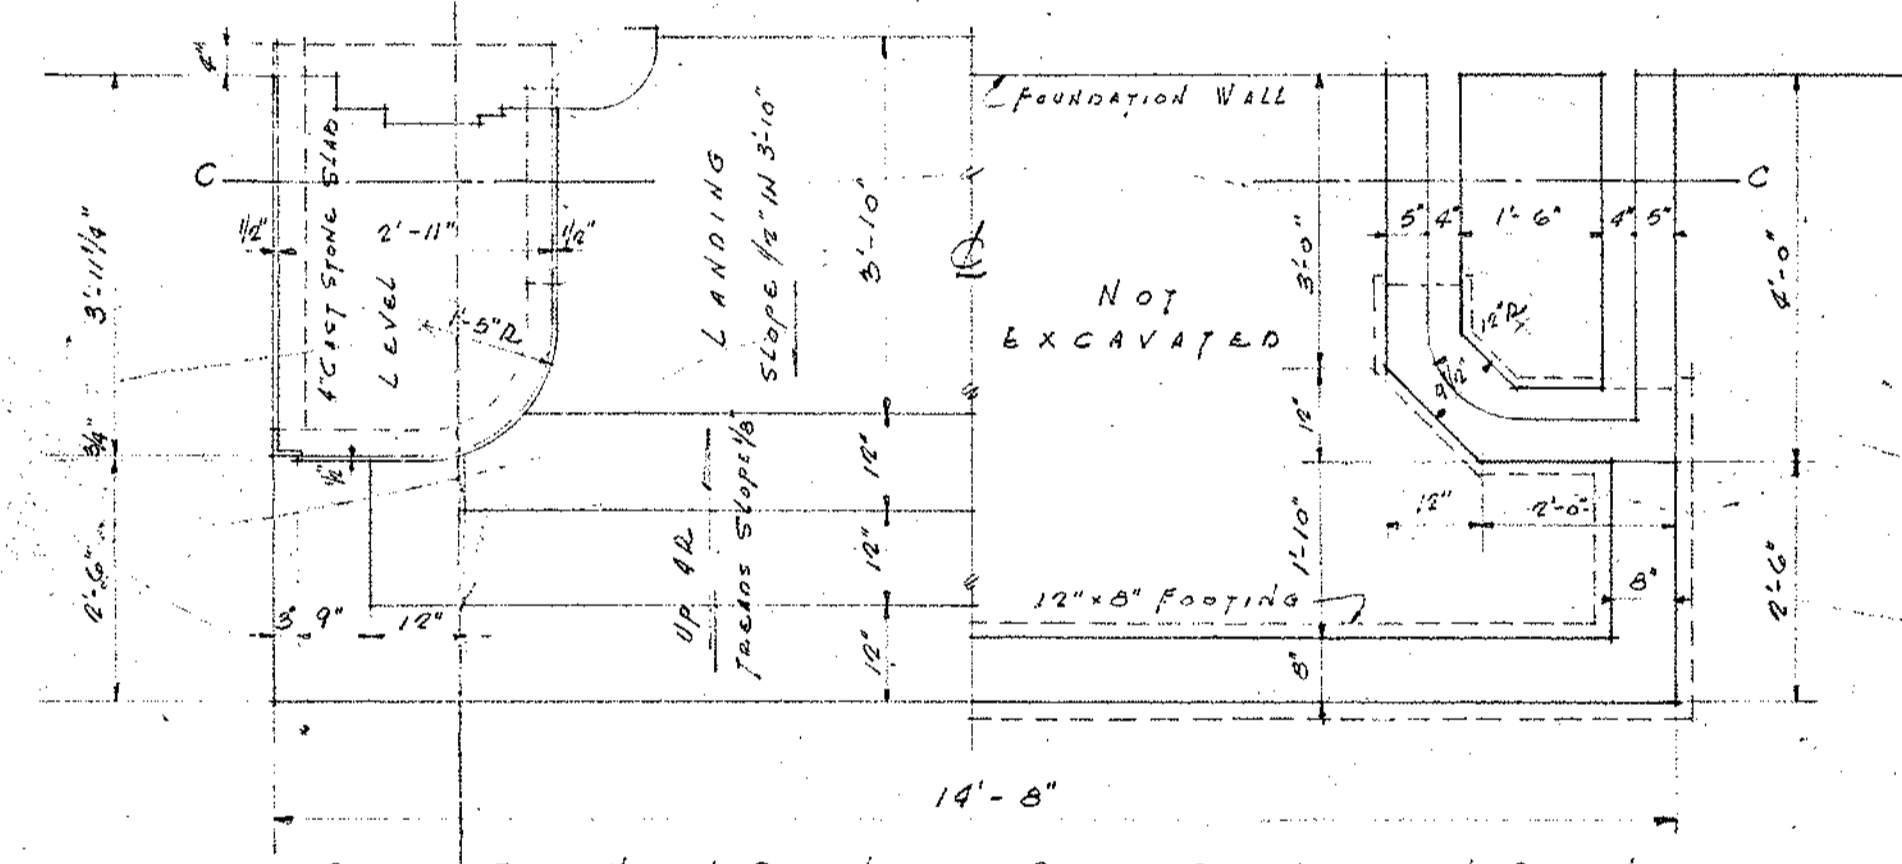
° PART TOP VIEW PLAN °

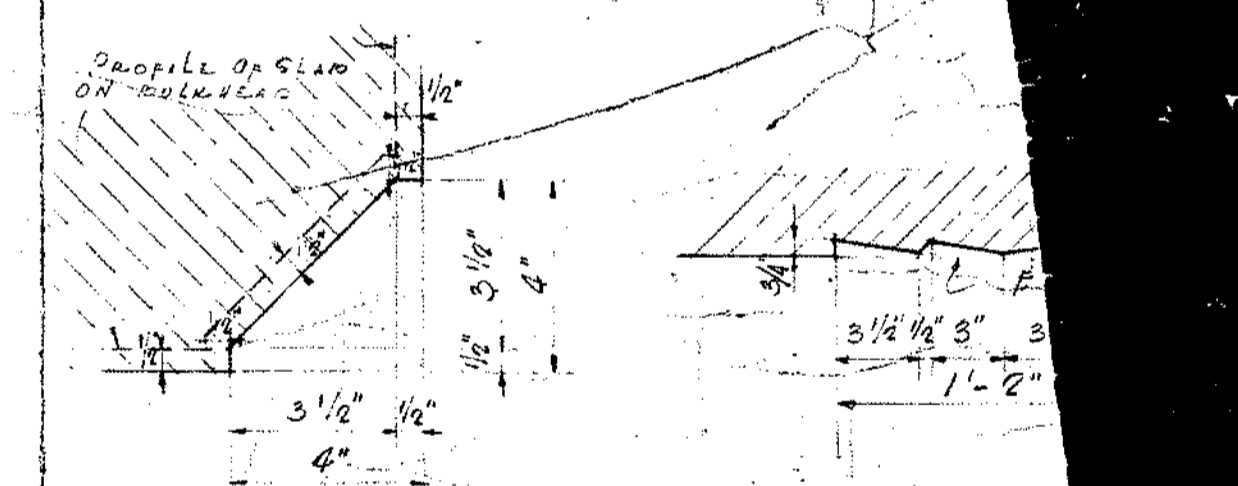
° DETAIL ON LINE "A-A" °

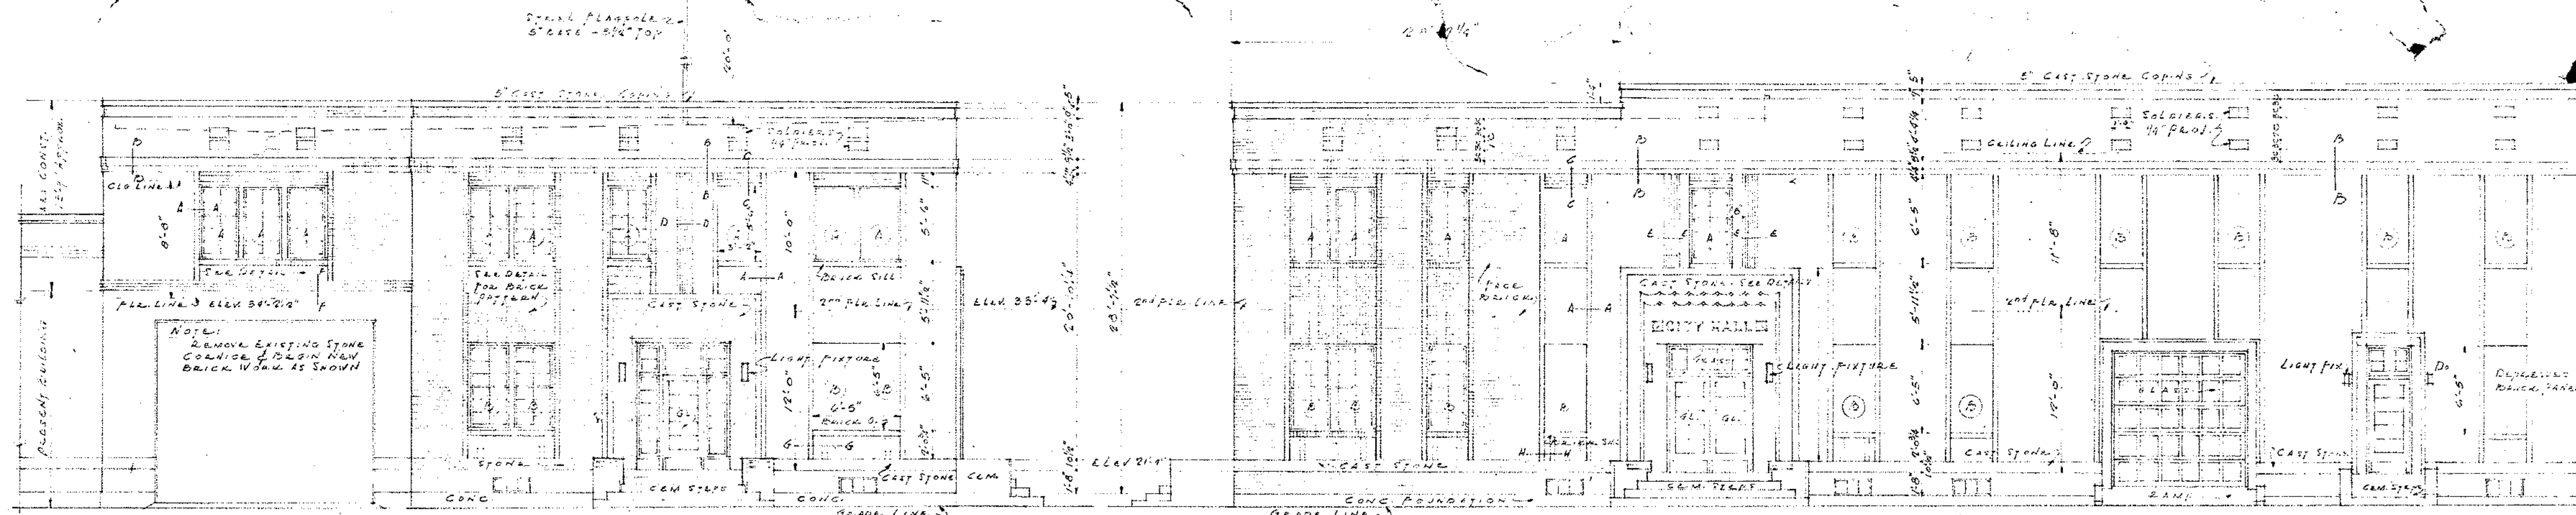
WEST ELEVATION
SCALE: 1/8" = 1'-0"

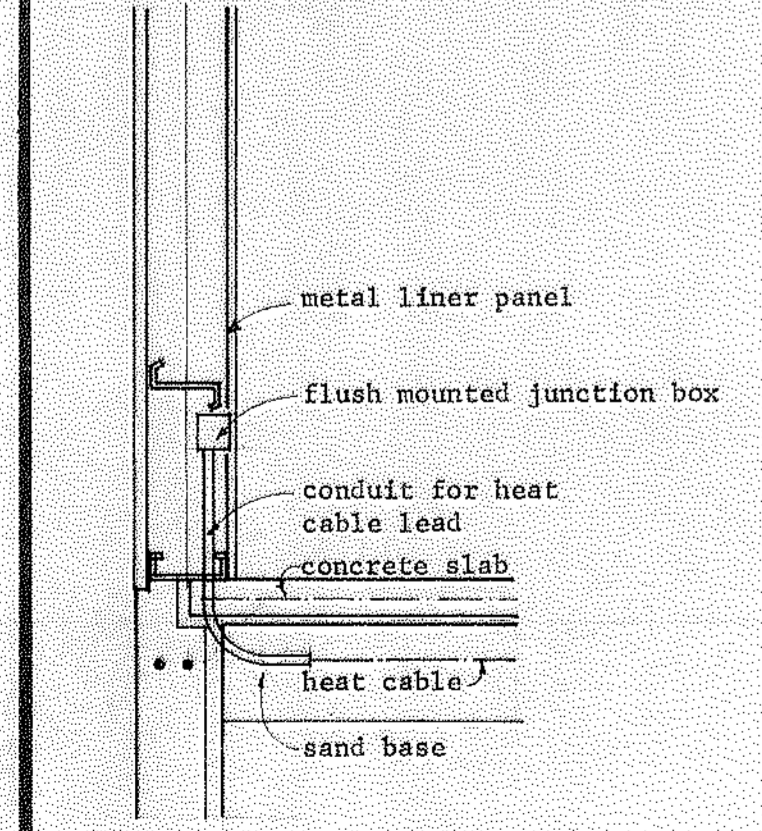
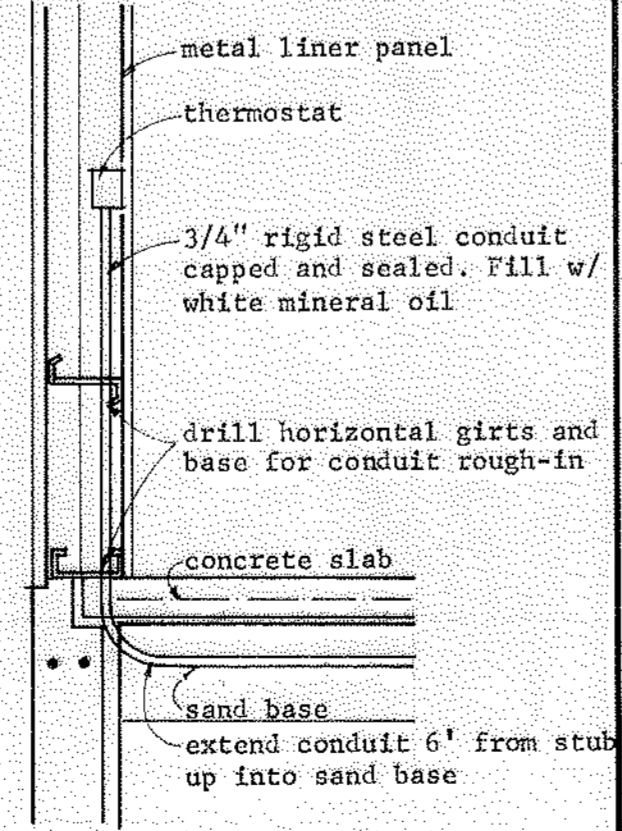
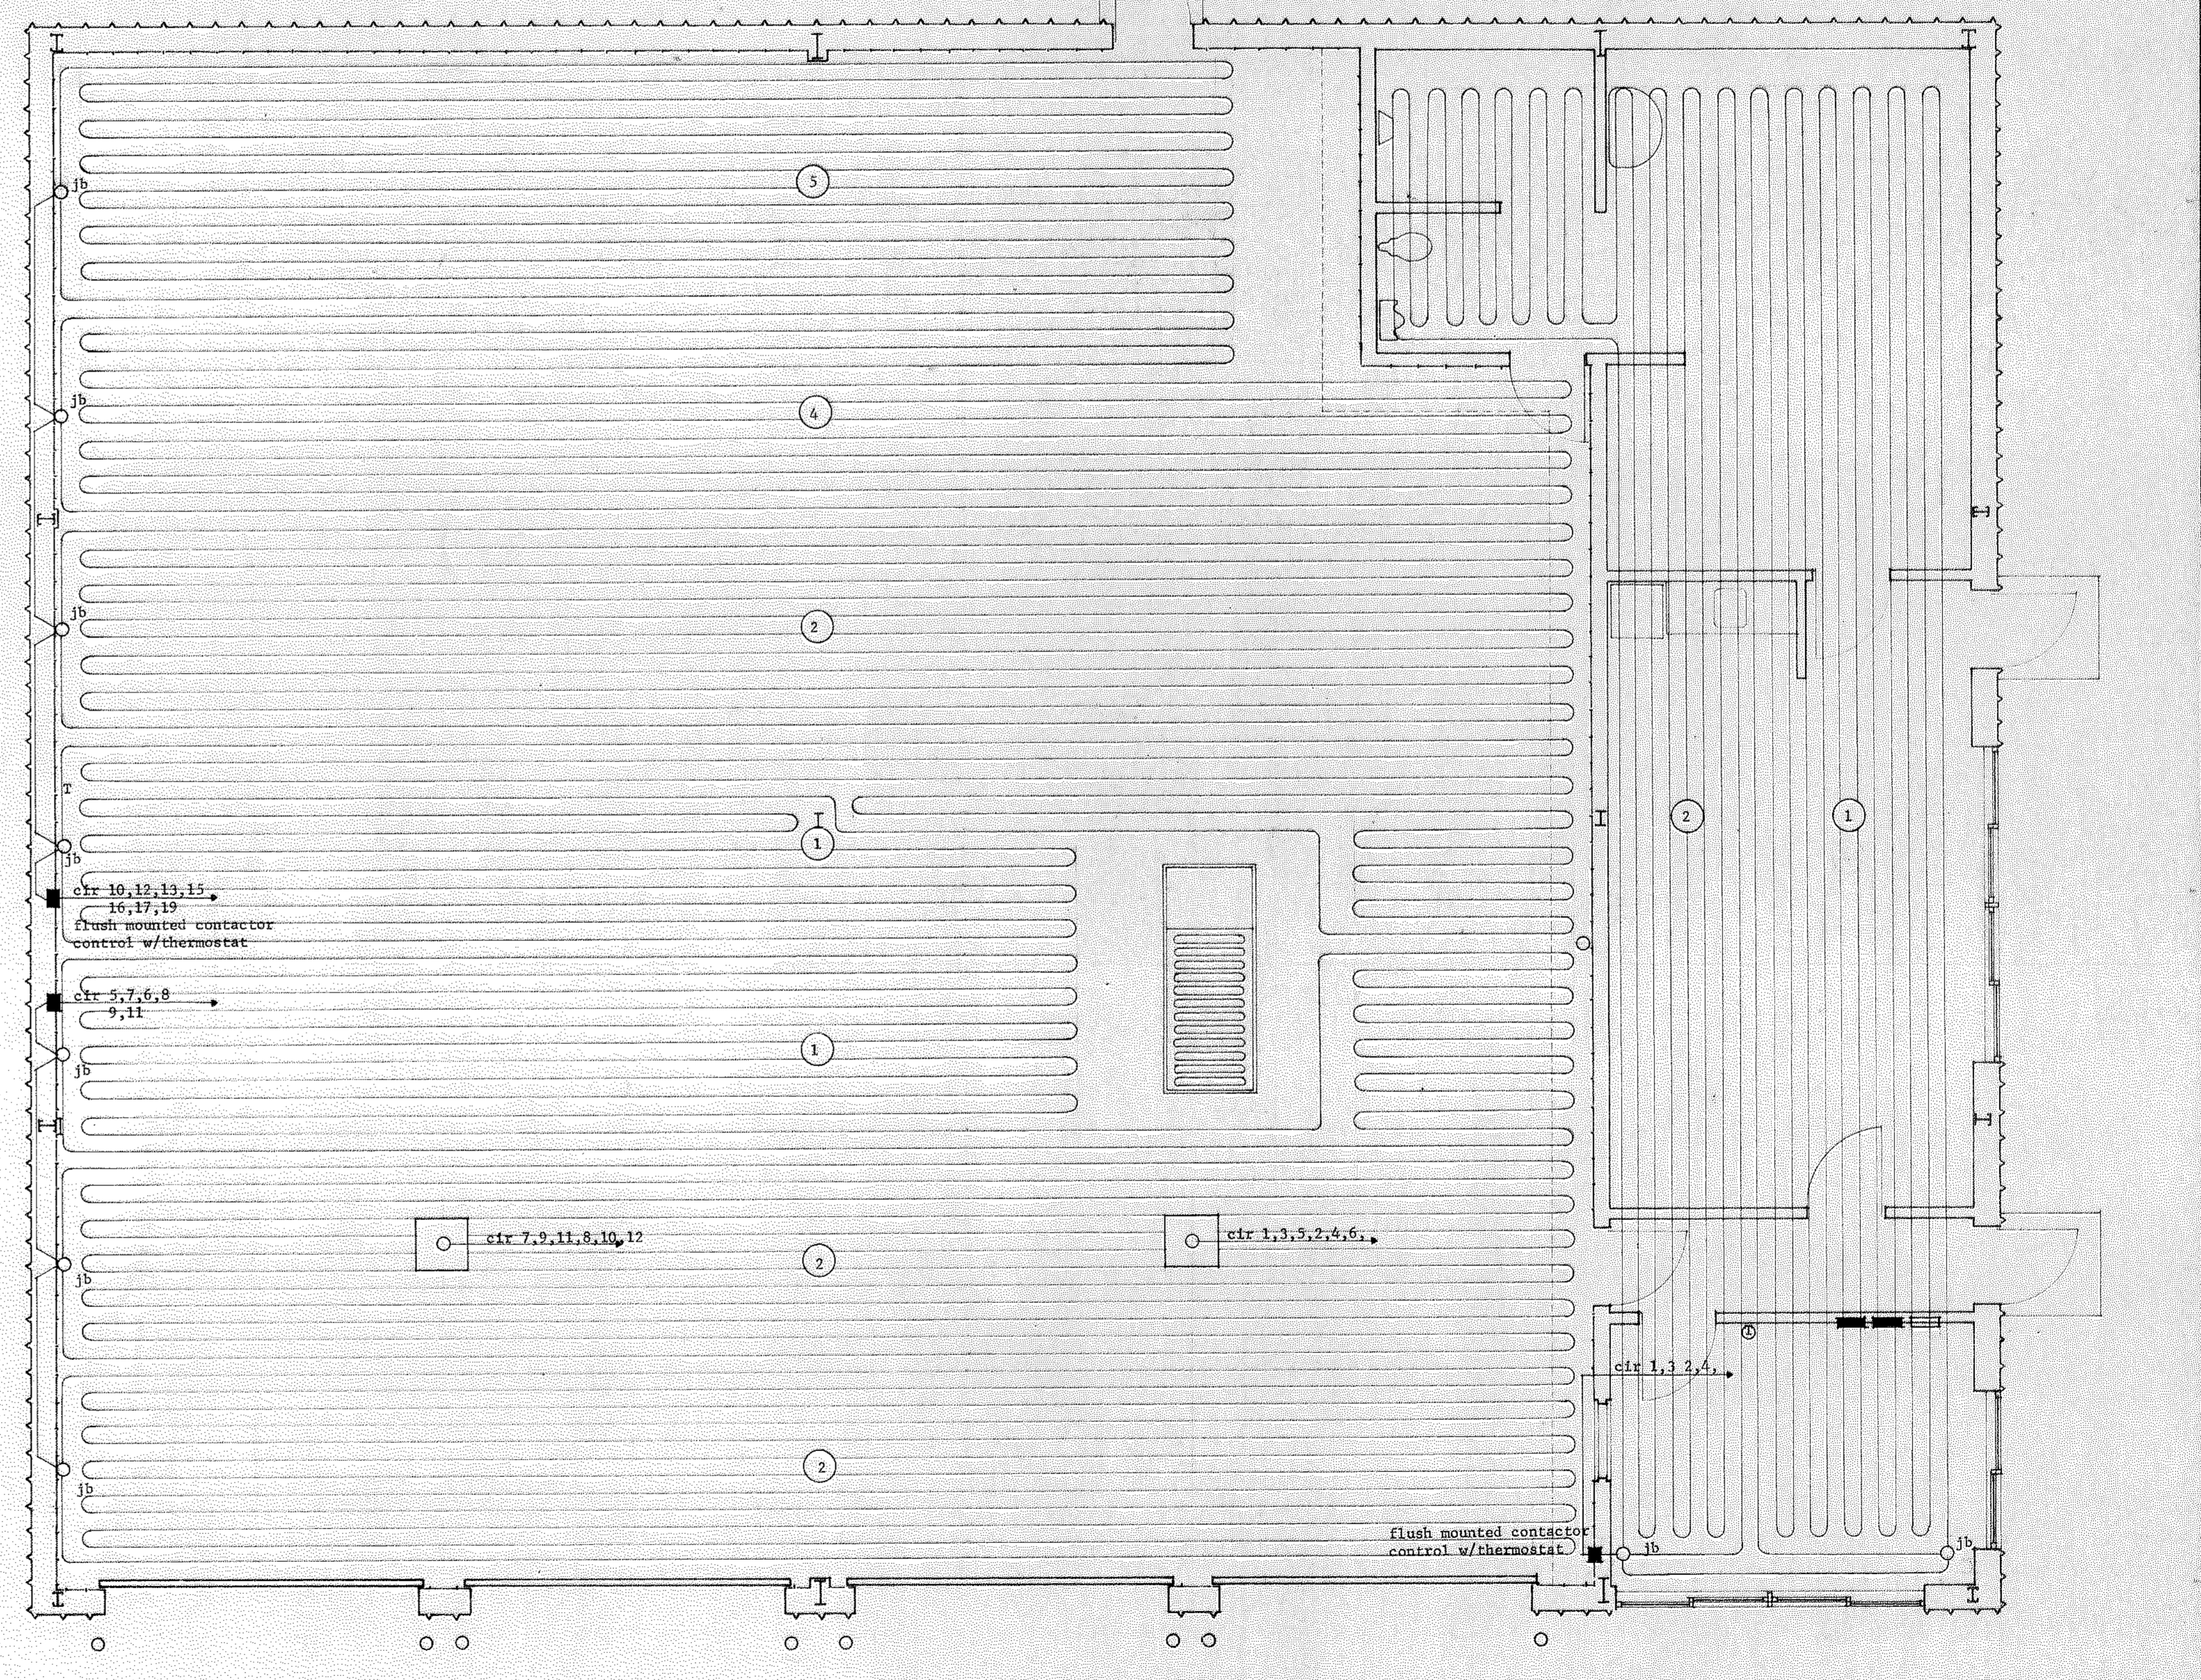
PROGRESS PRINT
NOT FOR CONSTRUCTION
