- My name is Jillian Schaible, and I am a Legislative employee
- I am here to testify in support of SB2146
- I love the legislative process and being here to watch it in action, but the Capitol itself, while architecturally beautiful, is not easy to access
- The pictures you will find in my testimony today are just some of the barriers North Dakotans with different abilities will currently encounter if they feel comfortable coming in here
- I, or anyone with a different ability, should feel they can work here as a state employee, legislator or government official and to be proud to be North Dakotan
- Your support of SB2146 would tell everyone with different abilities that you feel the same way

Capitol Accessibility Photos

Jillian Schaible

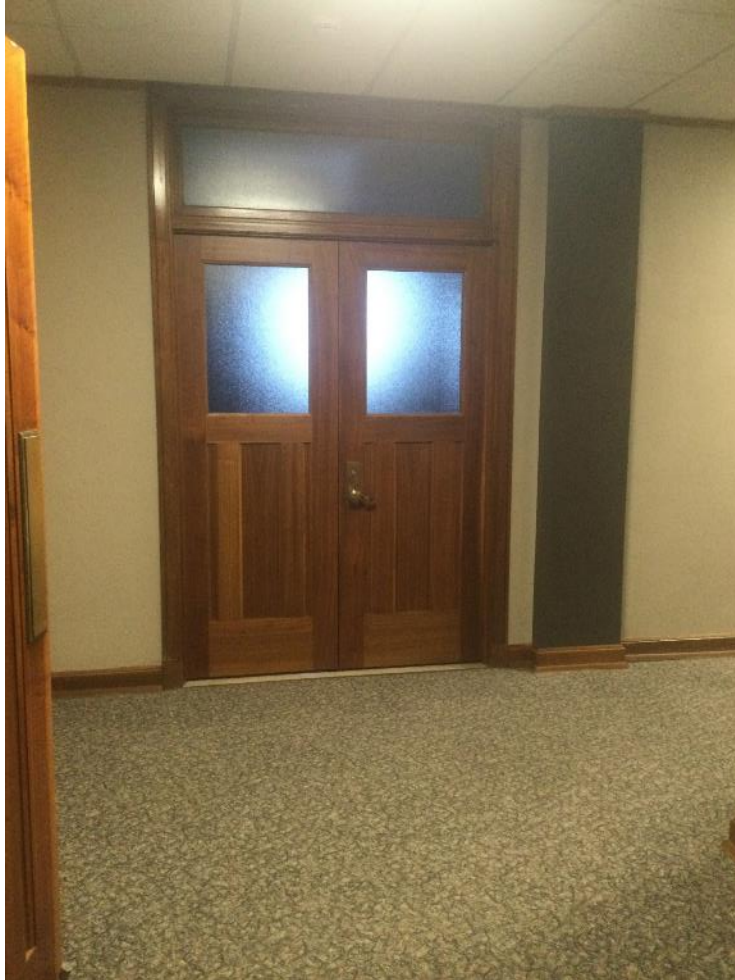
Brynhild Haugland upper entrance

- No signage indicating room location or accessibility
- I accidentally found this door, but prior to, avoided the room when possible, as I did not want to sit on the “bottom” and/or use the elevator
- Brynhild Haugland is included in SB2146, HB1015 and HB1249

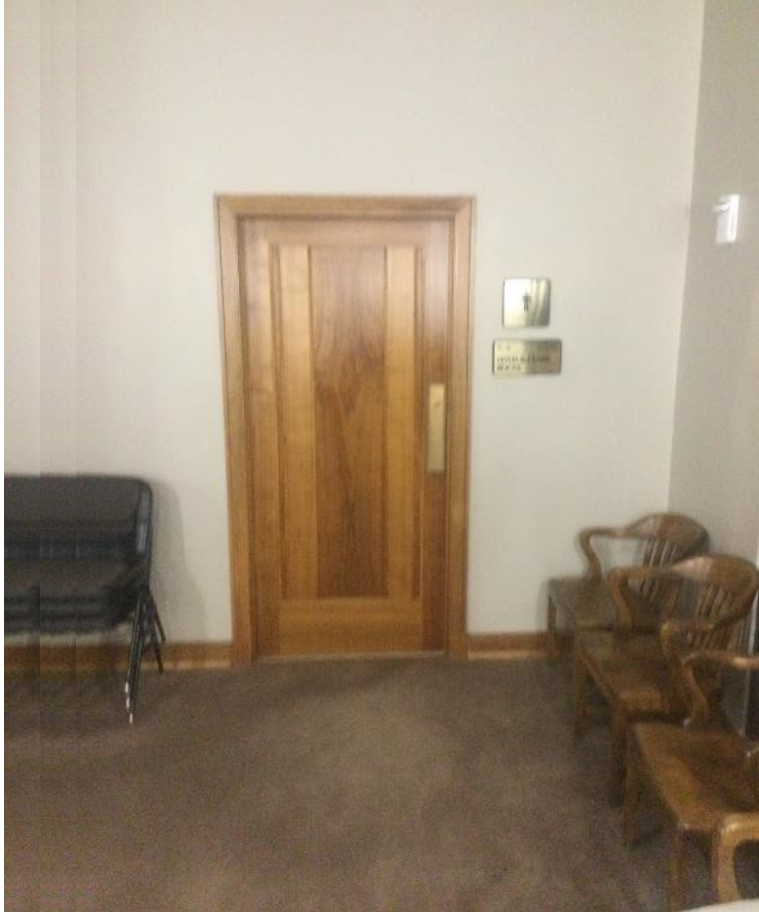
Brynhild Haugland bathroom entrance

- Stair door to ground floor men's bathroom
- There is a room behind the door, but this door blocks it

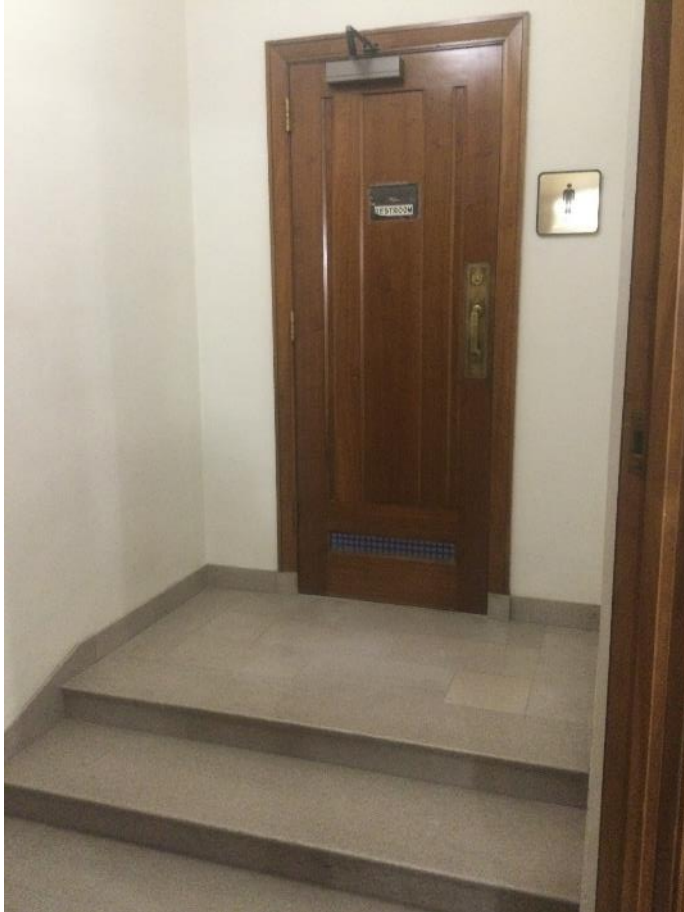
Brynhild Haugland

- Inside ground floor men's bathroom

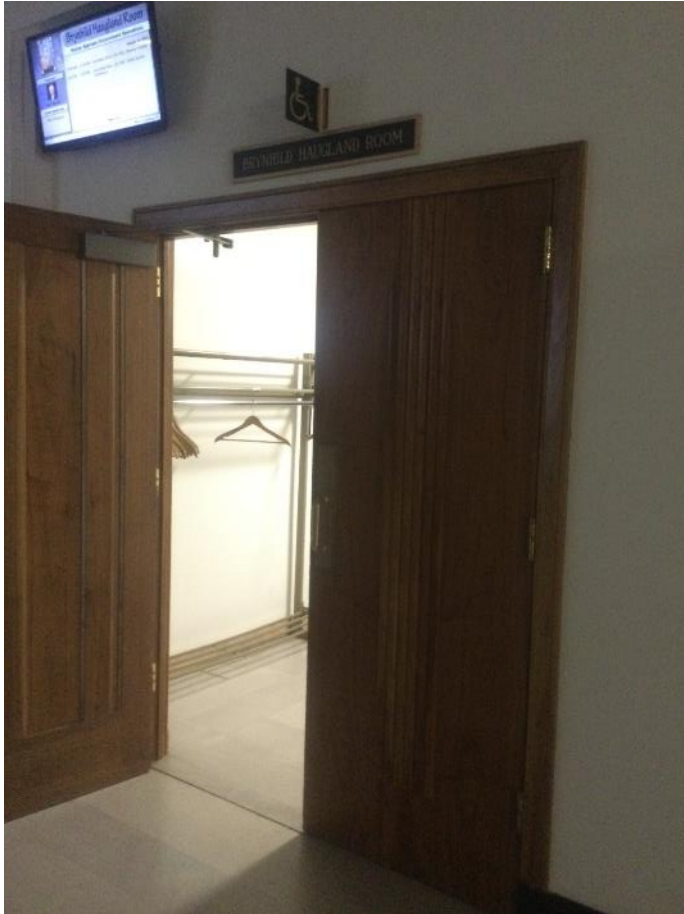
Brynhild Haugland

- Both TVs outside both entrances are too high
- Wheelchair elevator is located here

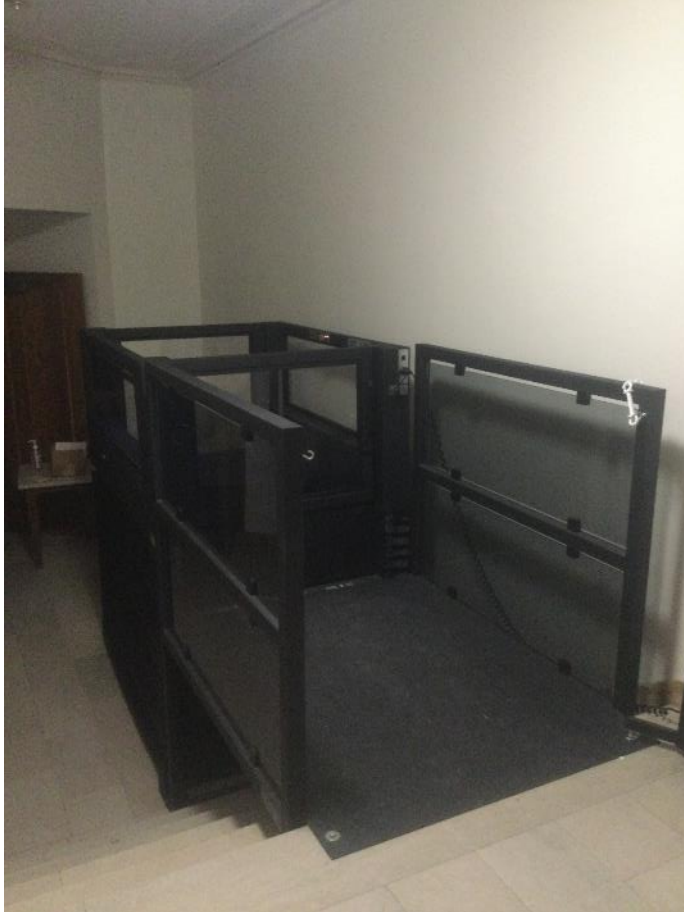
Brynhild Haugland Elevator

- Installed when?
- Who maintains it?
- How often is it checked?

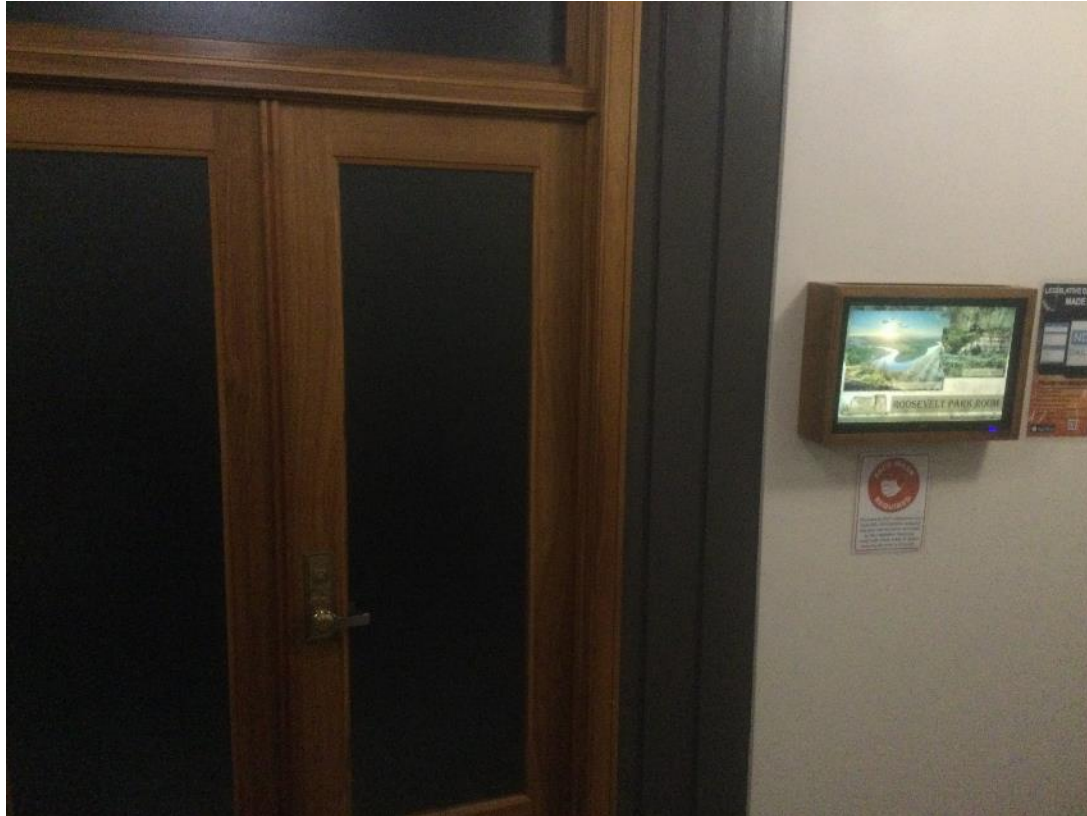
Horseshoe Rooms

- Can the doors remain unchanged?
- What about having a doorbell outside with an indicator light? When it goes off someone could open both doors
- Can we stream committee hearings on these TVs?
- All TVs appear to be the same height; no changes made to doors

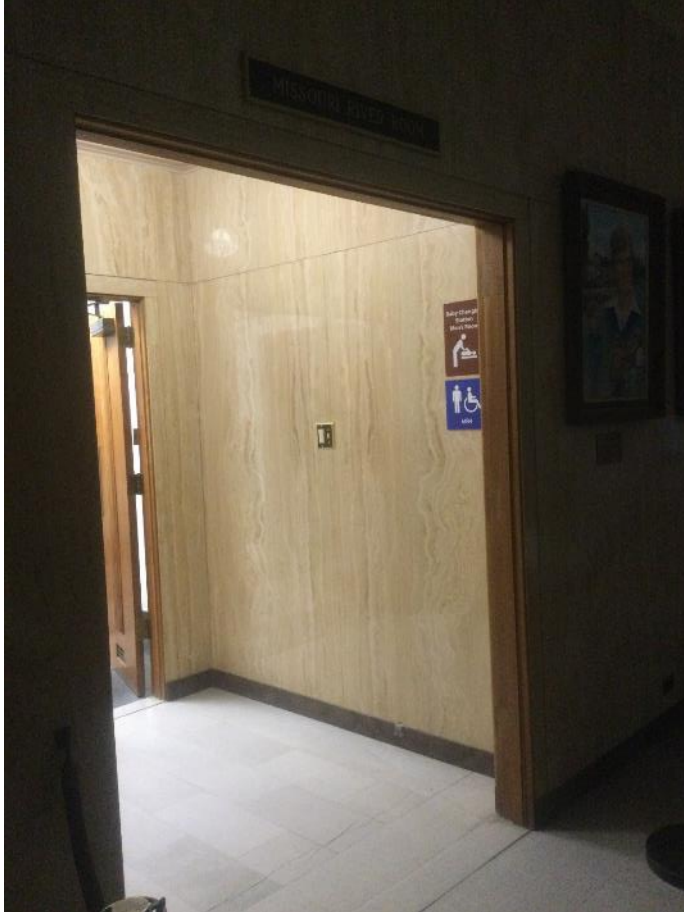
Ground Floor Men's Bathroom A

- Accessibility signage is too high
- There is another sign on the opposite wall at the same height

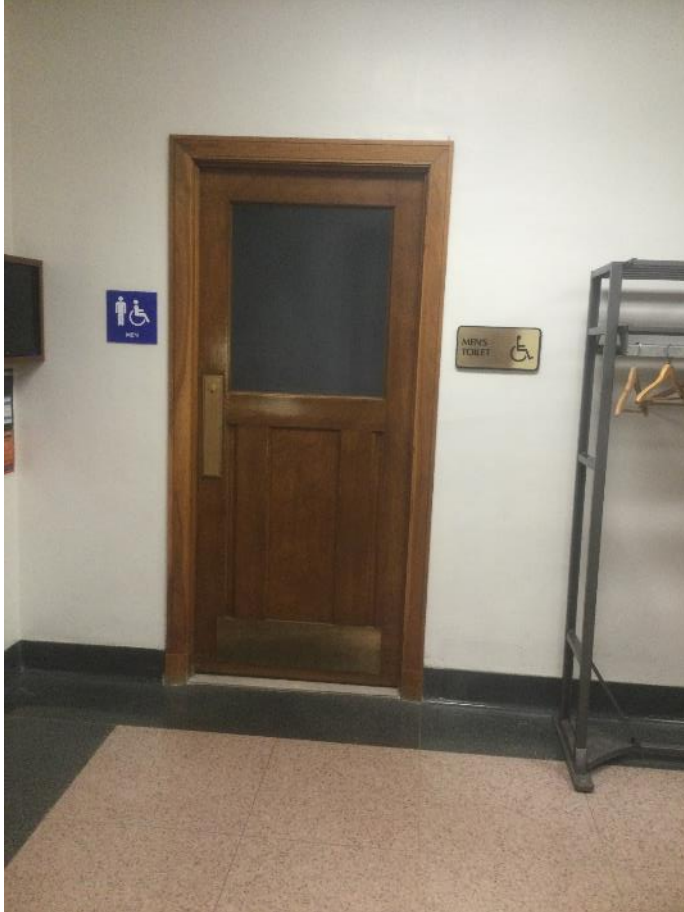
Ground Floor Men's Bathroom A

- Accessible entrance
- All accessibility signage should be at the same level everywhere

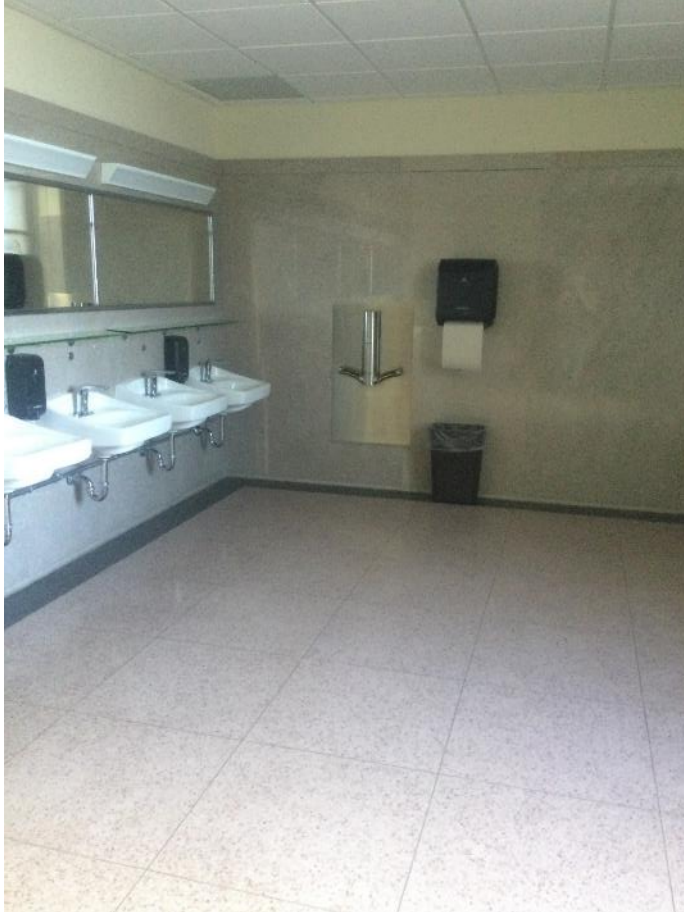
Ground Floor Men's Bathroom A

- Accessible entrance view
- Trash can should not be underneath dispenser
- Same view from stair door

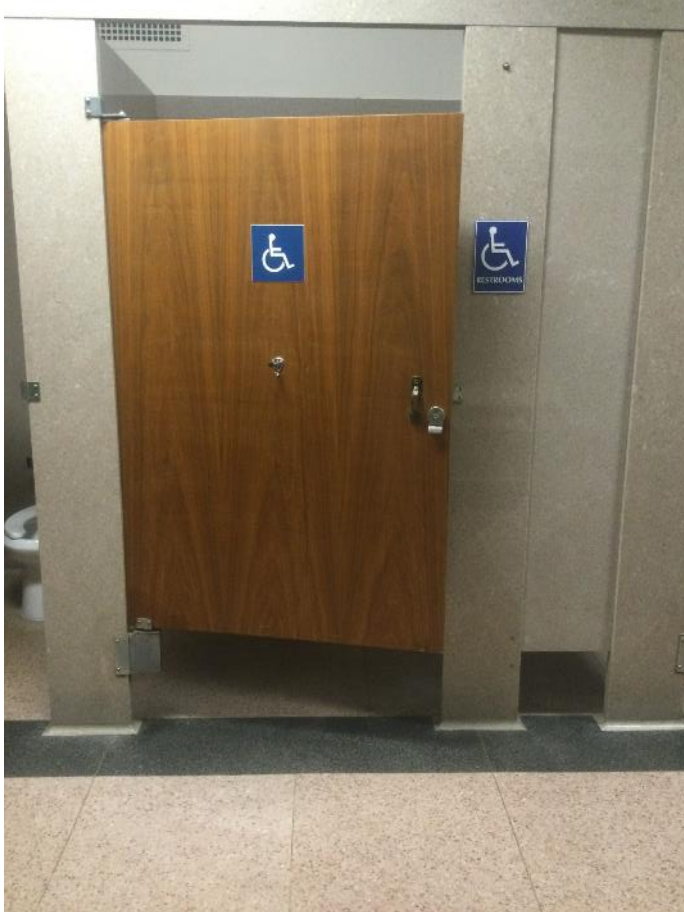
Ground Floor Men's Bathroom A

- Is the stall wall accessible?
- There are at least two other doors where the sign indicating accessibility is placed on a stall wall and not on the door itself. A visually impaired individual could mistake the wall for the door
- Outside coat hanger could cause injury. Other doors have the same issue
- Lock could be a problem

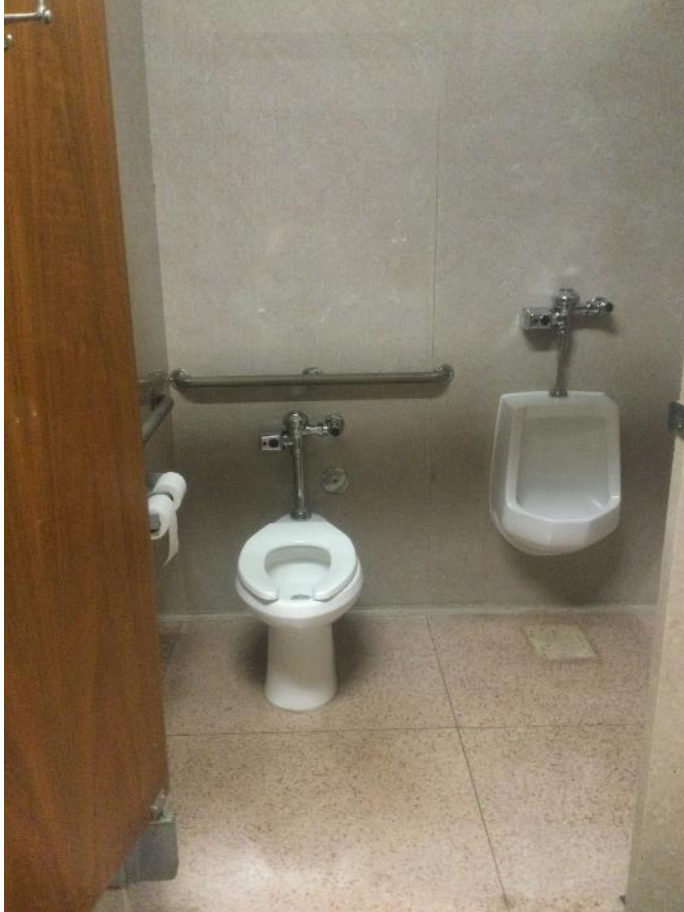
Ground Floor Men's Bathroom A

- Reverse in, forward to lock door, then position
- Massive space between wall and toilet
- Side transfer may not be possible
- Urinal bar also far away
- There are better accessible urinals and grab bars to have
- Same setup in Ground Floor Men's Bathroom B

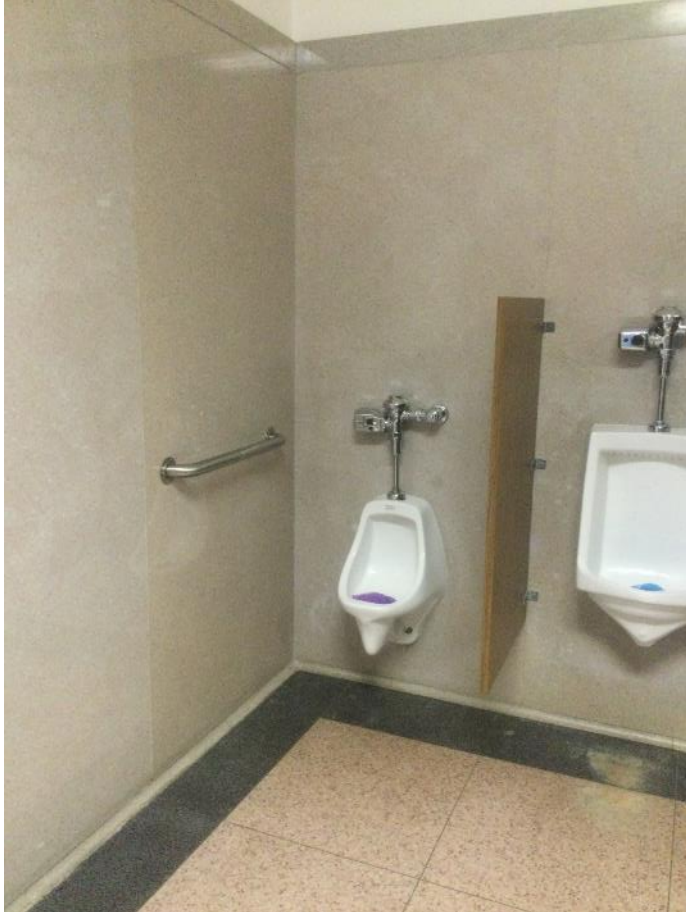
Men's Bathroom A

- This is the only horizontal grab bar next to a urinal in an “accessible” area in the building – and it makes the most sense
- There should be a grab bar on both sides for balance and strength dominance assistance
- Install a floor urinal wherever accessible urinals are located

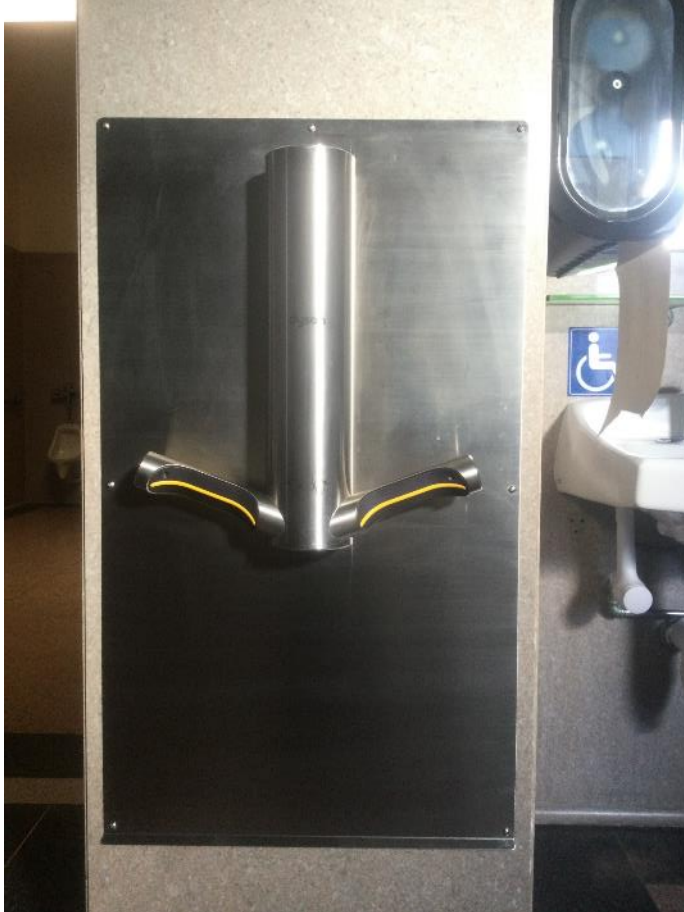
Ground Floor Men's Bathroom A

- [Dyson Airblade 9kJ | Dyson](#)
- \$1,199.00
- HEPA filter (est. \$79/each, requires monitoring/replacing)
- 2 in this bathroom
- 1 in women's ground floor bathroom
- Accessible sink sign
- Paper towel dispenser may be too high

Airblade 9kJ is less than 4 inches protruding from the wall. Traditional hand dryers that protrude beyond the 4" are allowed to be of an unlimited distance by ADAAG as long as they are mounted at 27" above finished floor (AFF) or lower so that they overlap the cone detection range. Objects mounted with their leading edges at or below 27" (685 mm) AFF may protrude any amount; however, protruding objects should not reduce the clear width of an accessible route or maneuvering space. Any retrofit installation must comply with the newest and most stringent code standards.

A clear area in front of the unit should be a minimum of 30" wide by 48" of length. This area can overlap a circulation path but should not overlap other required accessible areas, for example, a lavatory sink in restrooms with access to more than one user at one time. Single use restrooms can overlap accessible areas due to the fact that they are used by only one person at a time.

Based on our review of data provided by Dyson for the Airblade 9kJ hand dryer it appears that if properly installed per manufacturer's recommendations for height, and the design professional allows the proper front approach clear area with no conflicting overlapping accessible areas, then the unit should comply with accessible requirements.

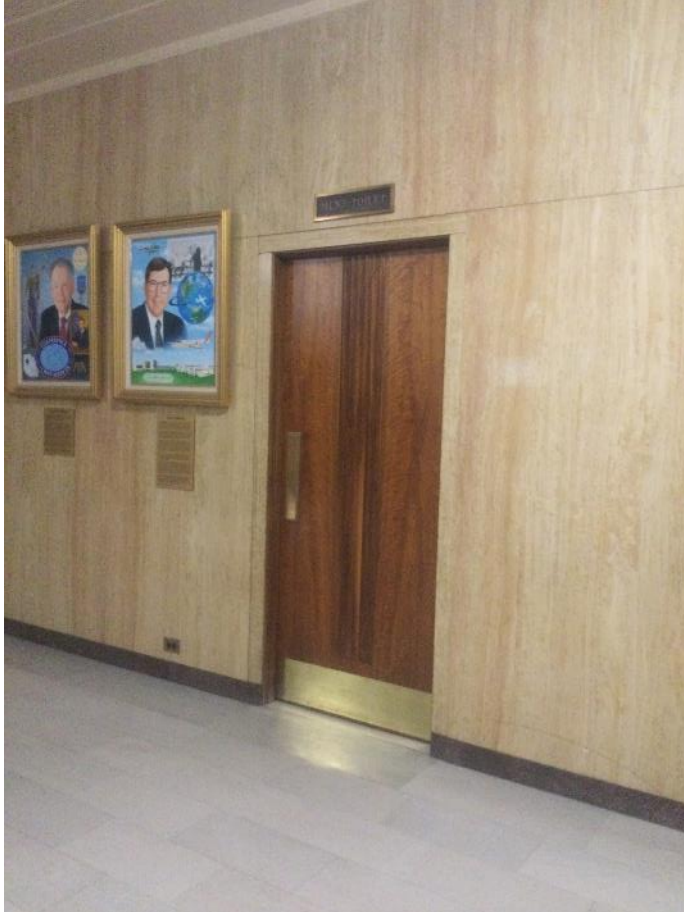
Ground Floor Men's Bathroom B

- No accessibility signage

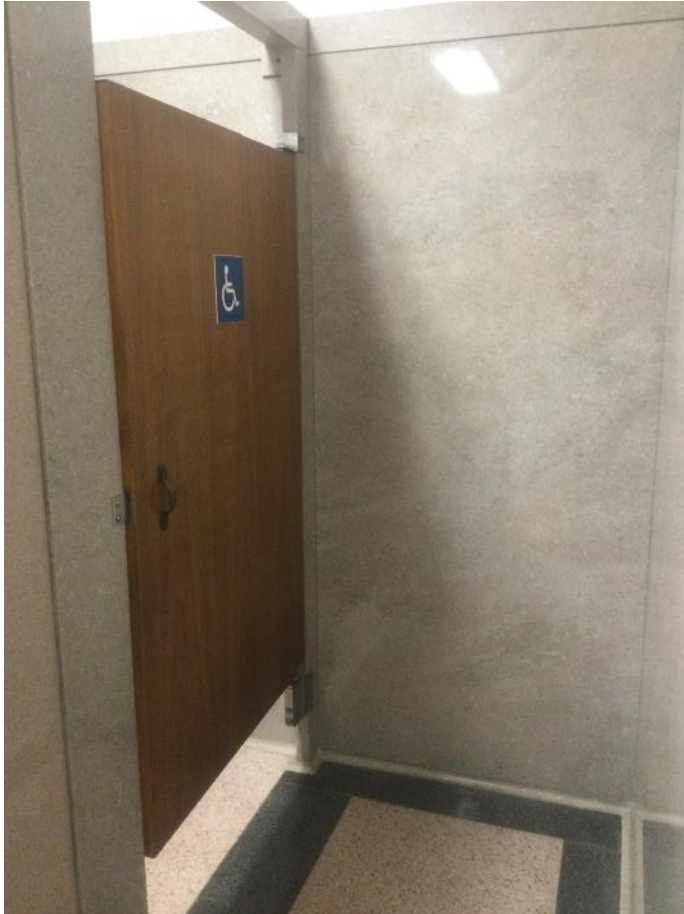
Ground Floor Men's Bathroom B

- Turning radius may not be legal
- Door may not stay open while trying to get in

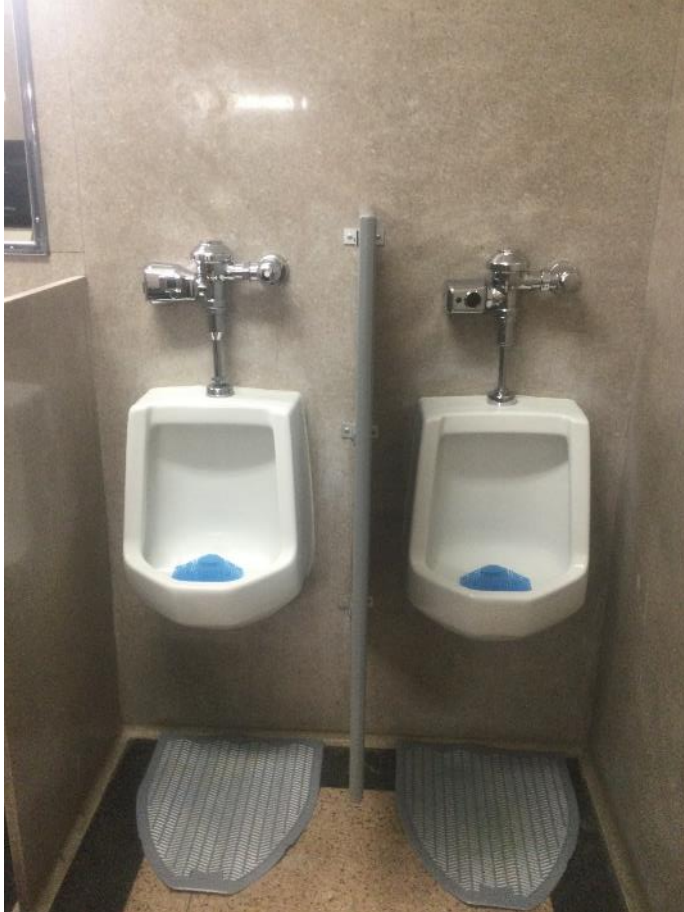
Ground Floor Men's Bathroom B

- Looks like the left urinal is attempting to be “accessible”
- Add horizontal grab bars?
- If the entire bathroom is not accessible, accessibility signage should not be used anywhere
- Sink area is not “accessible either

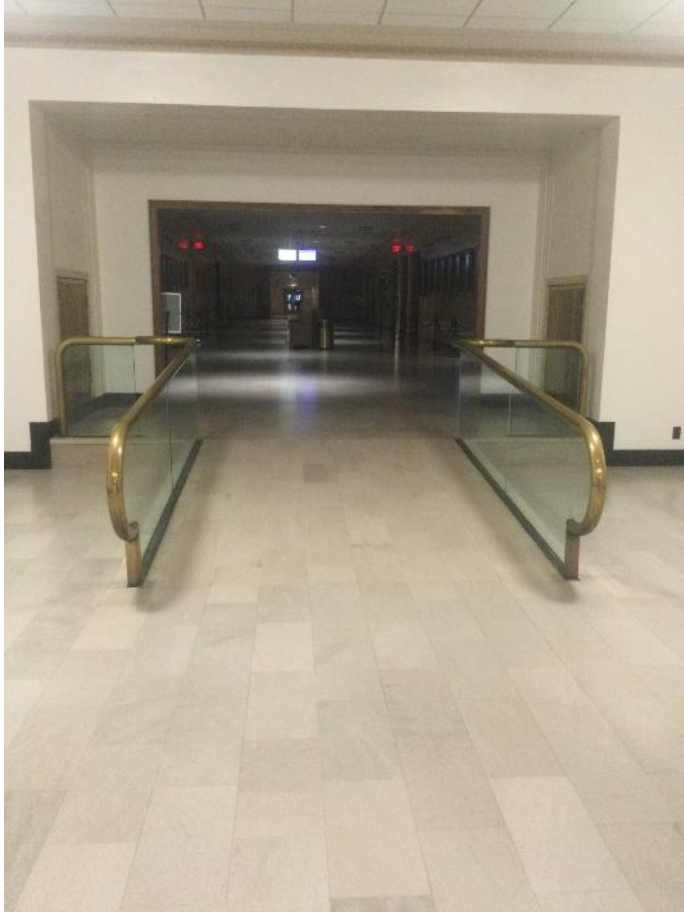
Ground Floor Ramp

- The architect said this was not ADA compliant somehow...

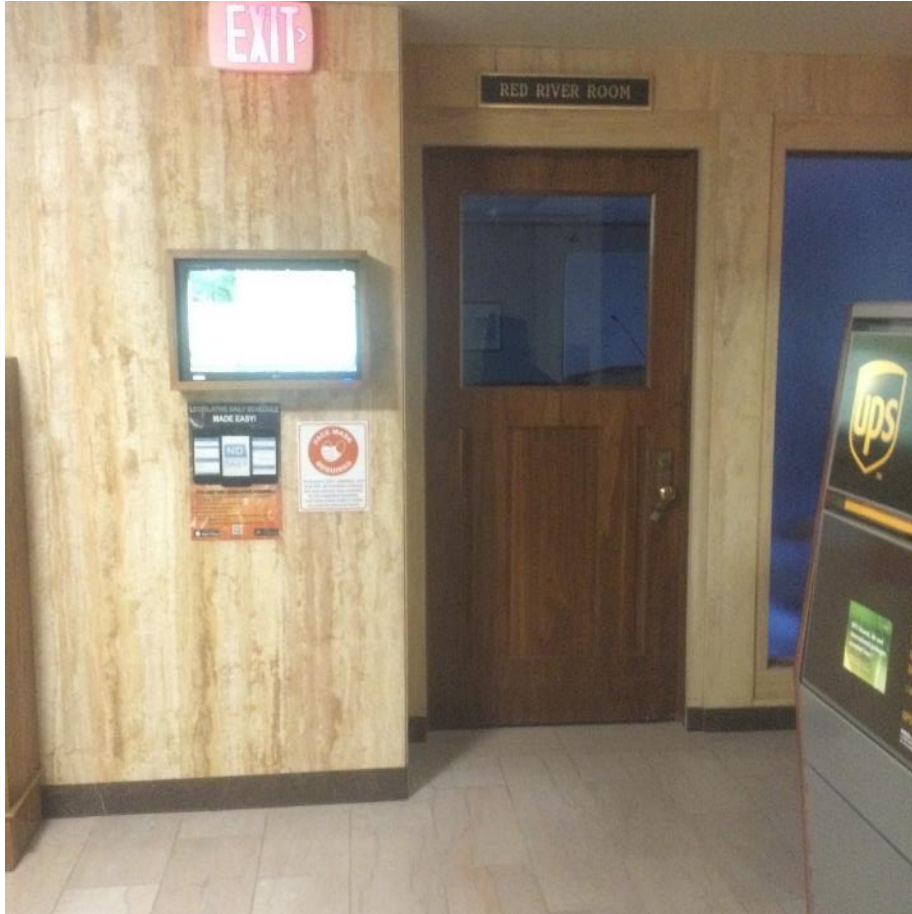
Red River Room

- Can access be given without door alterations?
- Good height for the TV
- Similar situation for Sakakawea Room

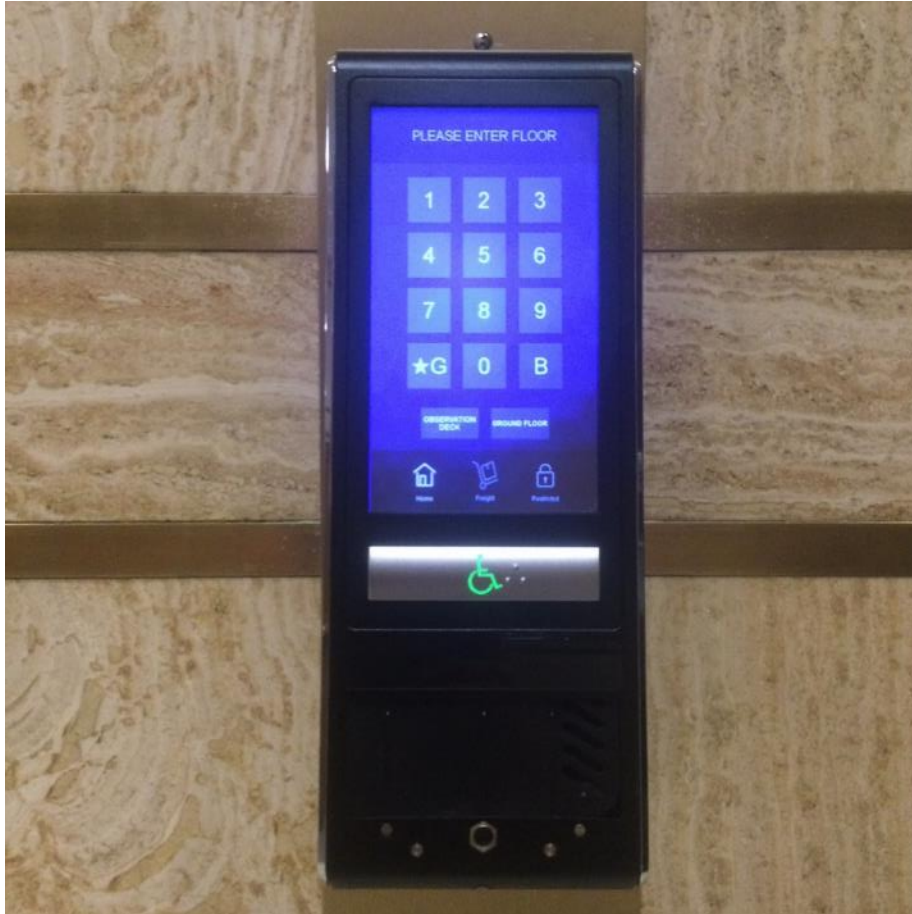
Small Elevator keypads – 37 total

- Who manufactures these?
- When were they installed?
- Do they get tested to ensure they are working properly?
- If so, how often?
- What happens if one breaks?
- Can pressure sensitivity, volume, tone, reaction speed, voice speed be changed?
- Post instructions on how to operate?

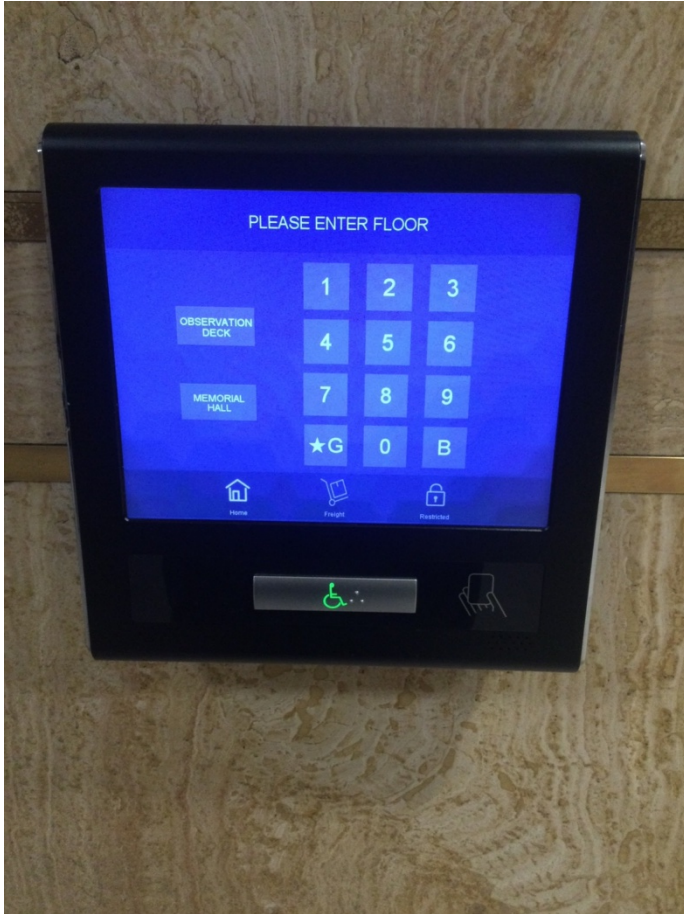
Large Elevator keypads – 2 – Ground floor

- Why are these different from the other 37?
- Same questions apply regarding the small elevator keypads

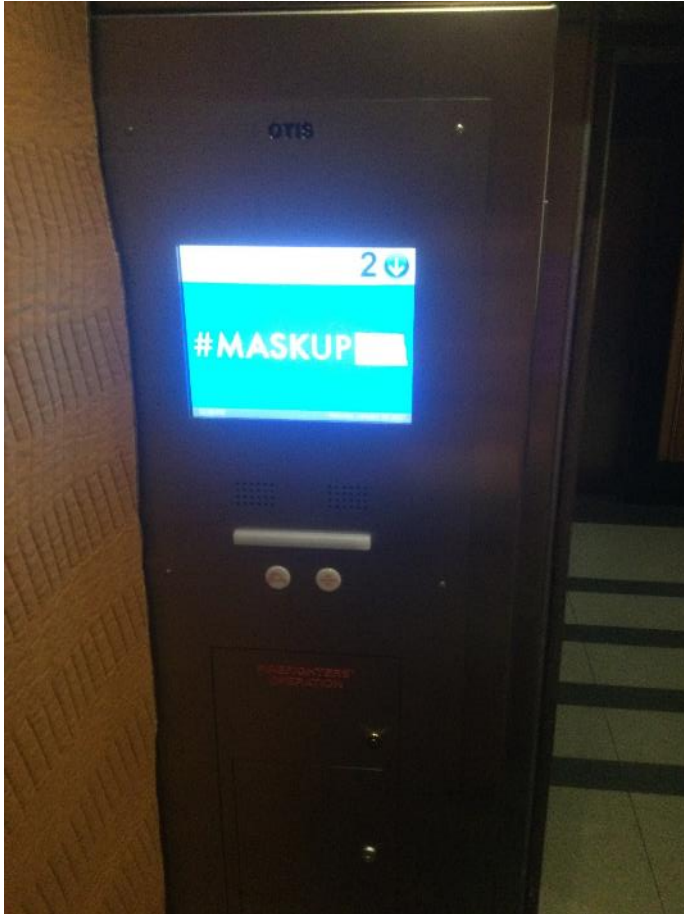
Executive Elevator Screens A, B, C, D

- Can these be programmed to better assist visually/hearing impaired?
- Who programs them?

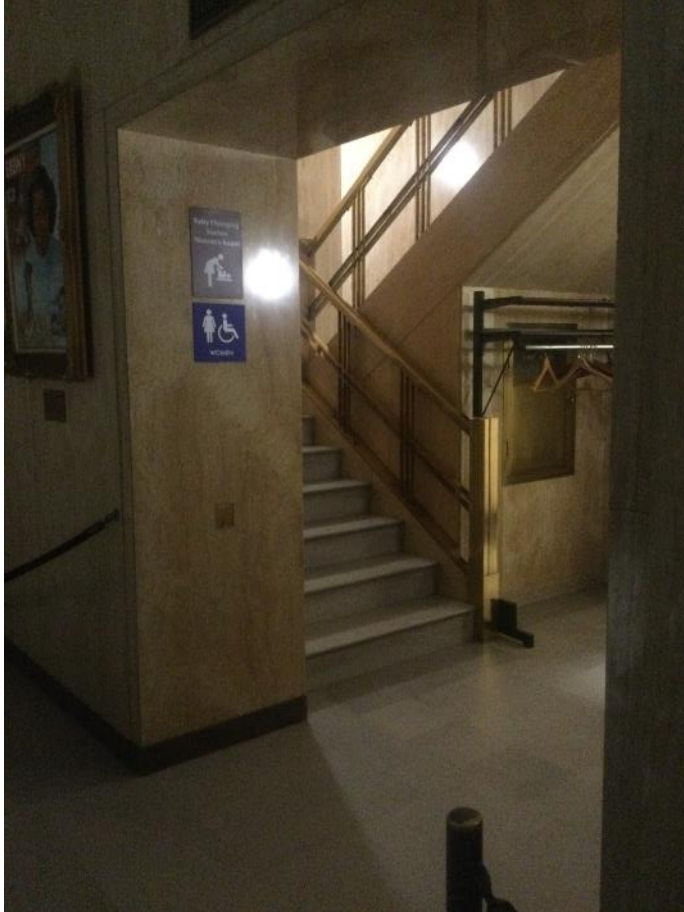
Ground Floor Senate Bathroom

- Accessibility signage is too high
- Also on opposite wall

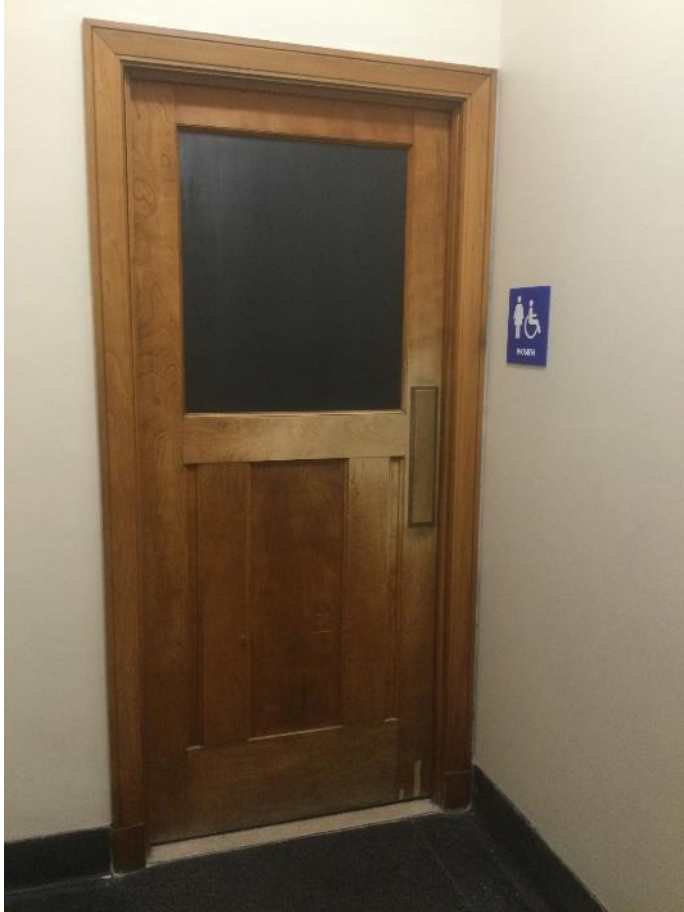
Ground Floor Senate Bathroom

- Accessible entrance

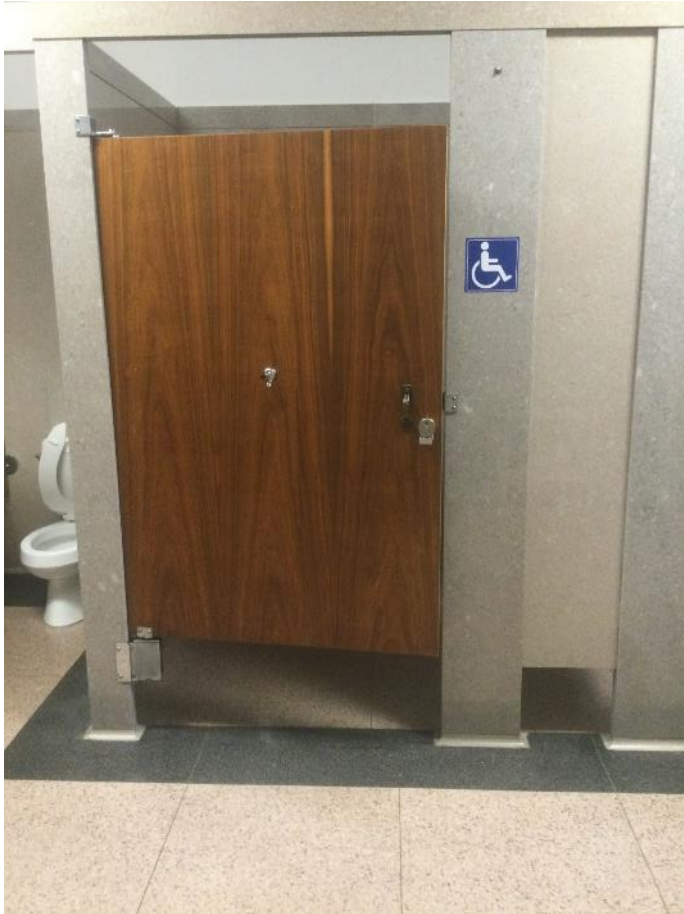
Ground Floor Senate Bathroom

- Another accessible stall wall?
- There is also a judicial wing bathroom accessible stall missing door signage, but it is on the stall wall
- Why is there no signage on the door, but a coat hanger is?
- Two judicial wing bathrooms have accessibility signage on the inside of the accessible stall door

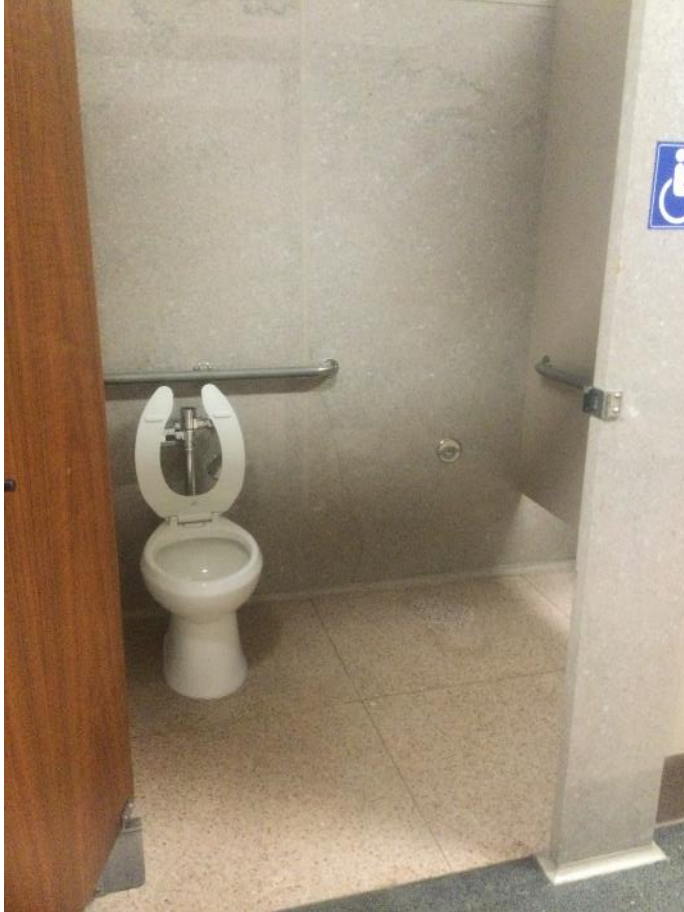
Ground Floor Senate Bathroom

- Looks like this was 2 stalls – wall with grab bar and toilet removed
- Reverse in, forward to close door, proceed to perhaps block the toilet, depending on need

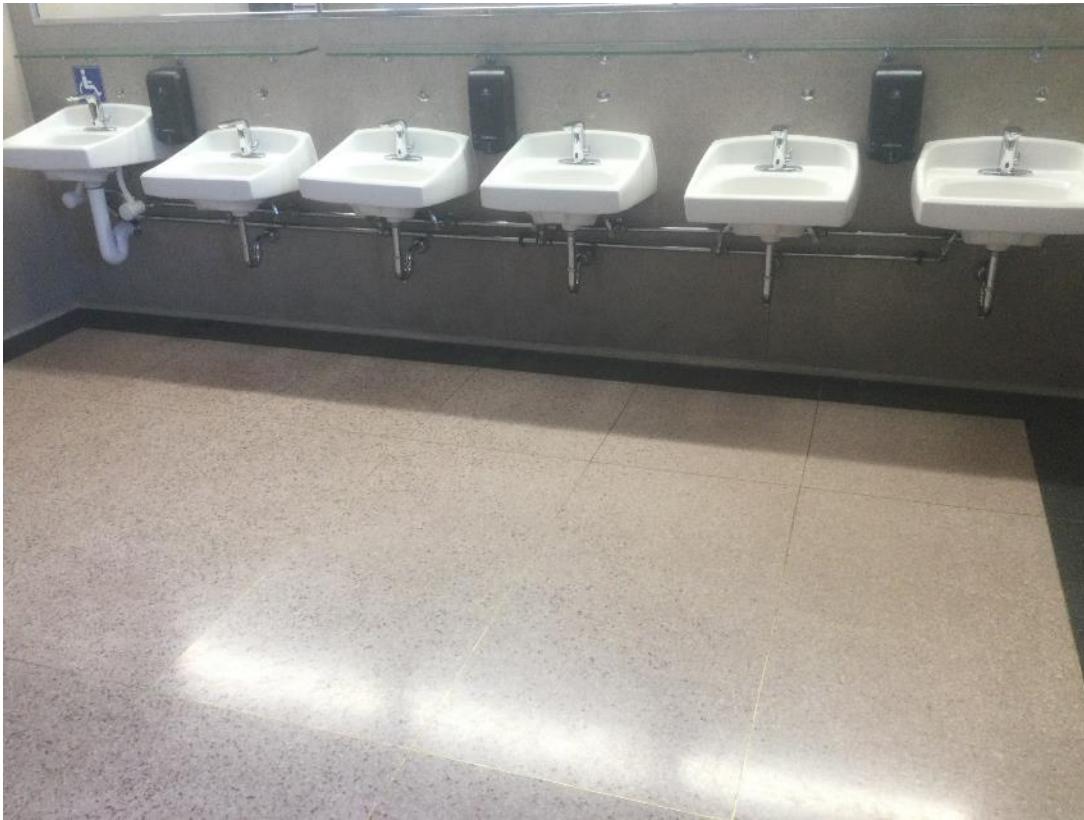
Ground Floor Senate Bathroom

- Accessible sink and soap dispenser
- Why not cover all sink plumbing?

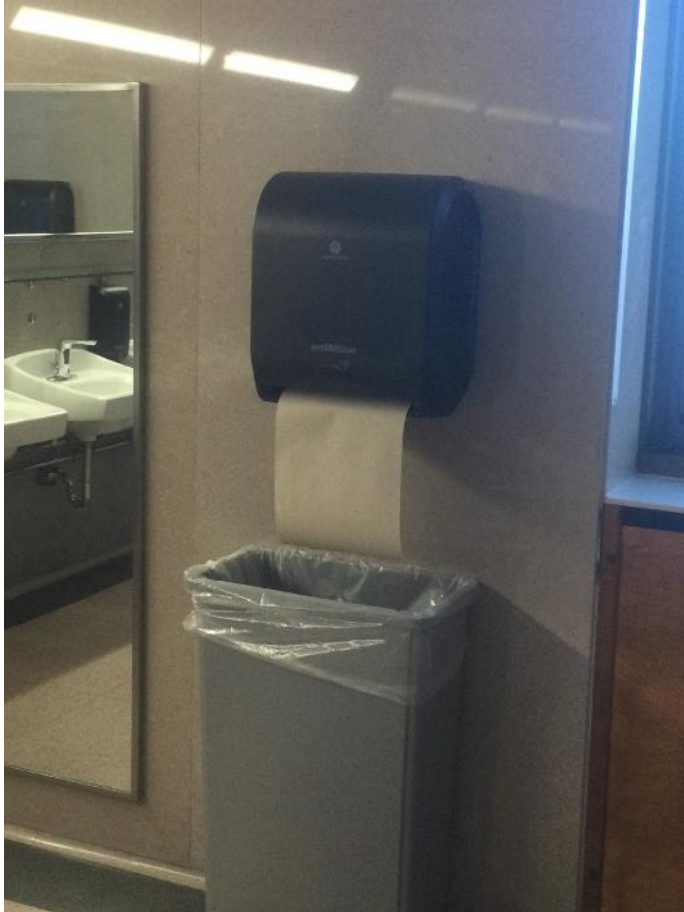
Ground Floor Senate Bathroom

- Most, if not all, bathrooms in the building have this paper towel dispenser
- Could not find ADA compliance documentation
- Why so far from accessible sink?

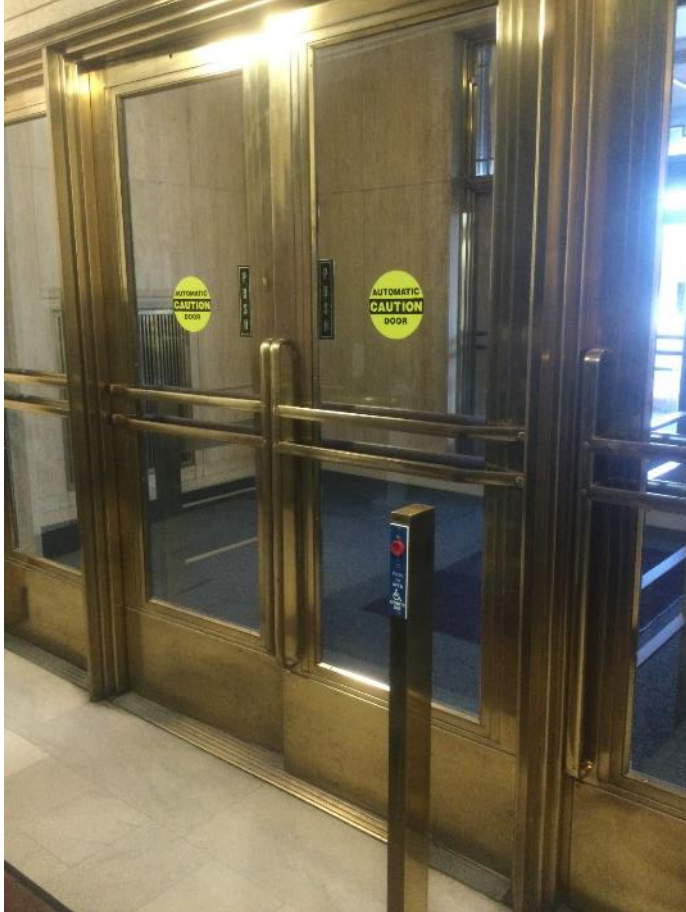
Ground Floor West Door

- Automatic door
- Why isn't there one on the Judicial wing entrance/exit door?

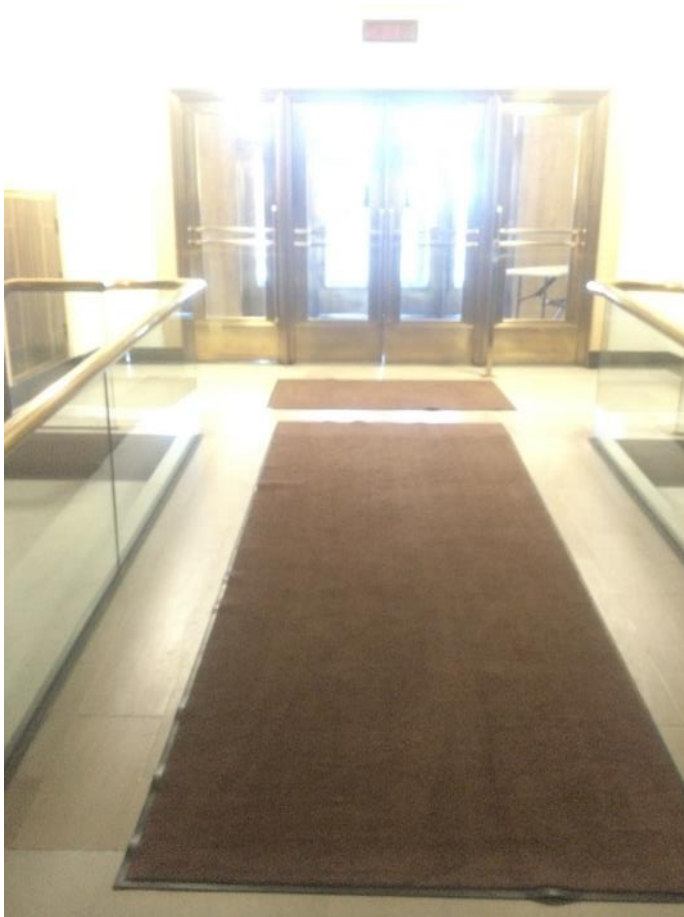
Ground Floor West Door Ramp

- Do not remember what the architect said about this ramp

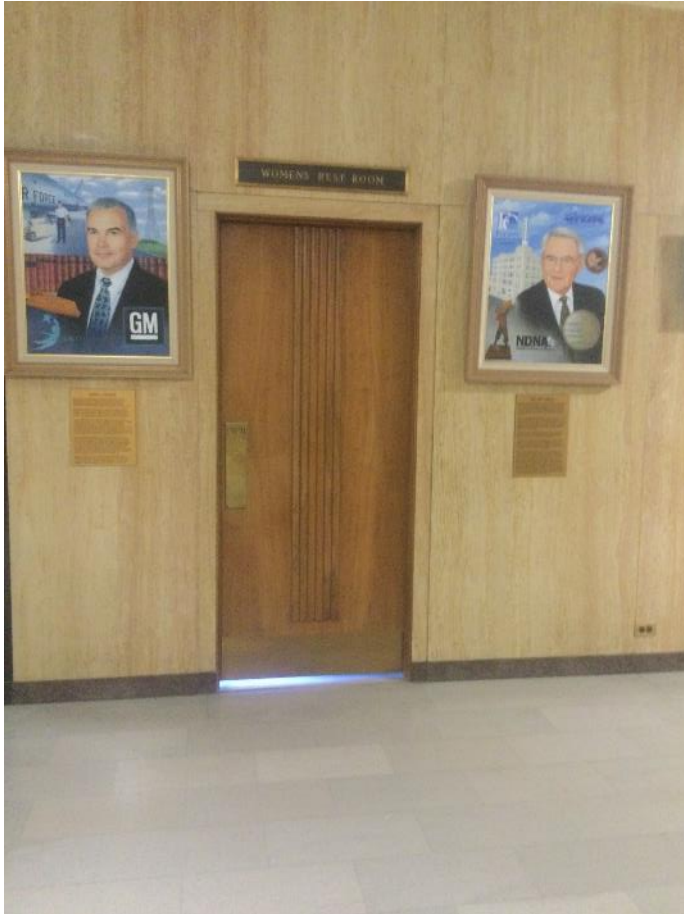
Ground Floor Women's Bathroom

- No accessibility signage

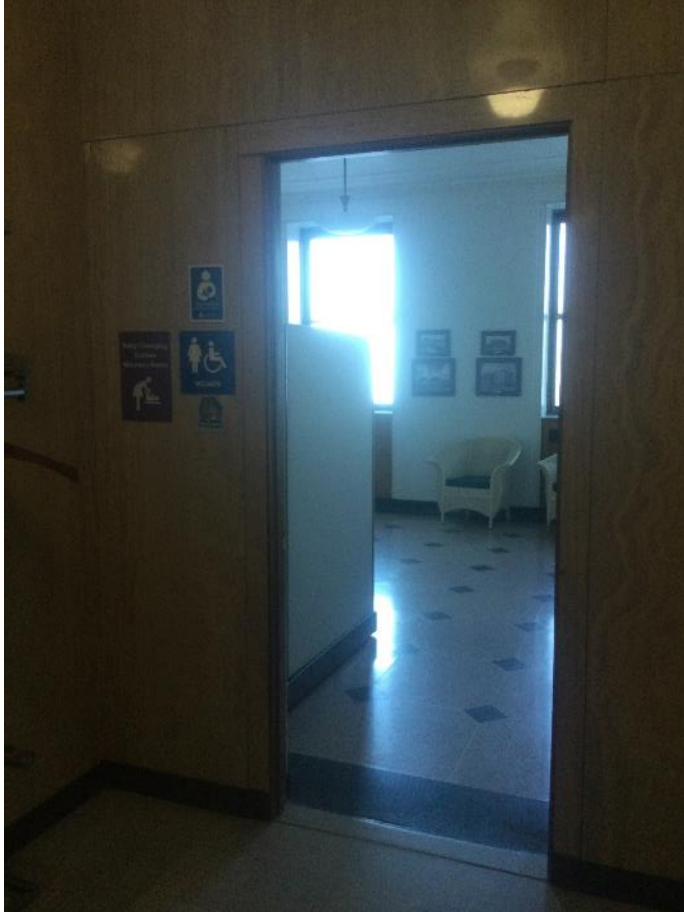
Ground Floor Women's Bathroom

- Why is the signage inside the second door?
- Signage is too high

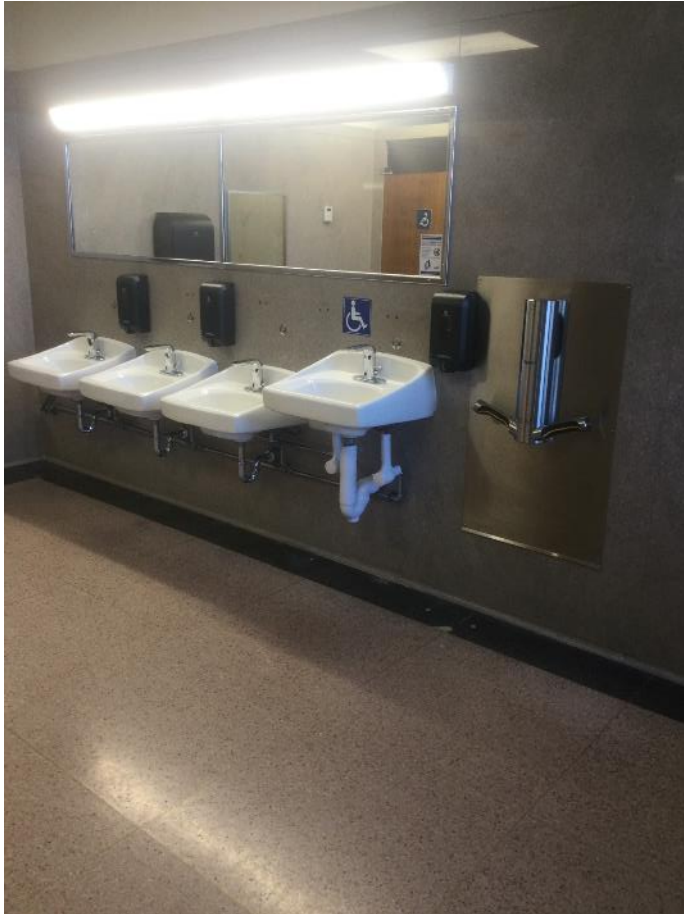
Ground Floor Women's Bathroom

- Good set up
- Cover all sink plumbing
