- My name is Jillian Schaible, and I am a Legislative employee
- I am here to testify in support of SB2146
- I love the legislative process and being here to watch it in action, but the Capitol itself, while architecturally beautiful, is not easy to access
- The pictures you will find in my testimony today are just some of the barriers North Dakotans with different abilities will currently encounter if they feel comfortable coming in here
- I, or anyone with a different ability, should feel they can work here as a state employee, legislator or government official and to be proud to be North Dakotan
- Your support of SB2146 would tell everyone with different abilities that you feel the same way

Capitol Accessibility Photos

Jillian Schaible

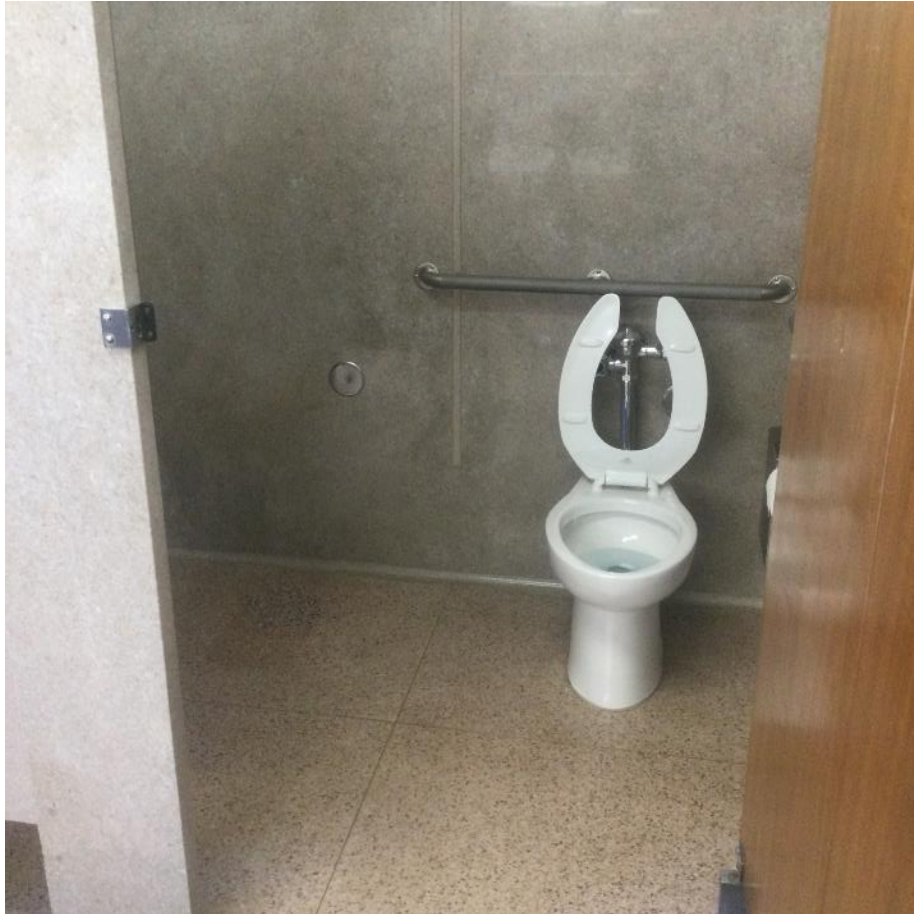
Ground floor Women's Bathroom

- Reverse in, and pull the door closed at the same time?
- What is with the gaps between the toilet and the grab bar?
- Ripping a stall out is not necessarily “accessible” or “compliant”

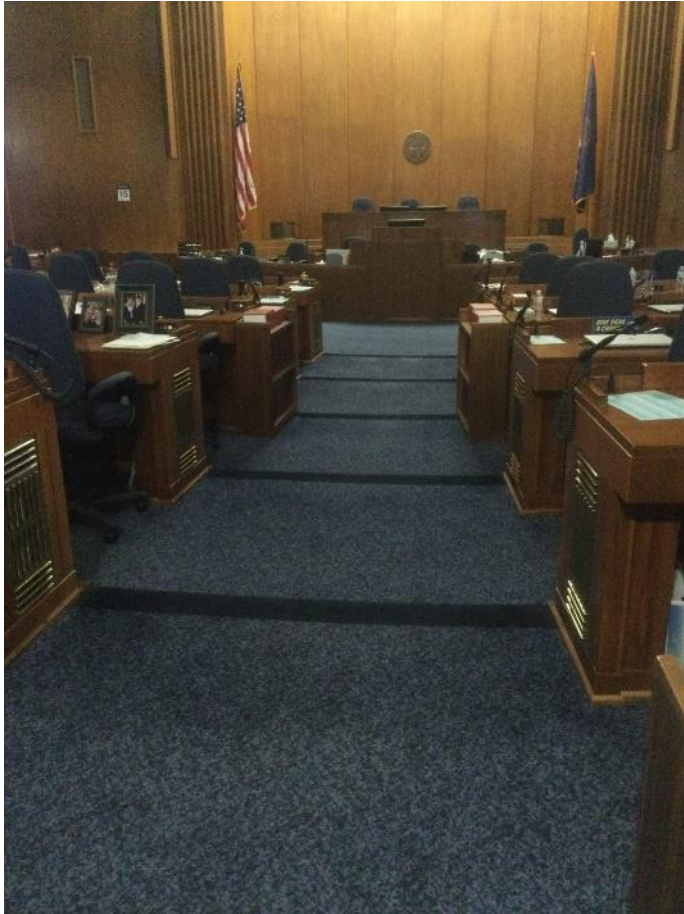
House Chamber

- Where are the ramps?
- There are none in the chamber
- The House and Senate chambers were not included in the “accessibility” study done by the architect hired by OMB

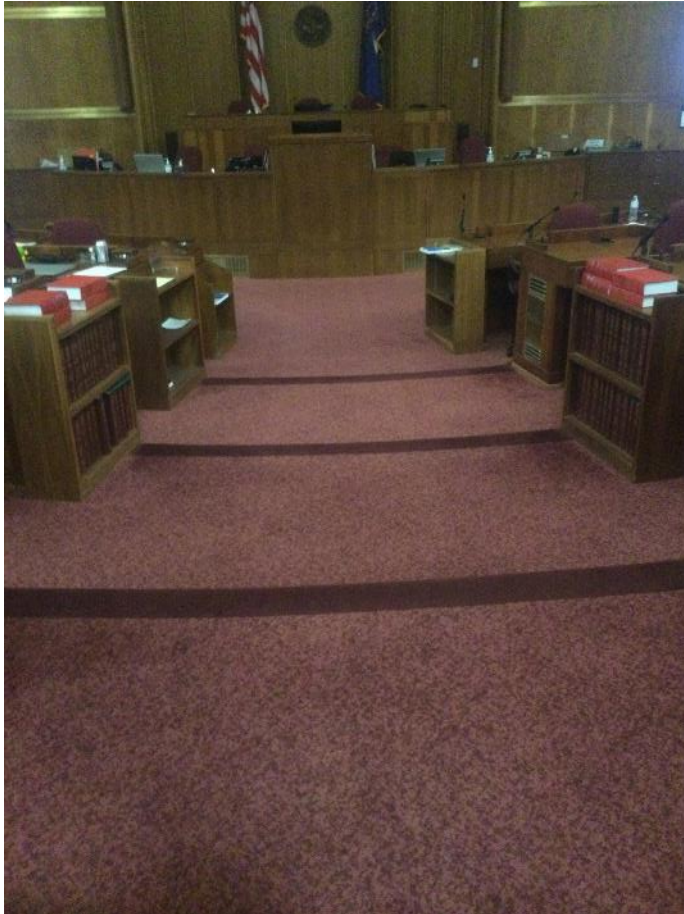
Senate Chamber

- Who built the existing ramps admitted to in SGVA testimony on 1.21.21?
- Built when?
- Meet current ADA compliance?
- Why are they not in use in either chamber?

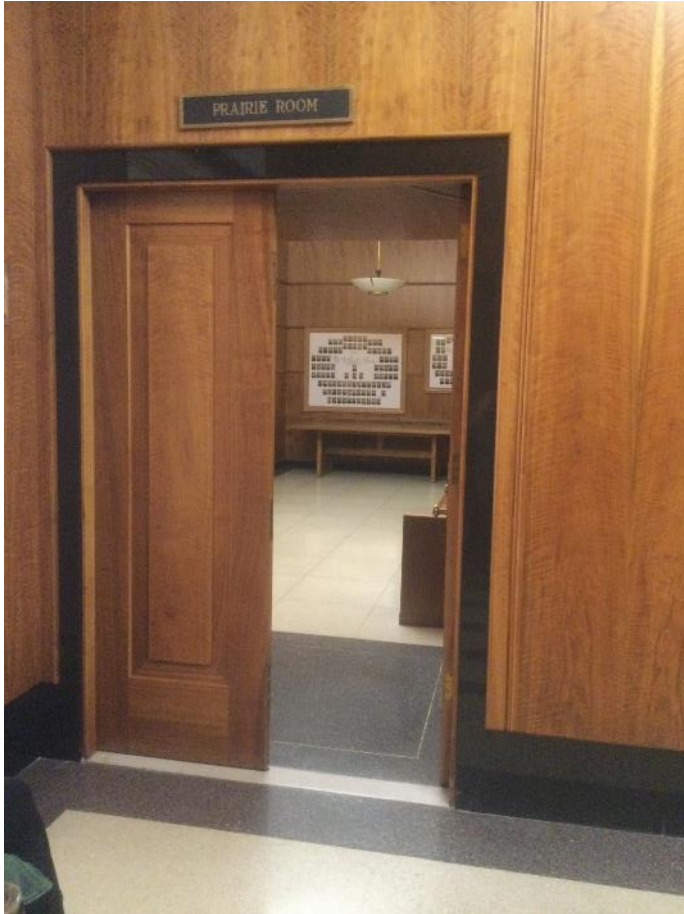
Prairie Room

- Can these doors be opened and unaltered when the room is in use?

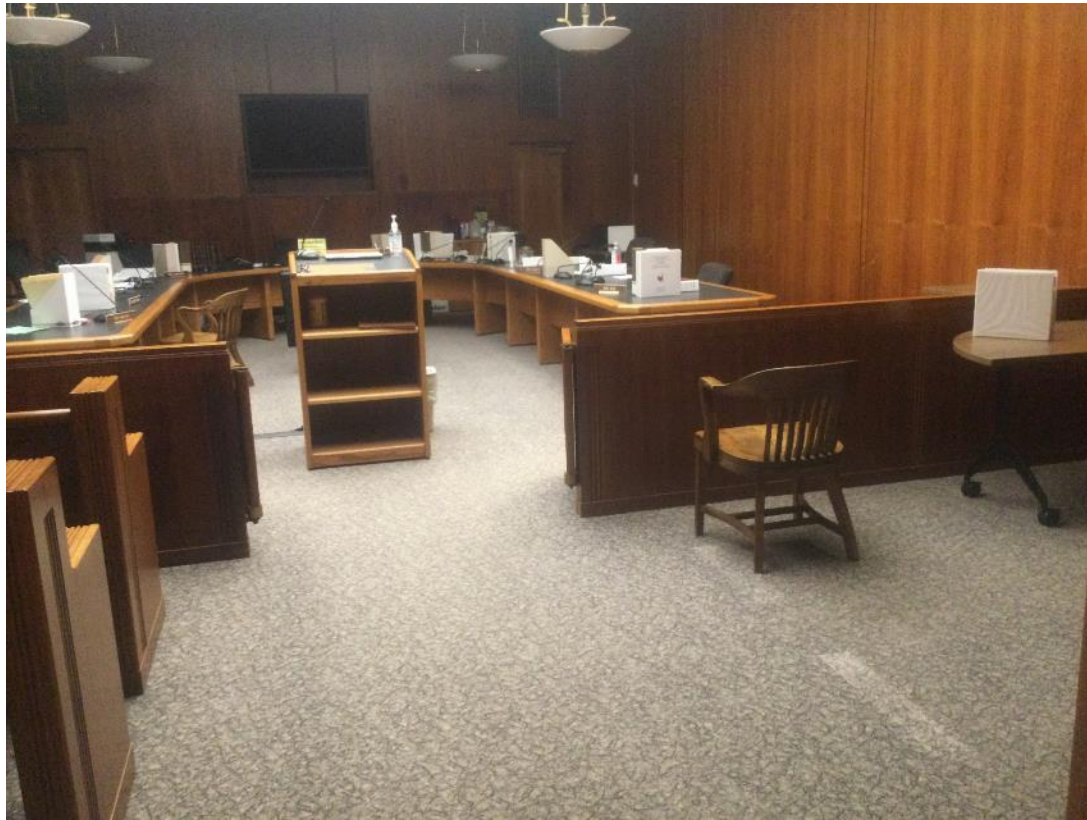
Prairie Room

- Change the table before altering room
- Same suggestions about leaving the room doors alone

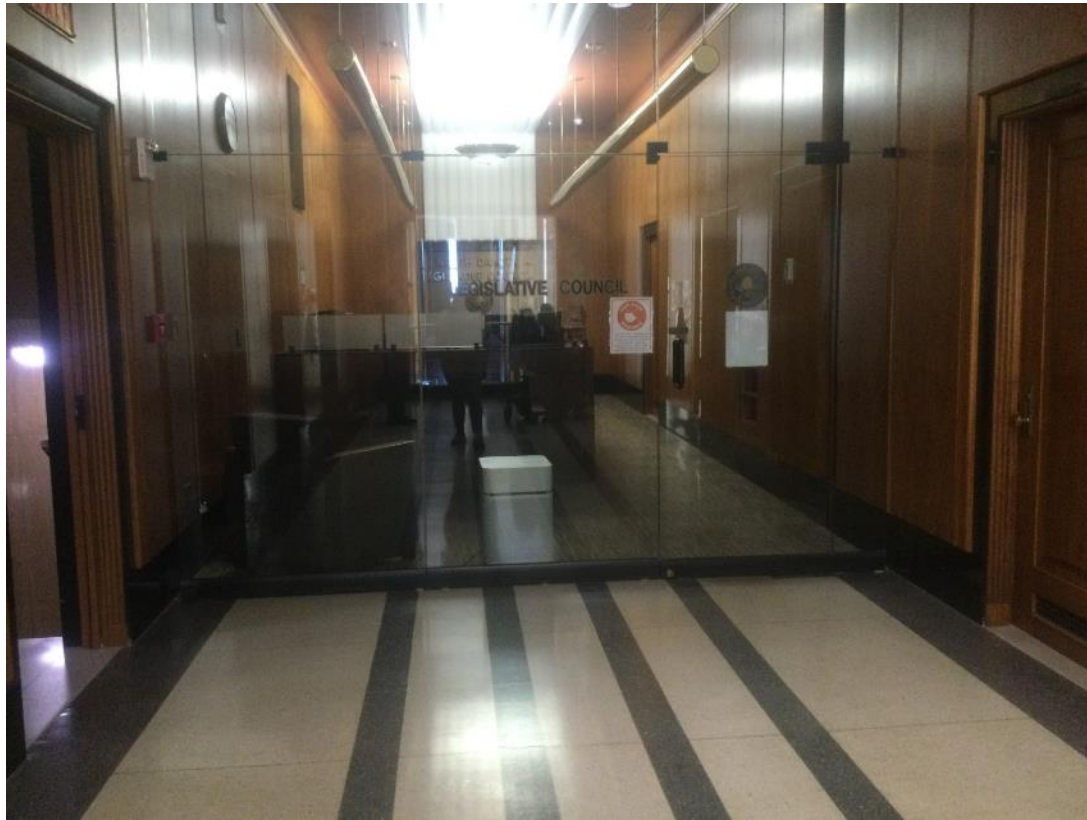
2nd Floor Offices

- Why are there not two doors here?

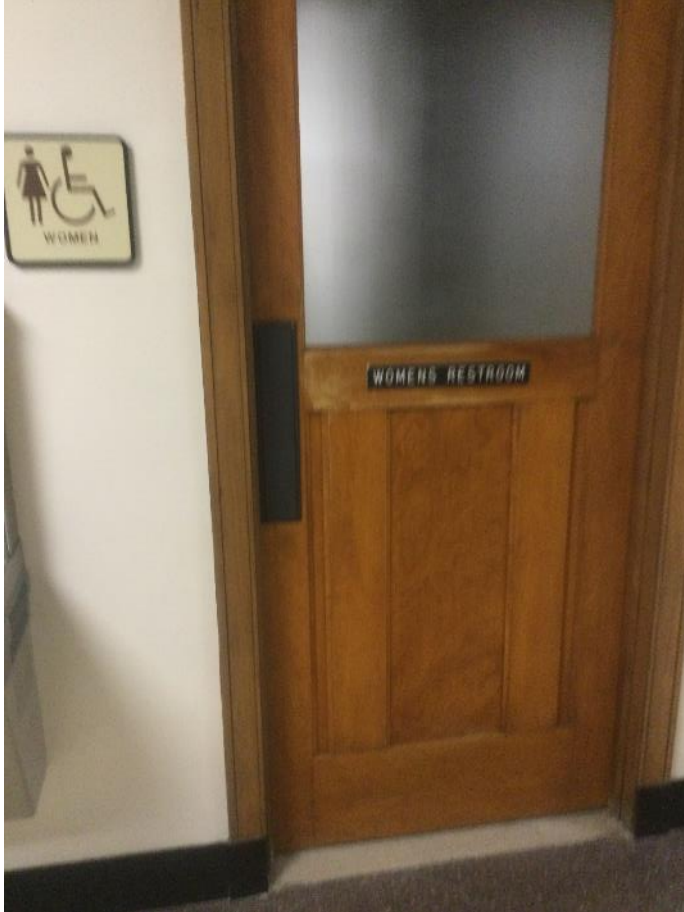
Executive Wing Department Floors 3-18

- Accessible signage for Executive wing bathrooms should be removed, as they will not be ADA compliant based on door width alone

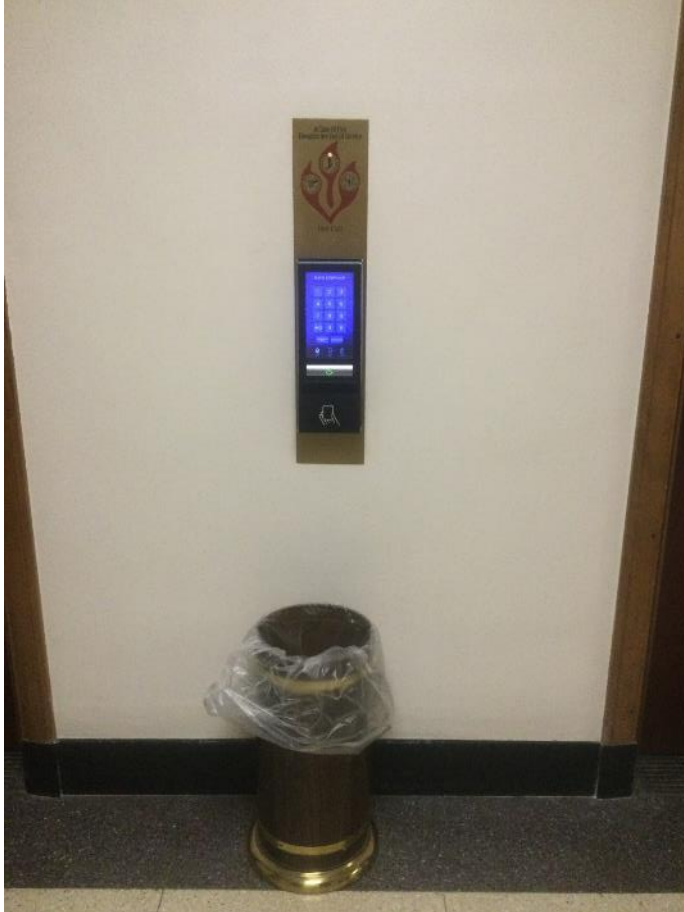
Executive Wing Department Floors 3-18

- Trash can blocking keypad access
- This occurs on multiple floors

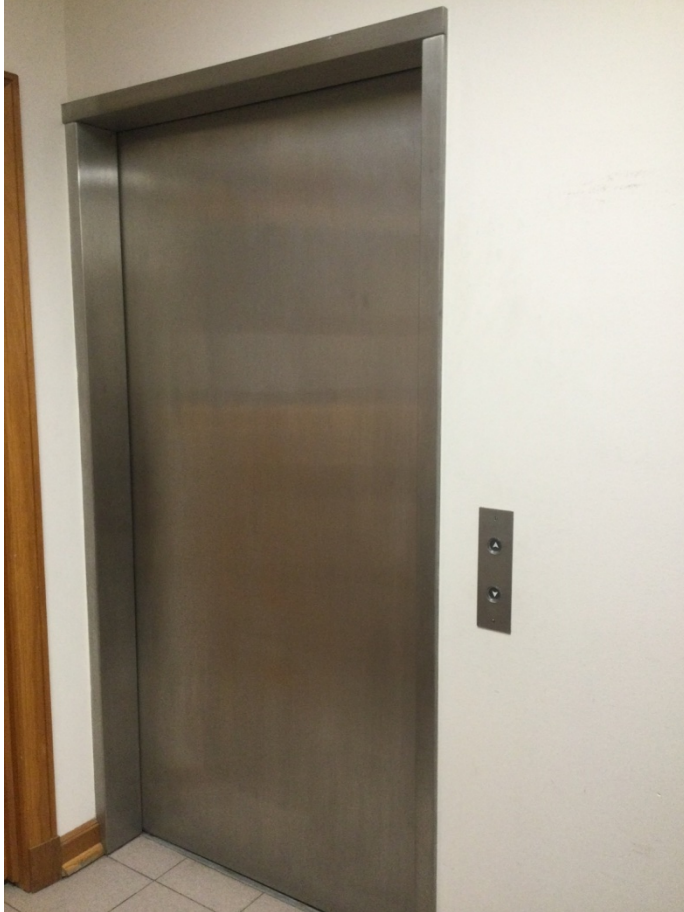
Senate Elevator – First Floor

- Ground, 1st, 2nd floors
- No accessibility signage
- No external signage on 1st floor
- I forget this elevator exists, and it's right by the Legislative Information Kiosk

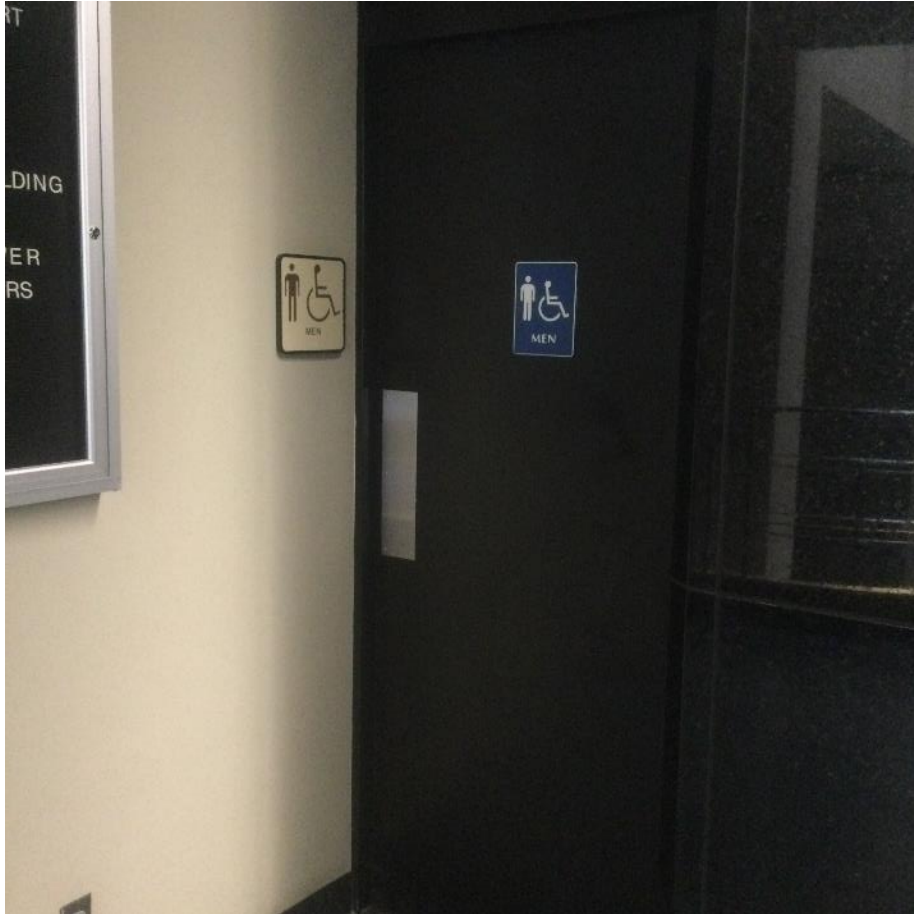
Judicial Wing – bathroom entrance

- Also women's bathroom
- Same set up on 2nd floor men's and women's bathrooms

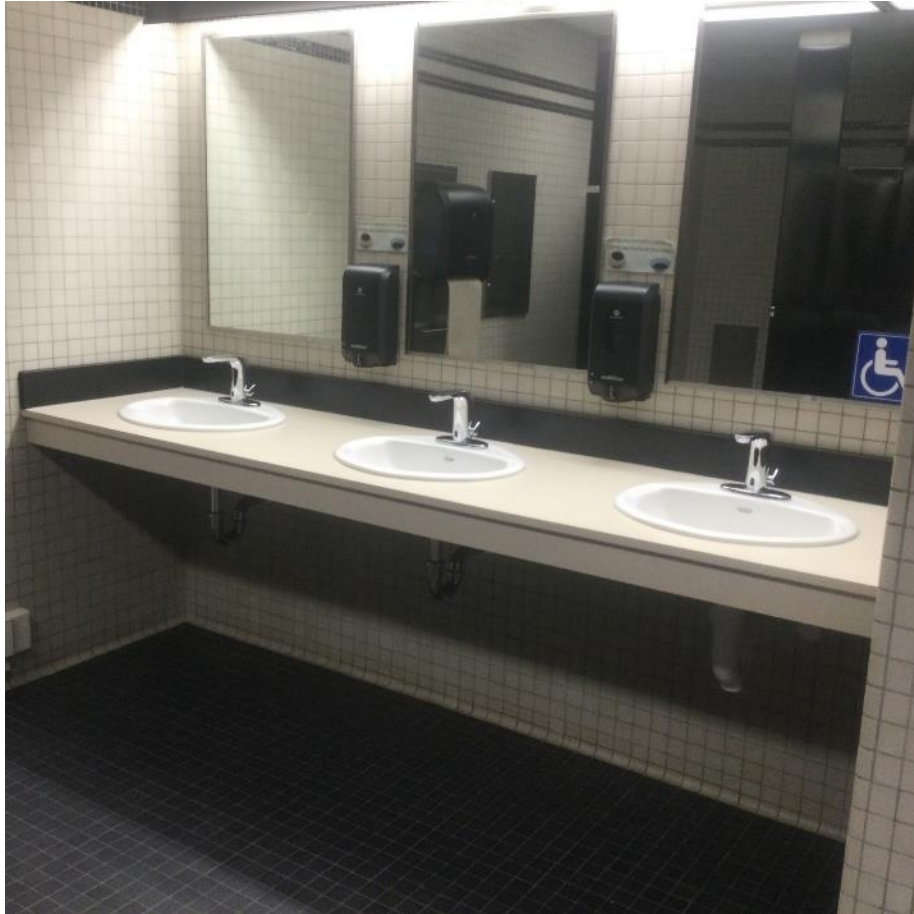
Judicial Wing – All Elevator Bathrooms

- Cannot access soap without water issue
- This is an issue in all Judicial wing bathrooms by the elevators
- Why not have soap on same wall as paper towels?
- Move a soap dispenser to wall where unused paper towel dispensers are?
- Cover sink plumbing

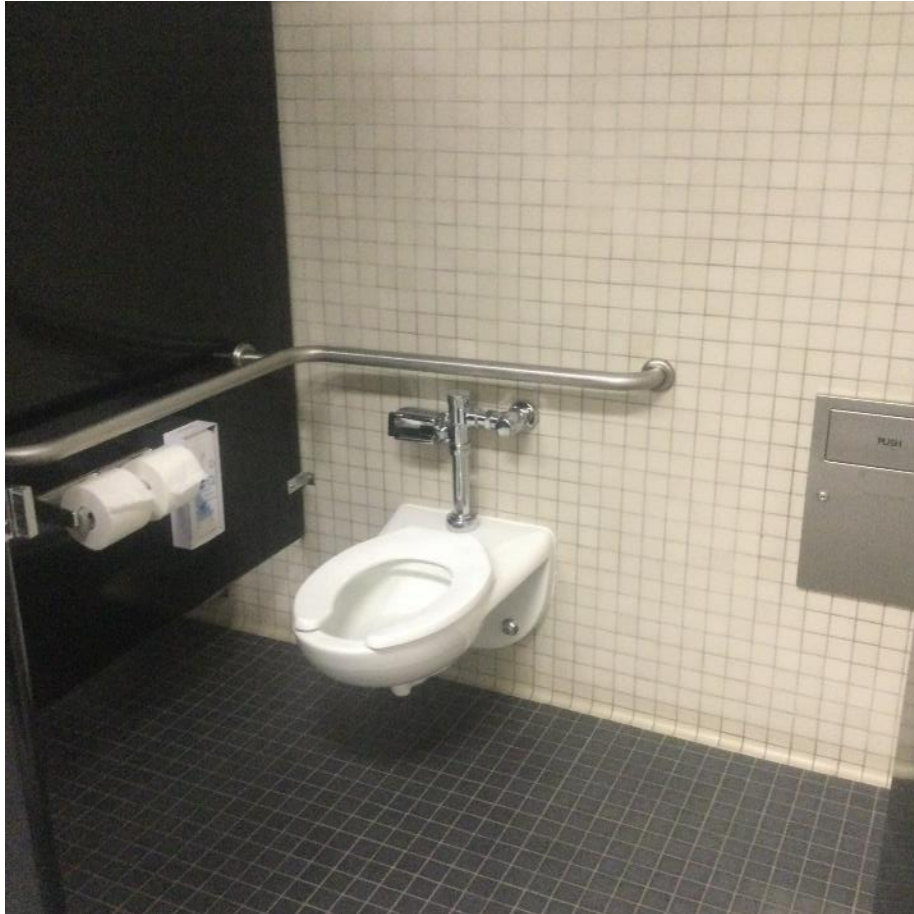
Judicial Wing – All “accessible” stalls

- Original grab bars
- Bar length should be longer so person won't be blocking toilet before transfer
- Vertical bar would help with this also
- All “accessible” judicial wing stalls have similar set up
- Most, if not all also have a coat hanger close to door lock, which could be a safety hazard and should be on the back of the stall door at an accessible height

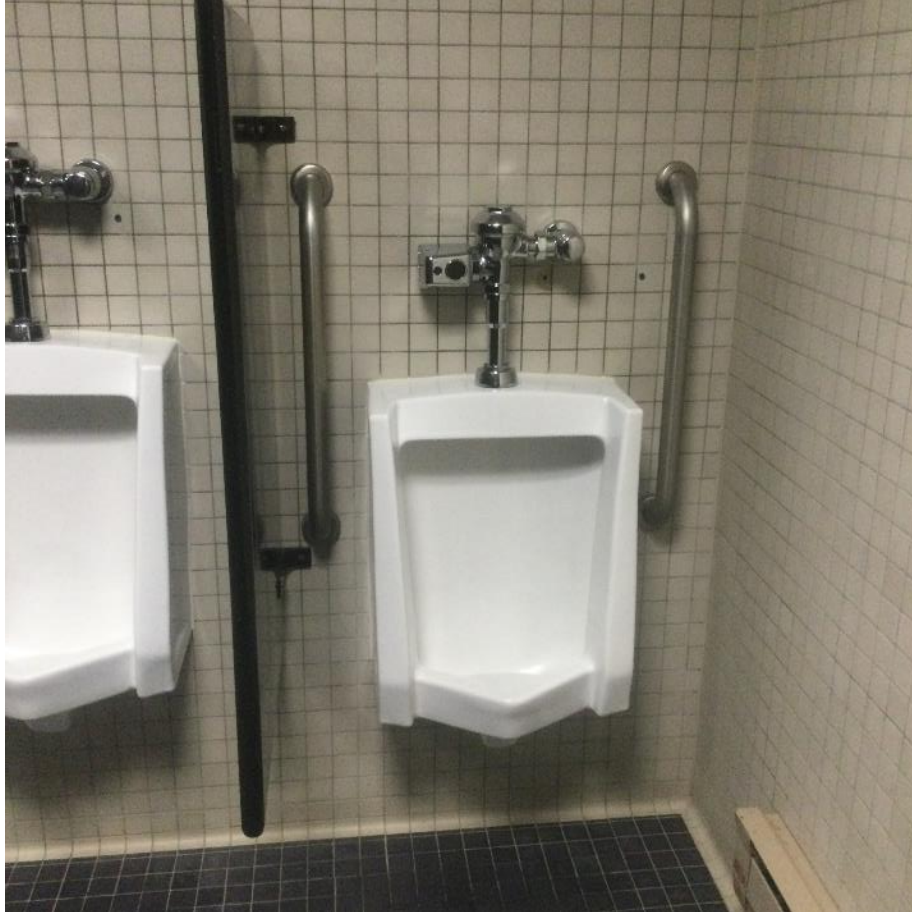
Judiciary Wing – “Accessible” urinal

- I do not understand how this can work sitting or standing with a mobility impairment
- Heat register changes access angle
- Similar lay out for all judicial wing “accessible” urinals

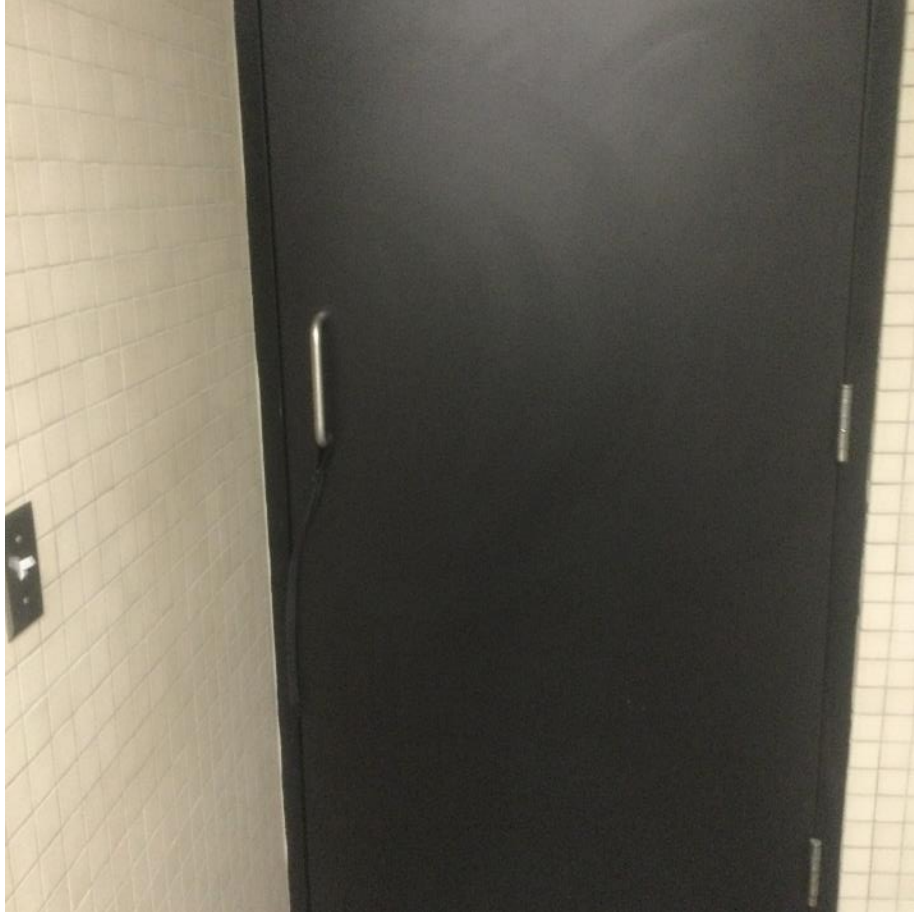
Judicial Wing – 1st and 2nd Inside bathrooms

- Difficult to open door with strap in a manual or powered wheelchair
- Need to reverse until there's enough room while still holding strap and driving chair
- How does a person hold the door open as far as they can, AND move through the door unassisted?
- Judicial wing 1st floor men's and women's, 2nd floor women's, not men's

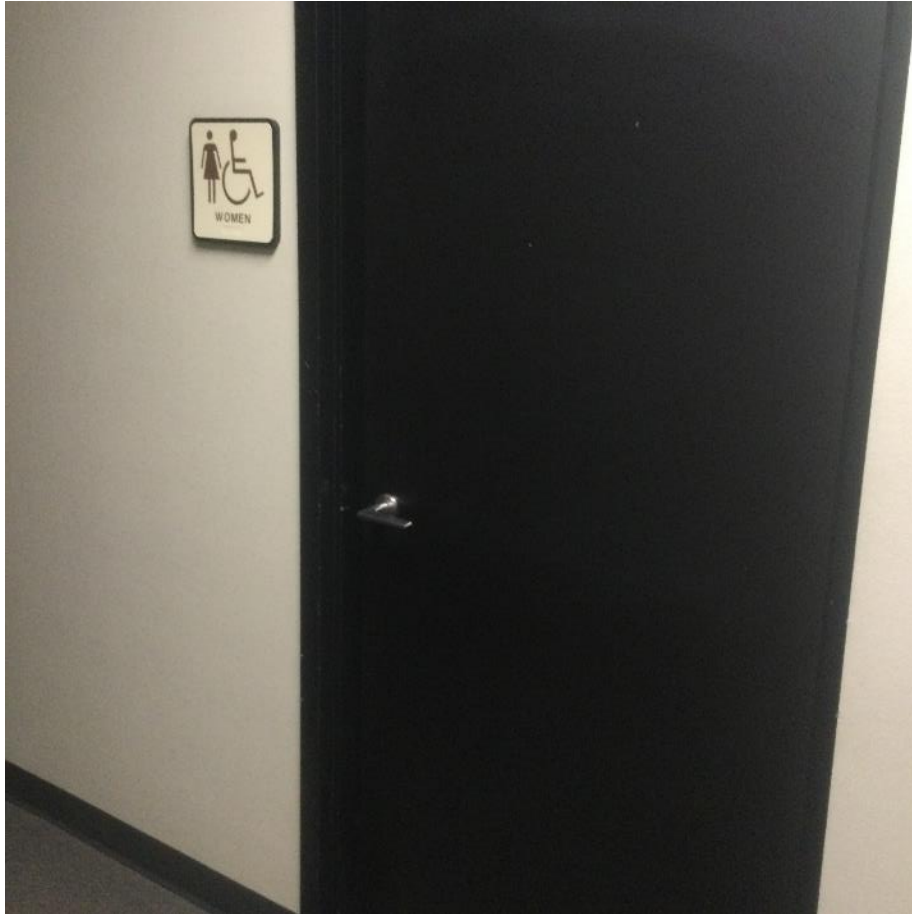
Judicial Wing – 1st Floor

- All 6 bathrooms inside Judicial wing halls have a “first” door with correct signage
- This first door does not meet 5 pound pressure limit standard, or the 3 second rule

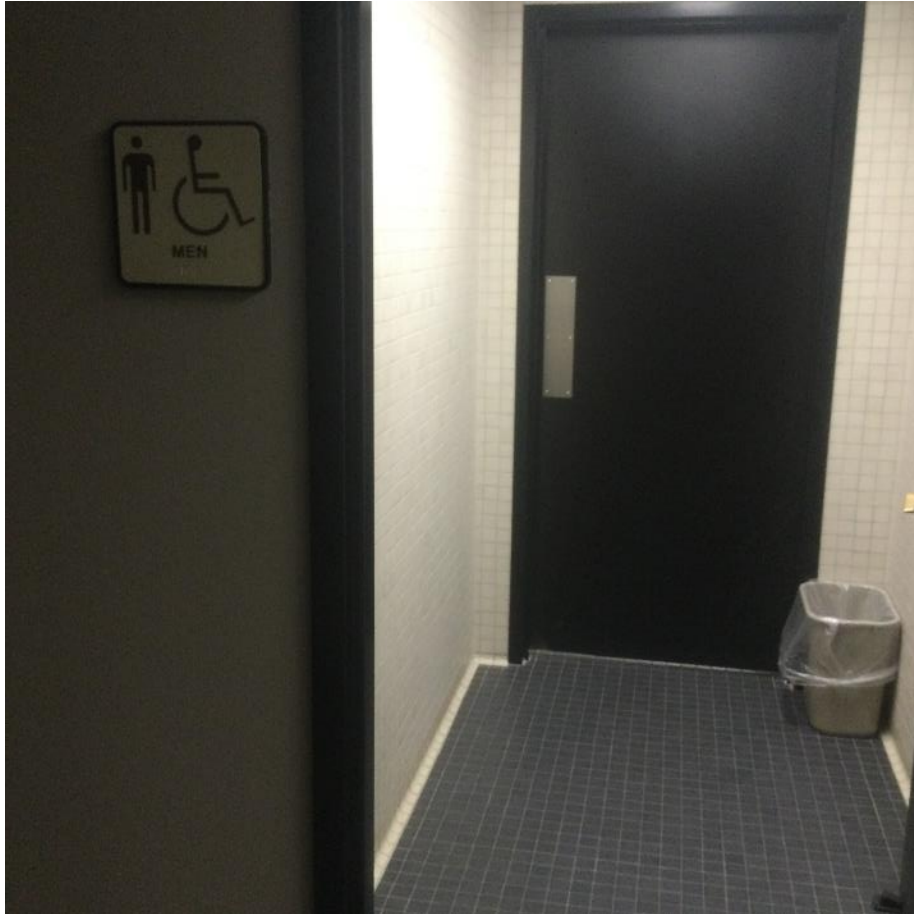
Judicial Wing – Hallway Bathrooms

- Door #2
- Occurs with all bathrooms inside Judicial wing hallways
- Trash can obstacle
- Easy to push door going in, may be difficult to open coming out due to counter location

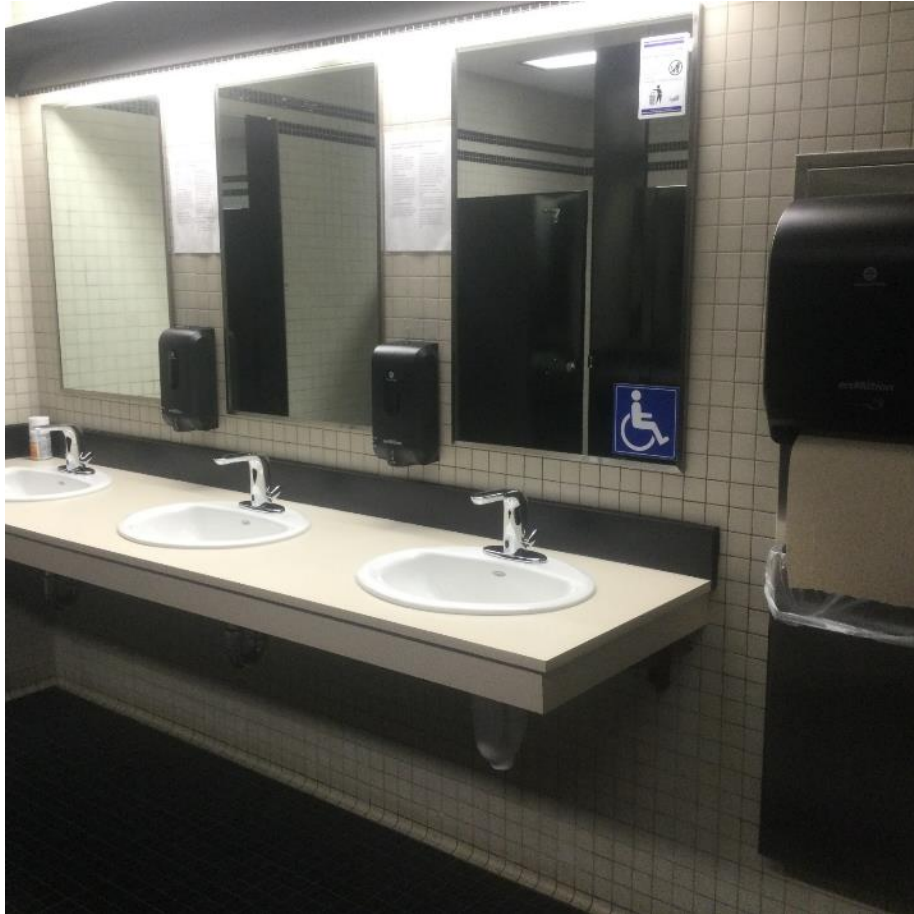
Judicial Wing – 2nd Floor

- Sink and paper towel setup inside all Judicial wing bathrooms
- Cover all sink plumbing

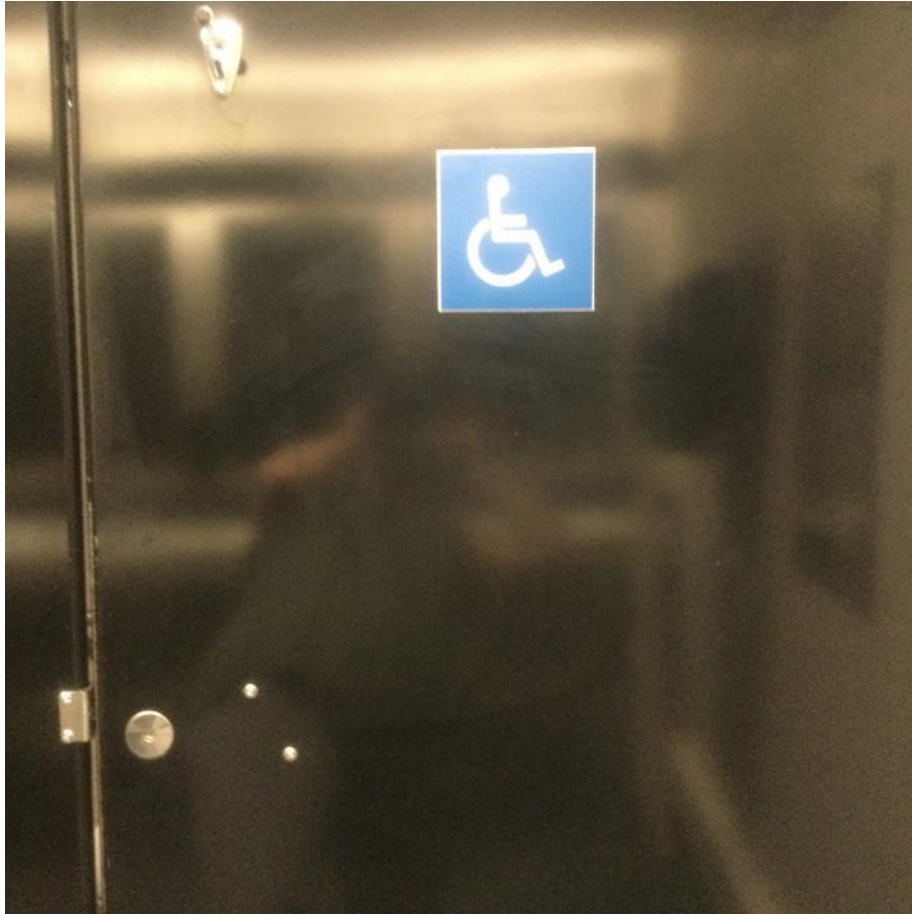
Judicial Wing – 1st Floor

- Missing door handle, but just think...you can hang your coat up, and not use the bathroom

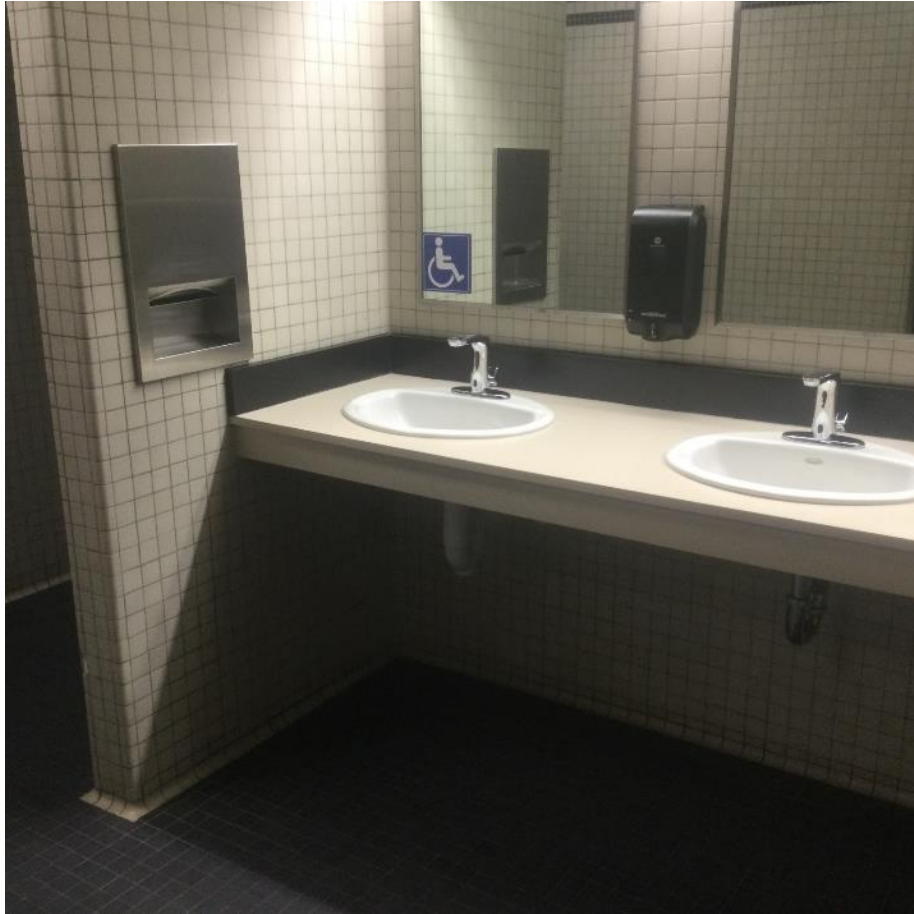
Judicial Wing – Ground Floor

- Move soap to paper towel dispenser to make it easier to reach
- Cover all sink plumbing

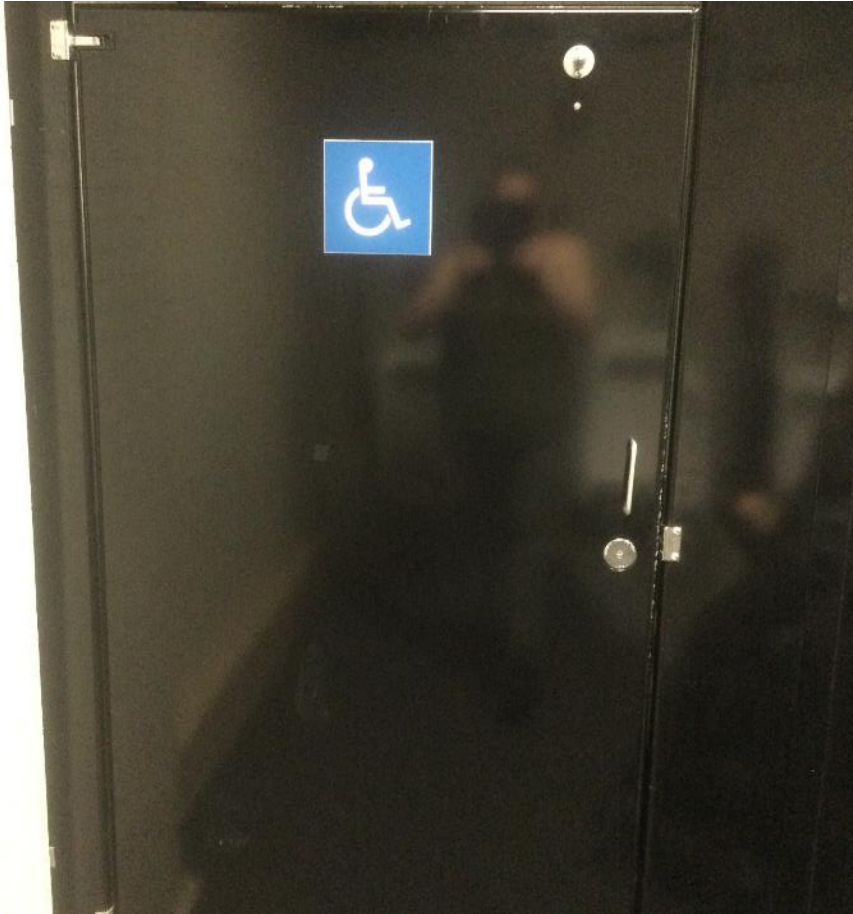
JWing – Ground Floor

- Accessibility signage
- Coat hanger is on the outside....why?
- How does a person using a wheelchair reach it?

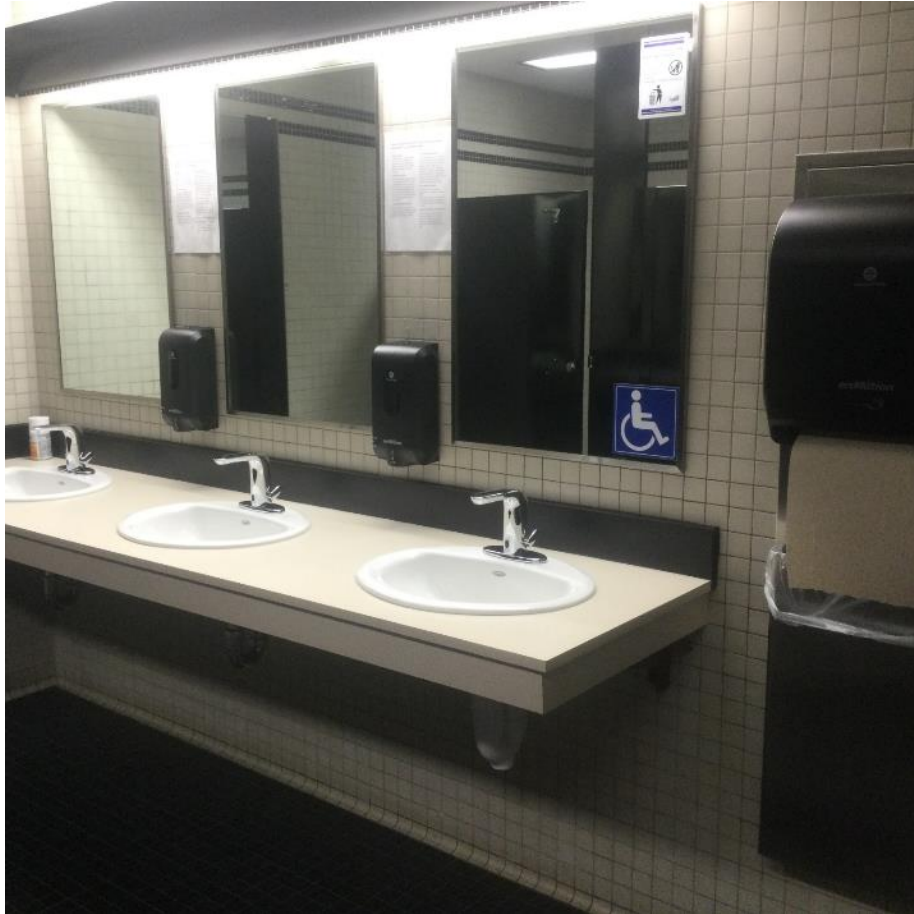
Judicial Wing – 2nd Floor

- This is the sink and paper towel setup inside all Judicial wing hall bathrooms
- Cover all sink plumbing

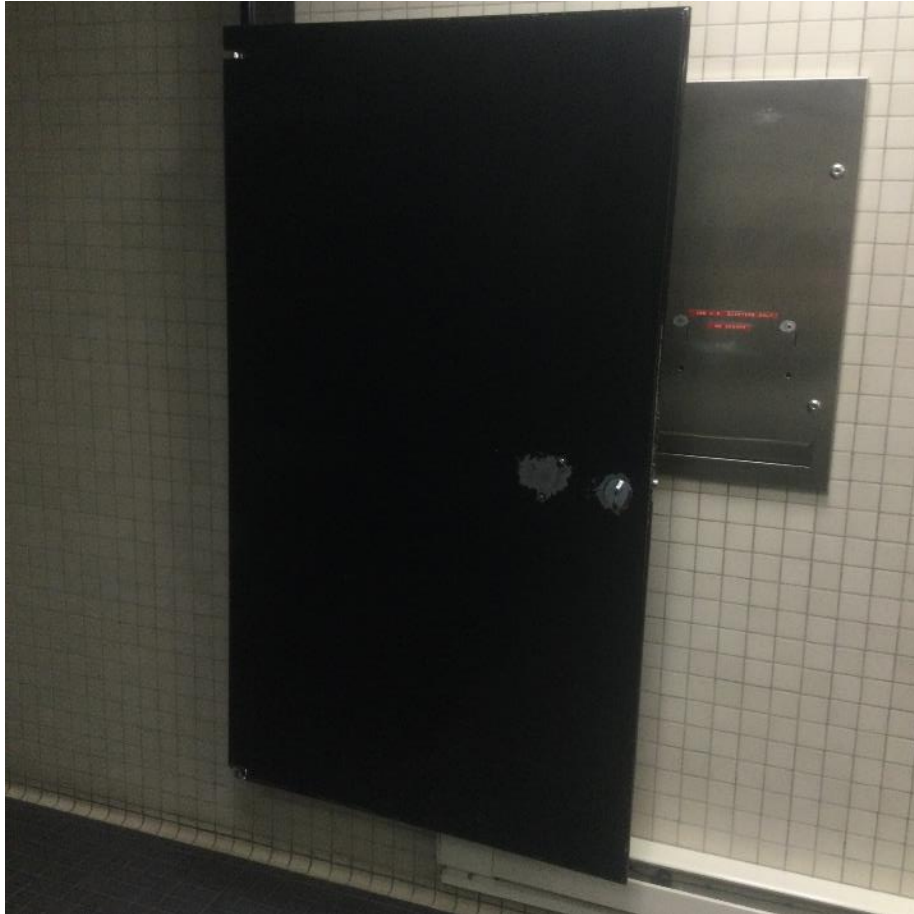
Judicial Wing – Women’s Ground Floor

- Missing door handle
- Put in request during 2019 session
- Also missing in women’s 1st floor Judicial wing bathroom

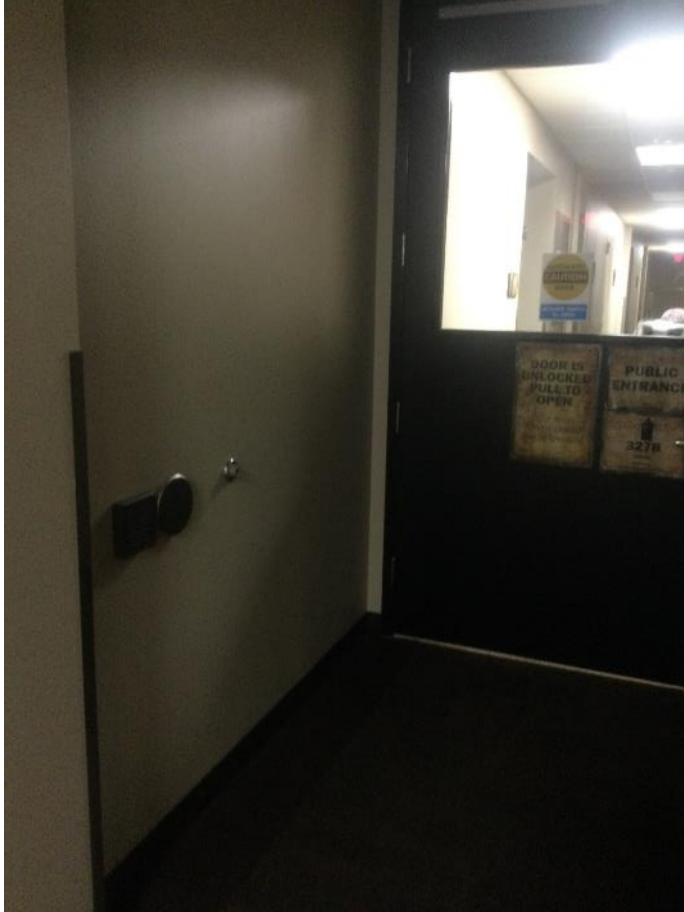
Judicial Wing – 3rd Floor

- Target (button) does not work on first contact – going in
- Random signage like door signage throughout this floor
