Capitol Accessibility Photos

Jillian Schaible

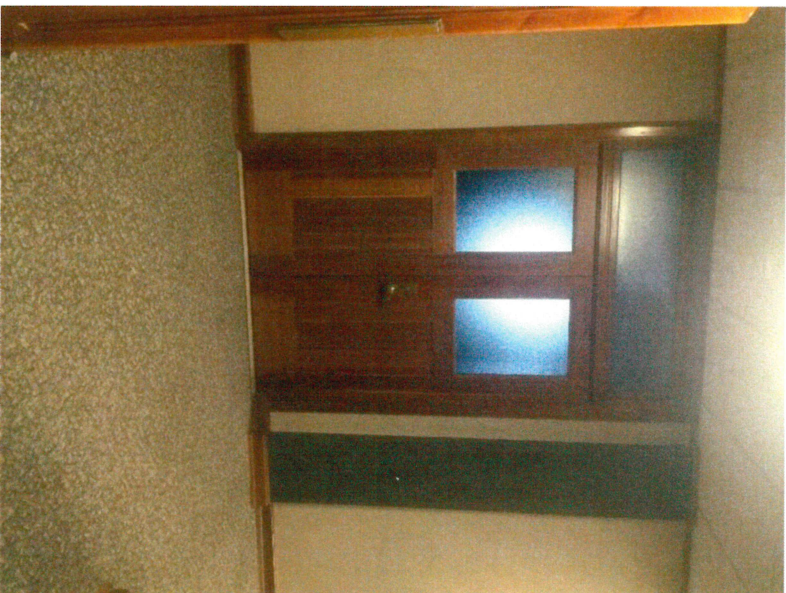
Brynchild Haugland upper entrance

- No signage indicating room location or accessibility
- I accidentally found this door, but prior to, avoided the room when possible, as I did not want to sit on the “bottom” and/or use the elevator
- Is Brynchild Haugland included in HB1510, HB1030 and SB2146?

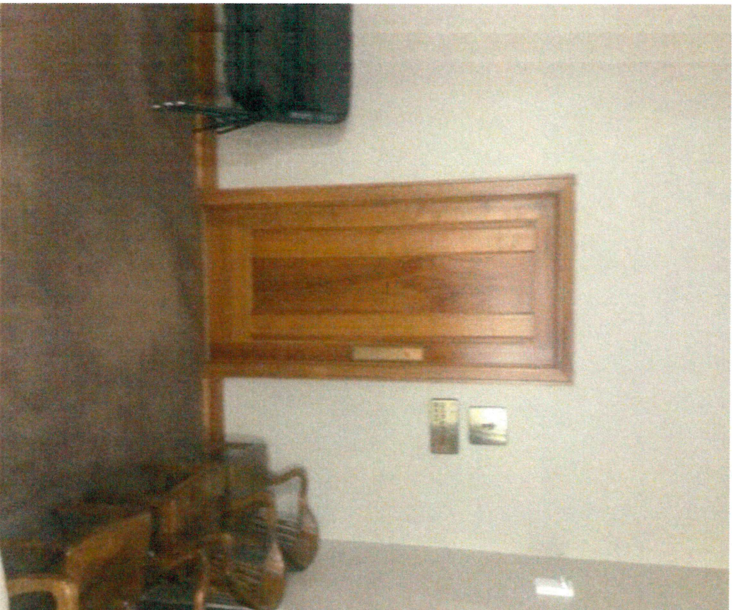
Brynchild Haugland bathroom entrance

- Stair door to ground floor men's bathroom
- There is a room behind the door, but this door blocks it

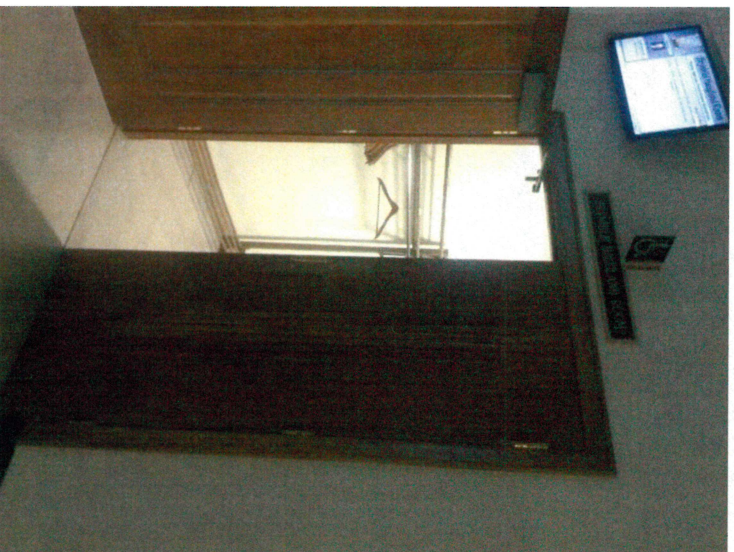
Brynchild Haugland

- Both TVs outside both entrances are too high
- Wheelchair elevator is located here

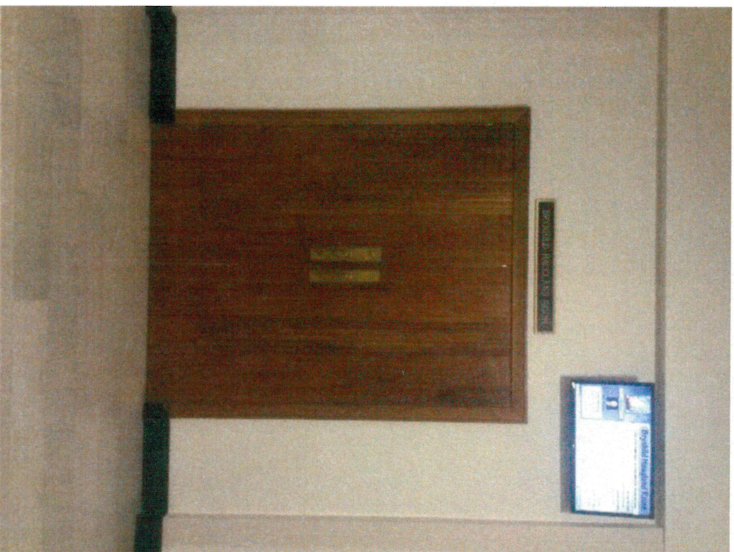
Brynchild Haugland second entrance

- TV height too high

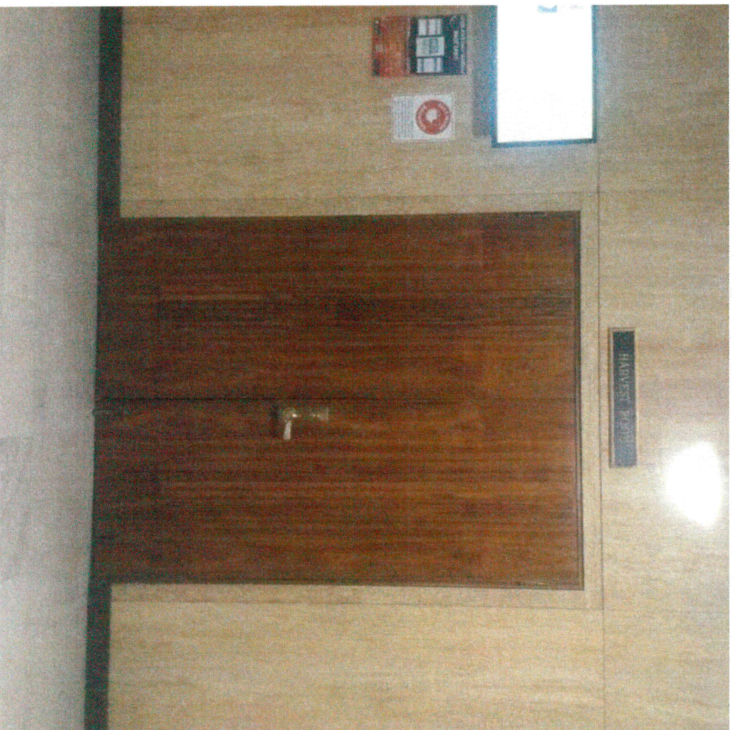
Harvest Room Entrance

- TV height is too high

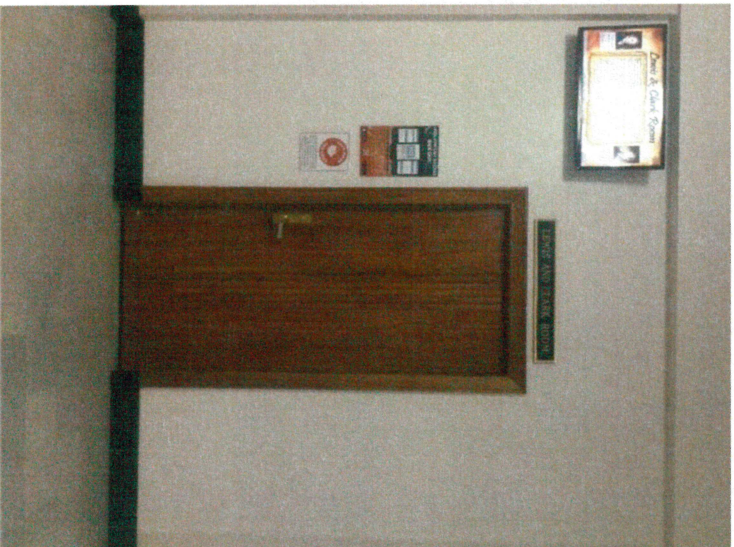
Lewis and Clark

- TV height too high
- Very narrow door

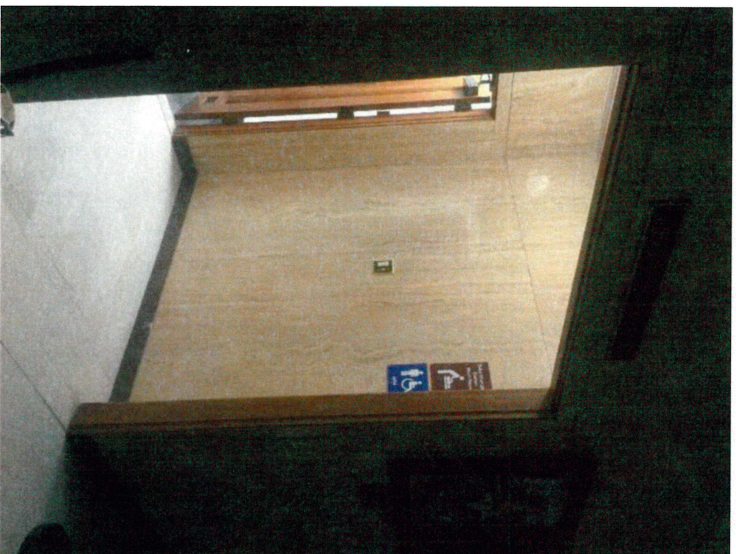
Ground Floor Men's Bathroom A

- Accessibility signage too high
- There is another sign on the opposite wall at the same height

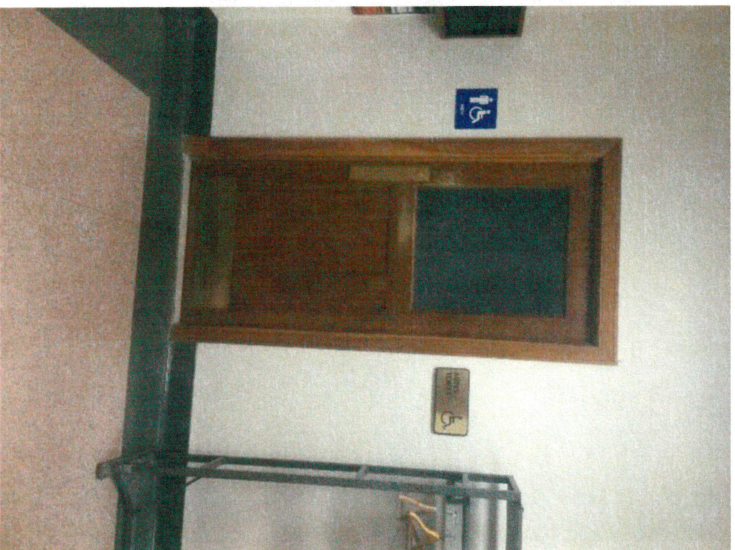
Ground Floor Men's Bathroom A

- Accessible entrance
- All accessibility signage should be at the same level everywhere

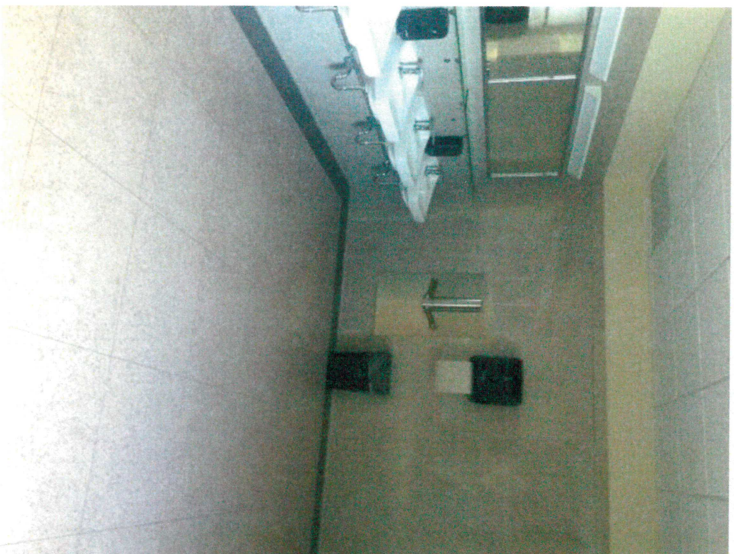
Ground Floor Men's Bathroom A

- Accessible entrance view
- Trash can should not be underneath dispenser
- Same view from stair door

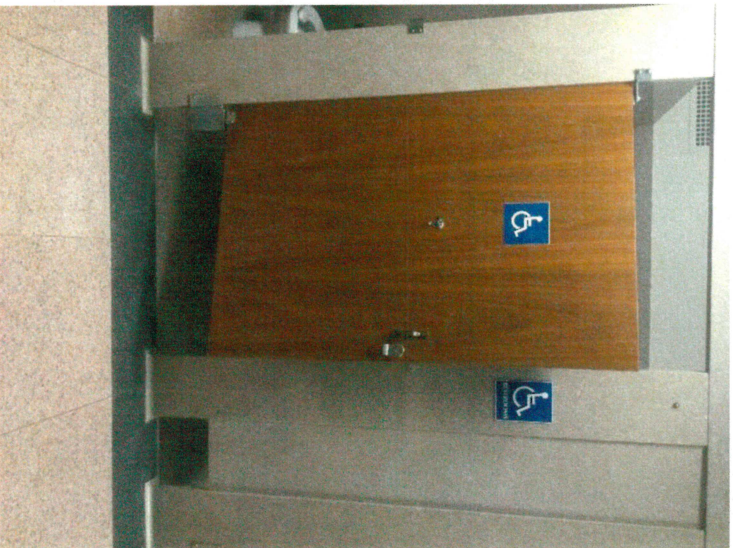
Ground Floor Men's Bathroom A

- Is the stall wall accessible?
- There are at least two other doors where the sign indicating accessibility is placed on a stall wall and not on the door itself. A visually impaired individual could mistake the wall for the door
- Outside coat hanger could cause injury. Other doors have the same issue
- Lock could be a problem

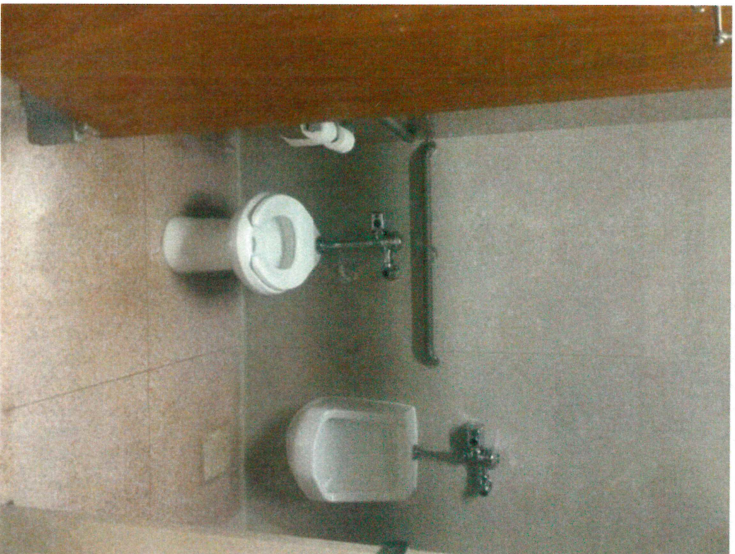
Ground Floor Men's Bathroom A

- Reverse in, forward to lock door, then position
- Massive space between wall and toilet
- Side transfer may not be possible
- Urinal bar also far away
- There are better accessible urinals and grab bars to have
- Same setup in Ground Floor Men's Bathroom B

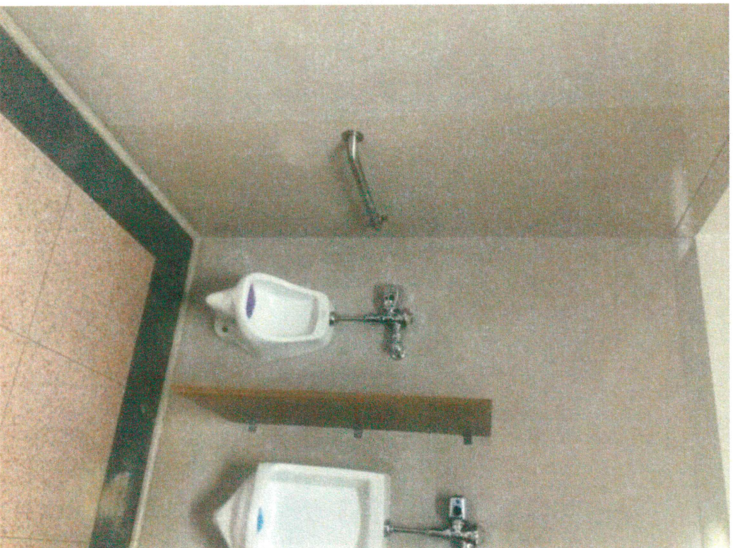
Men's Bathroom A

- This is the only horizontal grab bar next to a urinal in an “accessible” area in the building – and it makes the most sense
- There should be a grab bar on both sides for balance and strength dominance assistance
- Install a floor urinal wherever accessible urinals are located

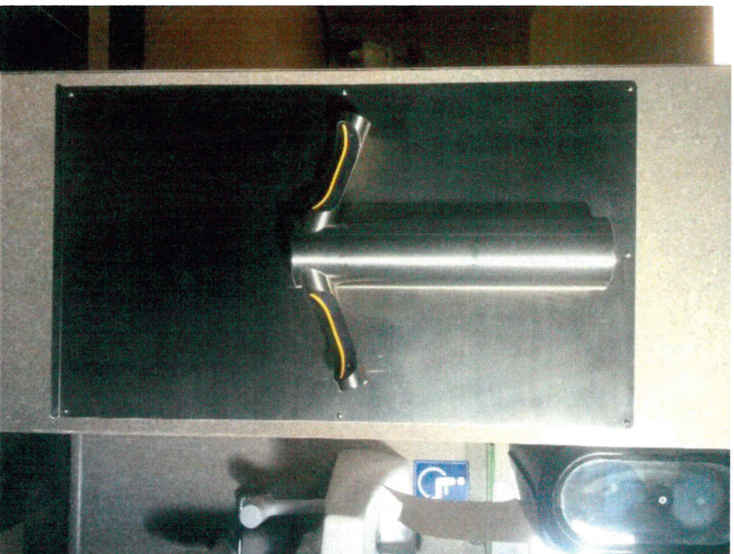
Ground Floor Men's Bathroom A

- [Dyson Airblade 9KJ | Dyson](#)
- \$1,199.00
- HEPA filter (est. \$79/each, requires monitoring/replacing)
- 2 in this bathroom
- 1 in women's ground floor bathroom
- Accessible sink sign
- Paper towel dispenser may be too high

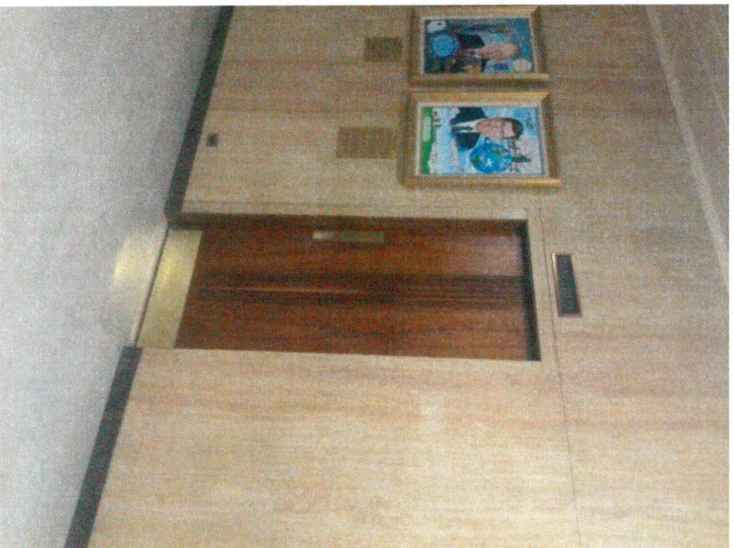
Ground Floor Men's Bathroom B

- No accessibility signage

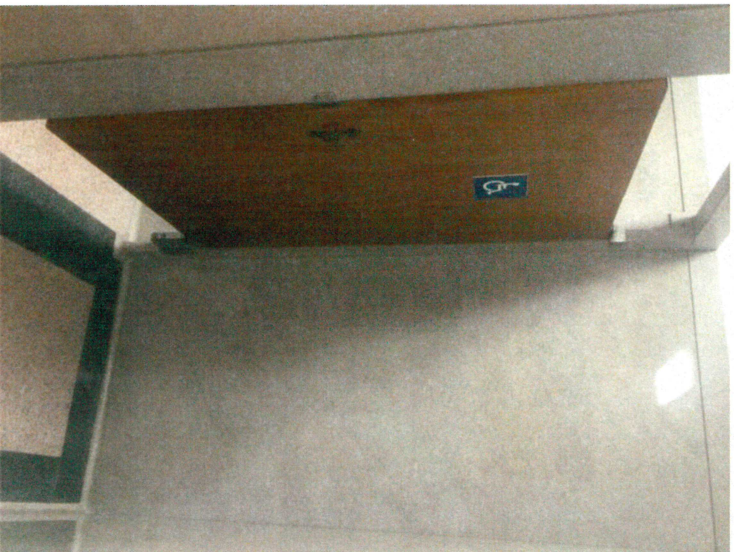
Ground Floor Men's Bathroom B

- Turning radius may not be legal
- Door may not stay open when trying to get in

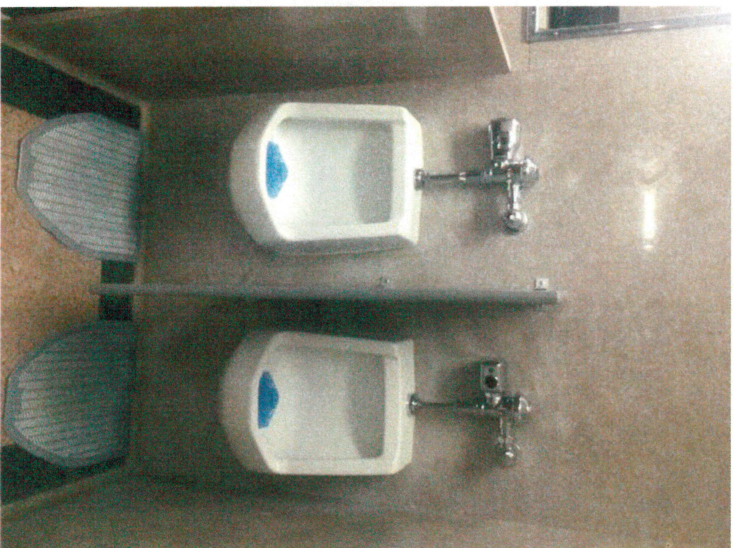
Ground Floor Men's Bathroom B

- Looks like the left urinal is attempting to be “accessible”
- Add horizontal grab bars?
- If the entire bathroom is not accessible, accessibility signage should not be used anywhere
- Sink area is not “accessible” as well

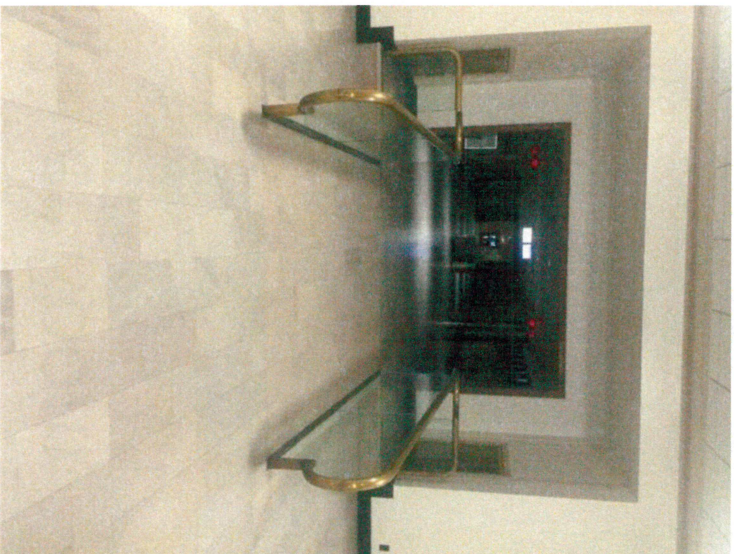
Ground Floor Ramp

- The architect said this was not ADA compliant somehow...

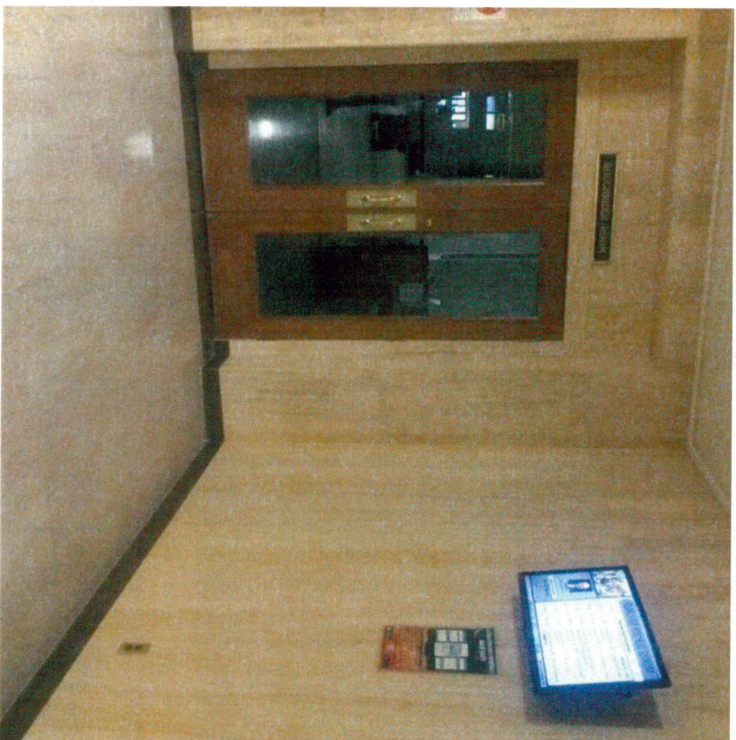
Roughrider Room

- TV height is too high
- No change to doors

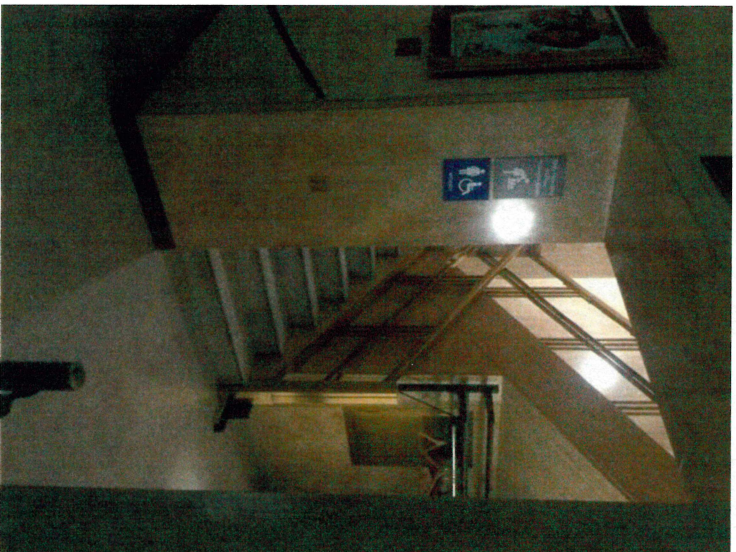
Ground Floor Senate Bathroom

- Accessibility signage too high
- Also on opposite wall

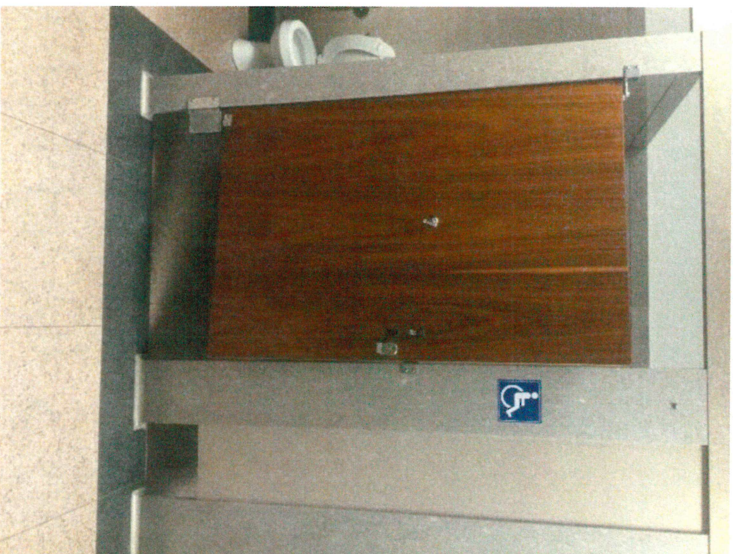
Ground Floor Senate Bathroom

- Another accessible stall wall?
- There is also a judicial wing bathroom accessible stall missing door signage, but it is on the stall wall
- Why is there no signage on the door, but a coat hanger is?
- Two judicial wing bathrooms have accessibility signage on the inside of the accessible stall door

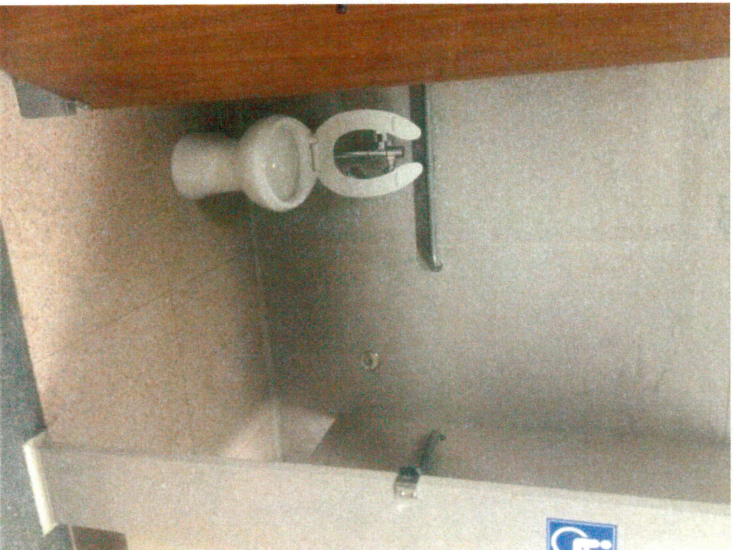
Ground Floor Senate Bathroom

- Looks like this was 2 stalls – wall with grab bar and toilet removed
- Reverse in, forward to close door, proceed to perhaps block the toilet, depending on need

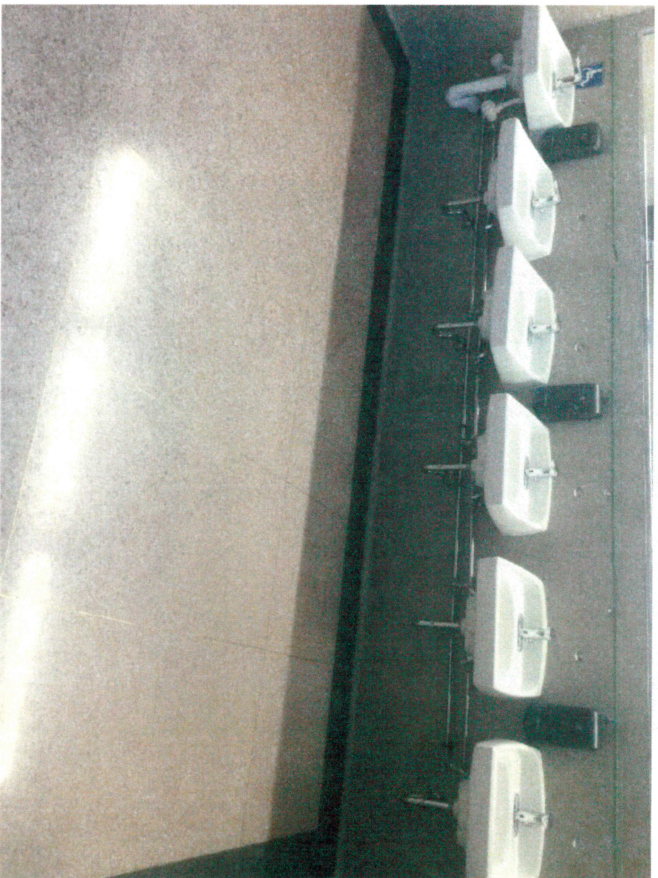
Ground Floor Senate Bathroom

- Accessible sink and soap dispenser
- Why not cover all sink plumbing?

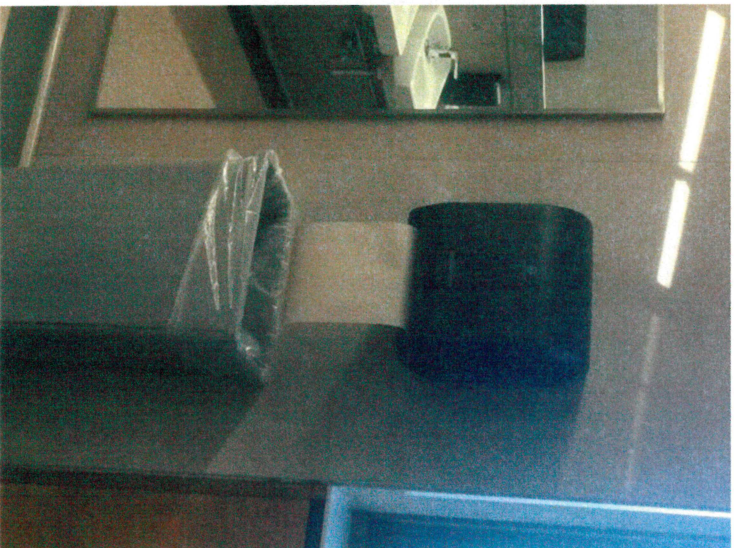
Ground Floor Senate Bathroom

- Most, if not all, bathrooms in the building have this paper towel dispenser
- Could not find ADA compliance documentation
- Why so far from accessible sink?

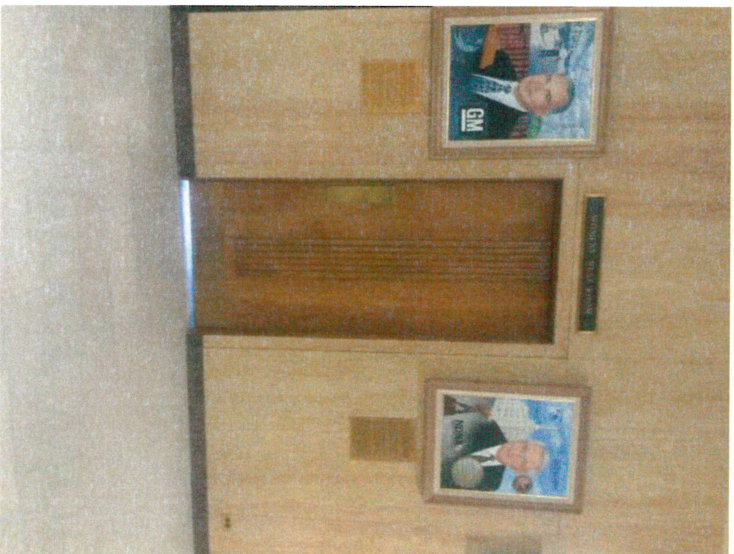
Ground Floor Women's Bathroom

- No accessibility signage

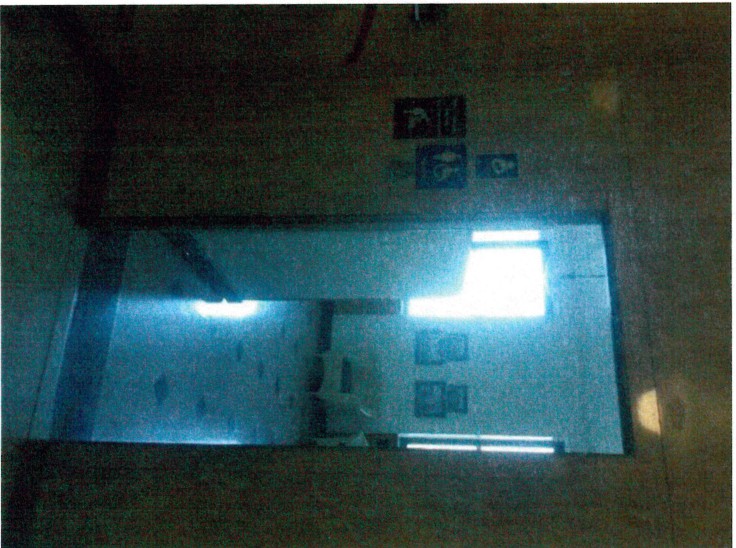
Ground Floor Women's Bathroom

- Why is the signage inside the second door?
- Signage is too high

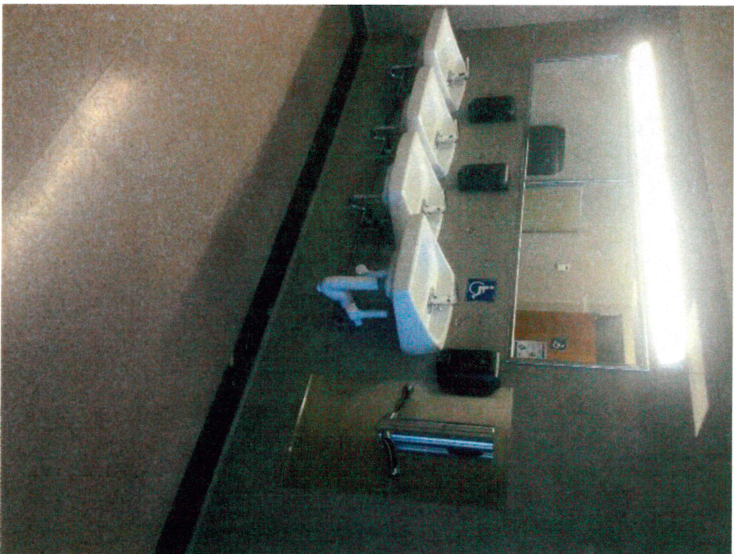
Ground Floor Women's Bathroom

- Good set up
- Cover all sink plumbing

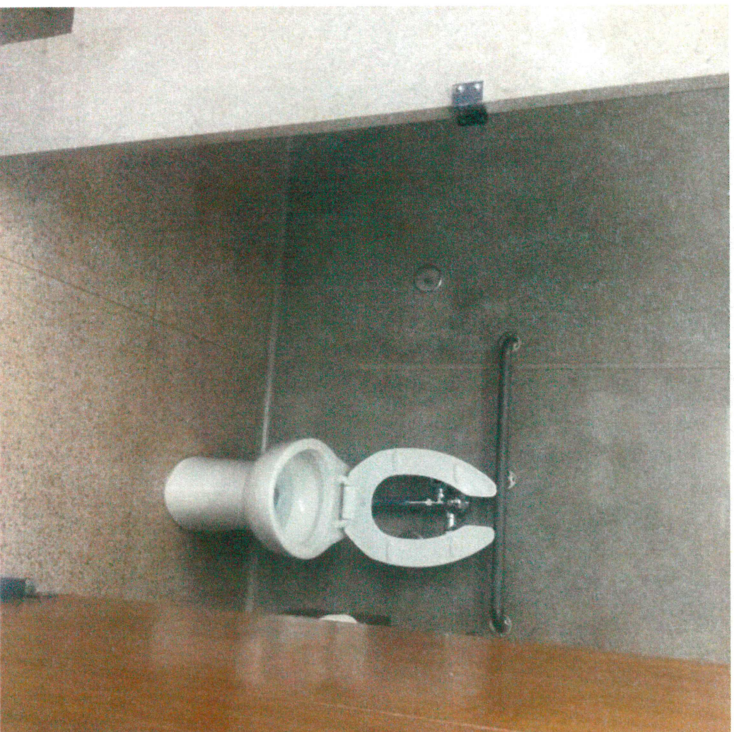
Ground floor Women's Bathroom

- Reverse in, and pull the door closed at the same time?
- What is with the gaps between the toilet and the grab bar?
- Ripping a stall out is not necessarily “accessible” or “compliant”

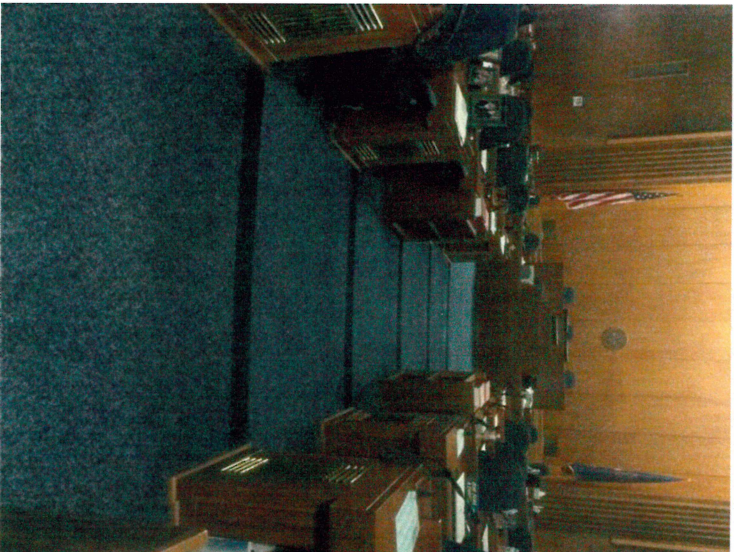
House Chamber

- Where are the ramps?
- There are none in the chamber
- The House and Senate chambers were not included in the “accessibility” study done by the architect hired by OMB

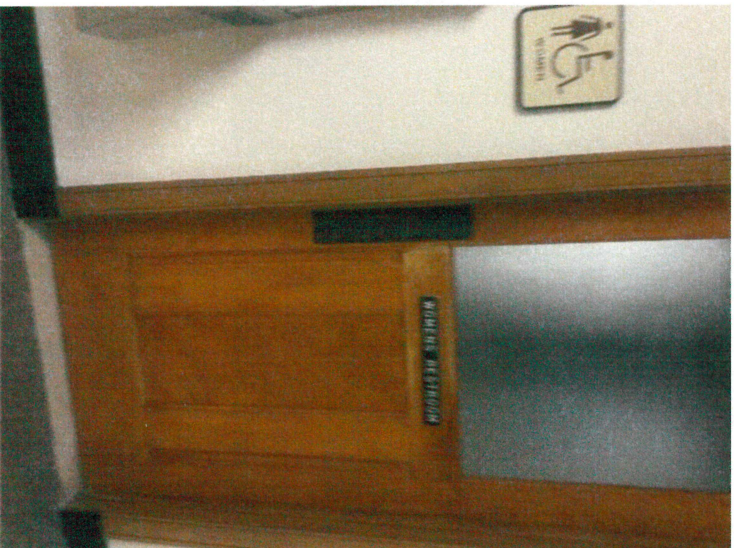
Executive Wing Department Floors 3-18

- Accessible signage for Executive wing bathrooms should be removed, as they will not be ADA compliant based on door width alone

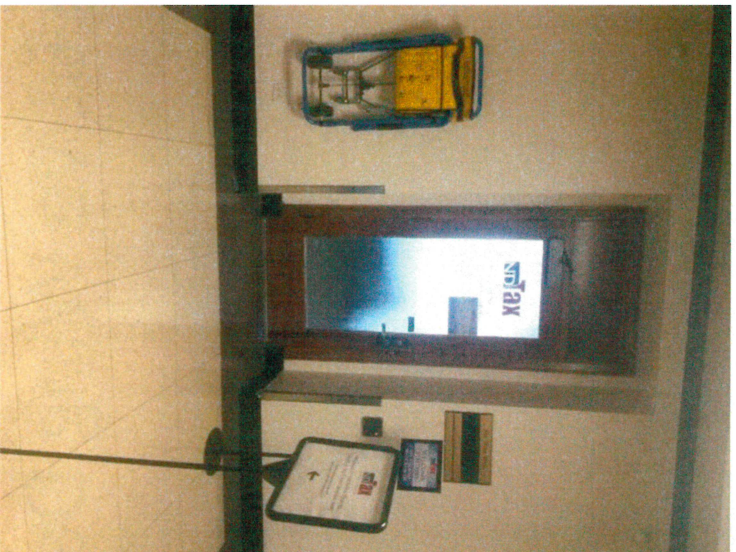
Executive Wing Department Floors 3-18

- Signage outside all department doors should be consistent and consider visually impaired
- Sign could be mobility impediment

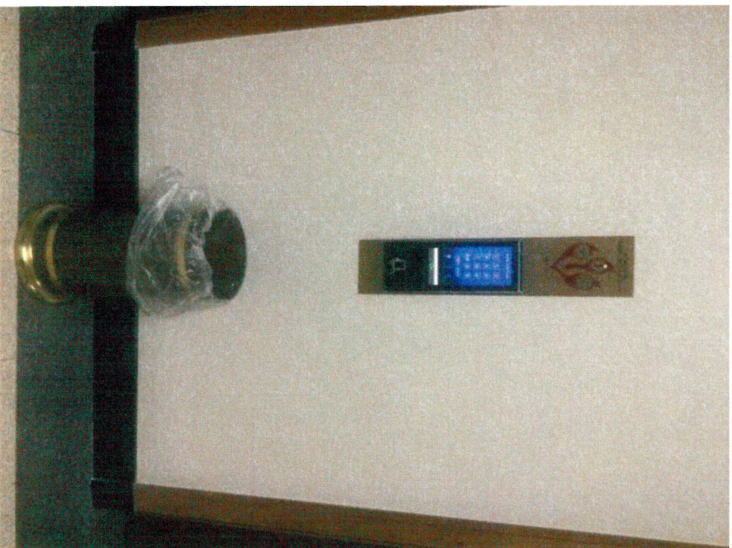
Executive Wing Department Floors 3-18

- Trash can blocking keypad access
- This occurs on multiple floors

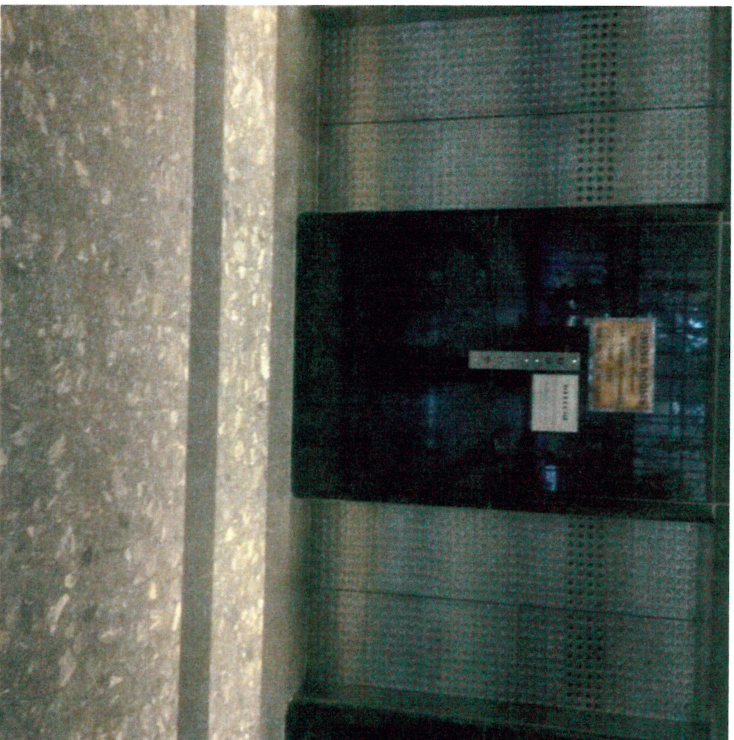
Judicial Wing Elevators

- No keypad
- No accessibility signage
- Poor signage
- Ironic, given this is the “accessible” wing
- Identical occurs on 1st, 2nd and 3rd judicial floors

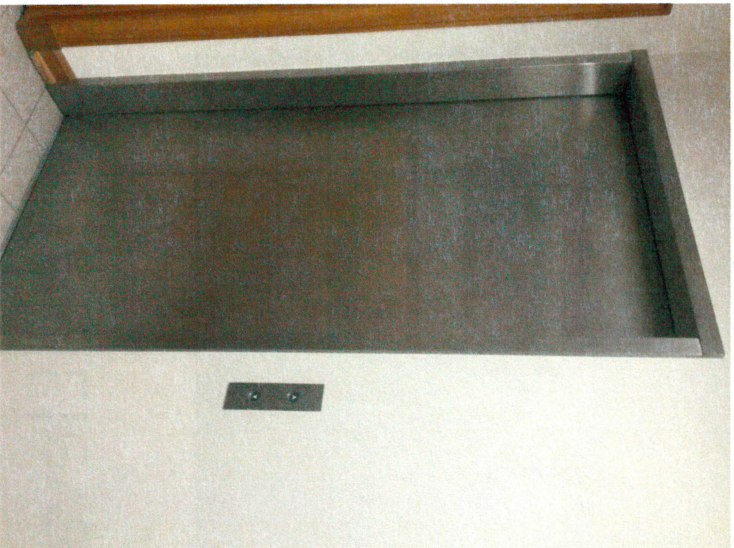
Senate Elevator – First Floor

- Ground, 1st, 2nd floors
- No accessibility signage
- No external signage on 1st floor

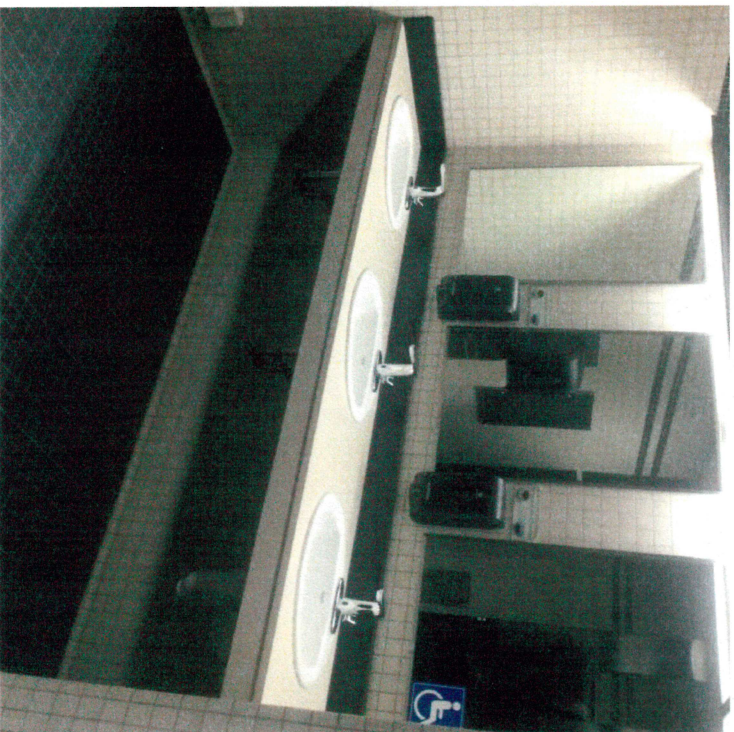
Judicial Wing – All Elevator Bathrooms

- Cannot access soap without water issue
- This is an issue in all Judicial wing bathrooms by the elevators
- Why not have soap on same wall as paper towels?
- Move a soap dispenser to wall where unused paper towel dispensers are?
- Cover sink plumbing

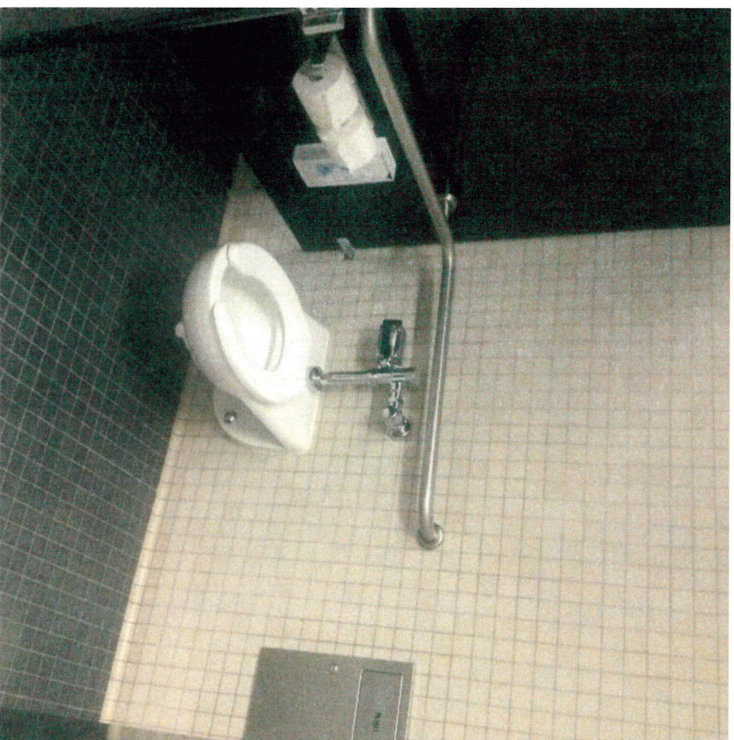
Judicial Wing – All “accessible” stalls

- Original grab bars
- Bar length should be longer so person won't be blocking toilet before transfer
- Vertical bar would help with this also
- All “accessible” judicial wing stalls have similar set up
- Most, if not all also have a coat hanger close to door lock, which could be a safety hazard and should be on the back of the stall door at an accessible height

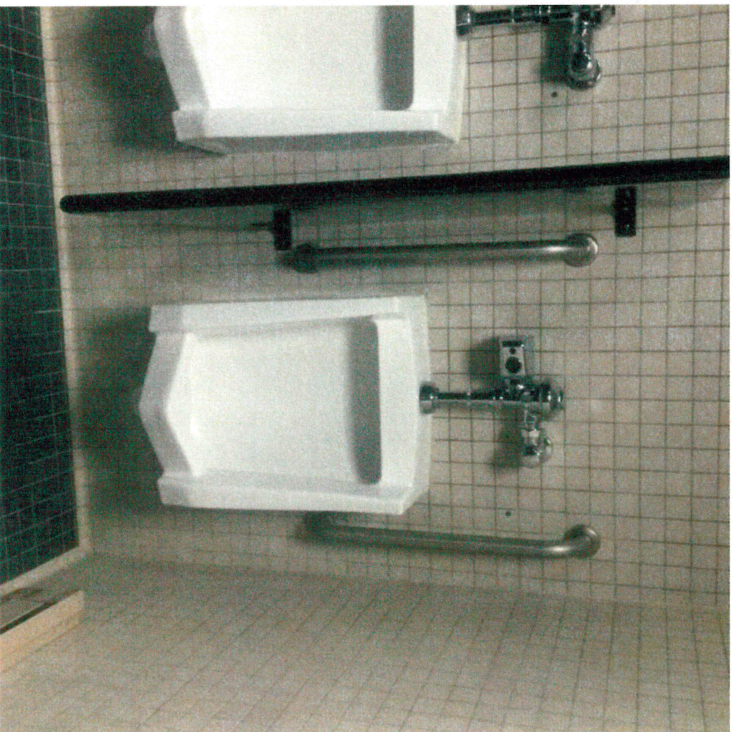
Judiciary Wing – “Accessible” urinal

- I do not understand how this can work sitting or standing with a mobility impairment
- Heat register changes access angle
- Similar lay out for all judicial wing “accessible” urinals

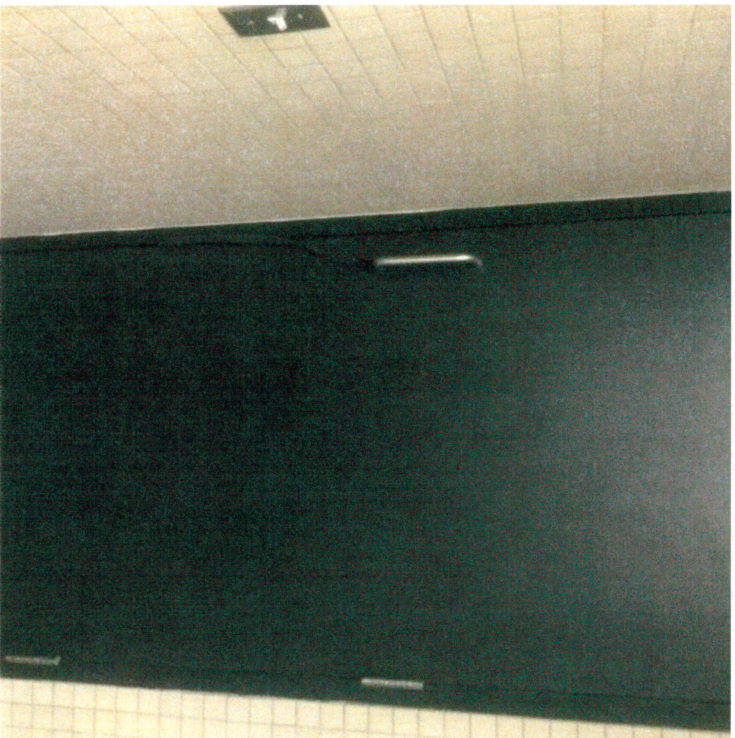
Judicial Wing – 1st and 2nd Inside bathrooms

- Difficult to open door with strap in a manual or powered wheelchair
- Need to reverse until there's enough room while still holding strap and driving chair
- How does a person hold the door open as far as they can, AND move through the door unassisted?
- Judicial wing 1st floor men's and women's, 2nd floor women's, not men's

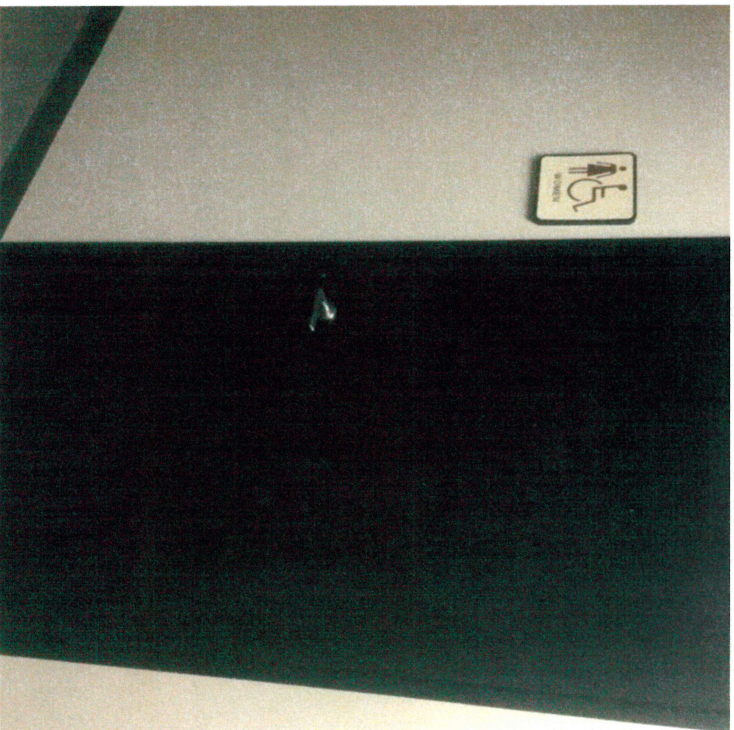
Judicial Wing – 1st Floor

- All 6 bathrooms inside Judicial wing halls have a “first” door with correct signage
- This first door does not meet 5 pound pressure limit standard, or the 3 second rule

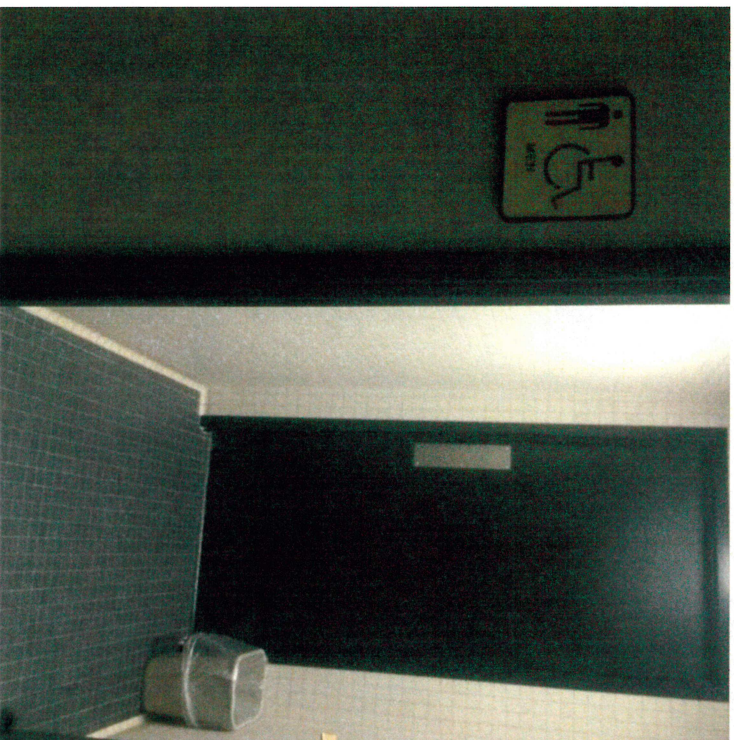
Judicial Wing – Hallway Bathrooms

- Door #2
- Occurs with all bathrooms inside Judicial wing hallways
- Trash can obstacle
- Easy to push door going in, may be difficult to open coming out due to counter location

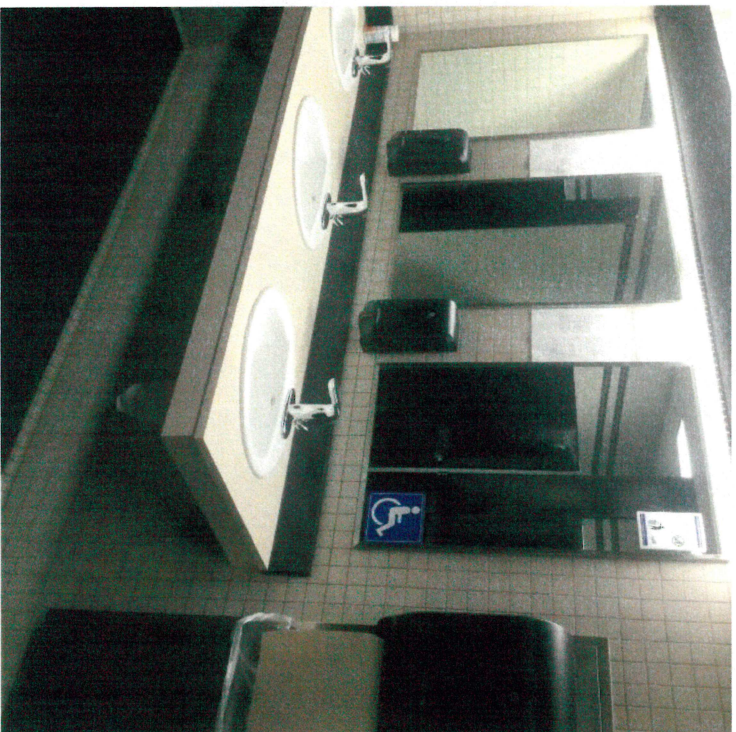
Judicial Wing – 2nd Floor

- Sink and paper towel setup inside all Judicial wing bathrooms
- Cover all sink plumbing

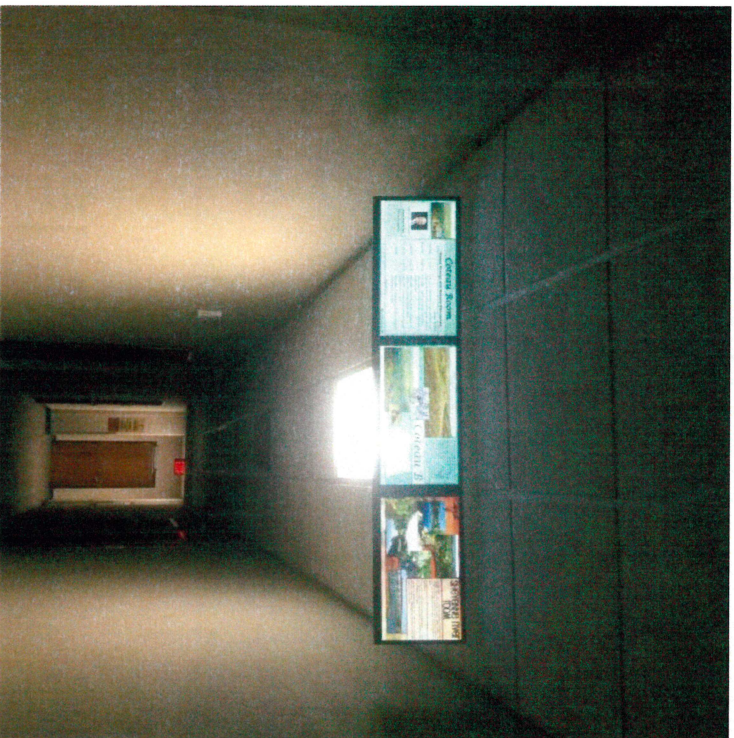
Sheyenne/Coteau Rooms – 1st Floor

- TV height is way too high
- This area is confusing, as there is poor signage
- Coteau is one room now, not two
- TVs next to rooms are at lower height

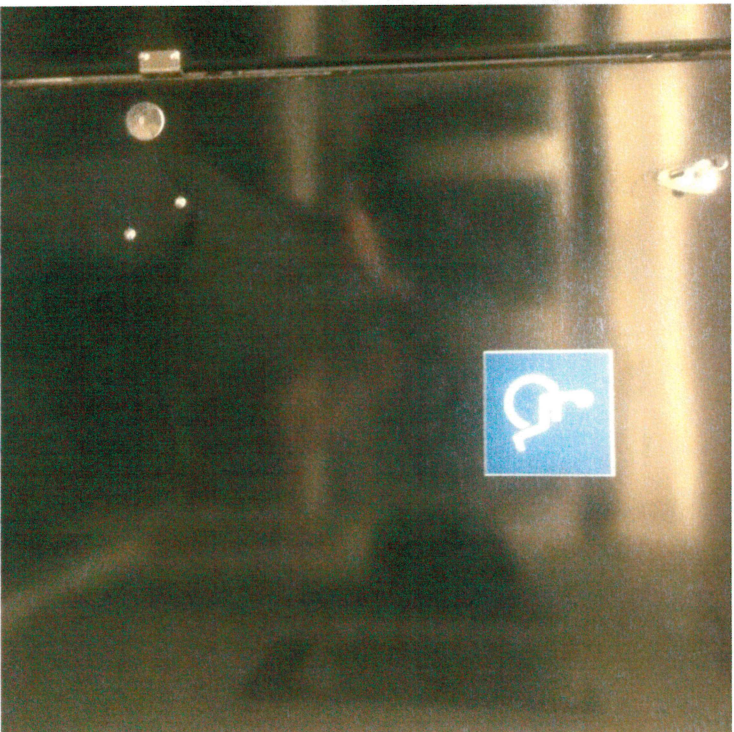
Judicial Wing – 1st Floor

- Missing door handle, but just think...you can hang your coat up, and not use the bathroom

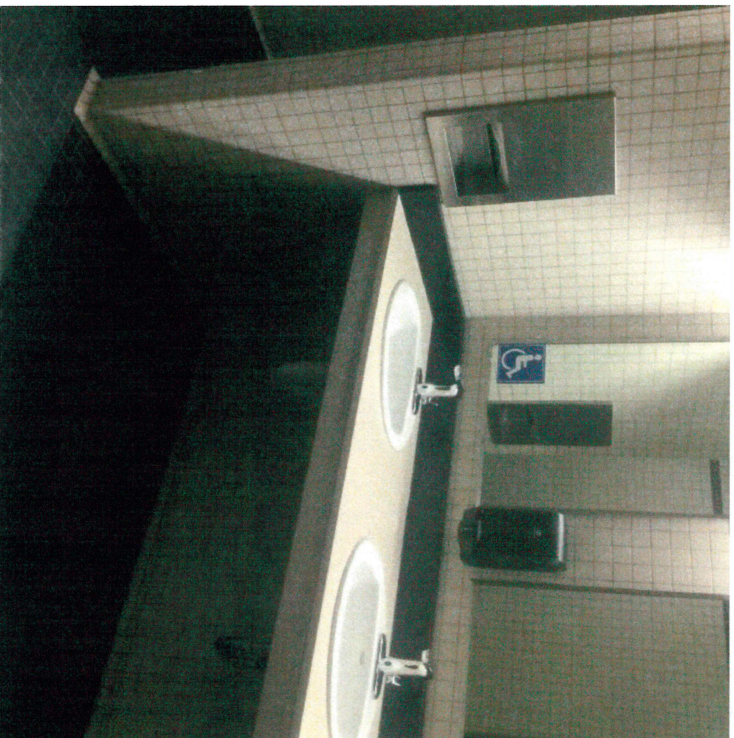
JWing – Ground Floor

- Move soap to paper towel dispenser to make it easier to reach
- Cover all sink plumbing

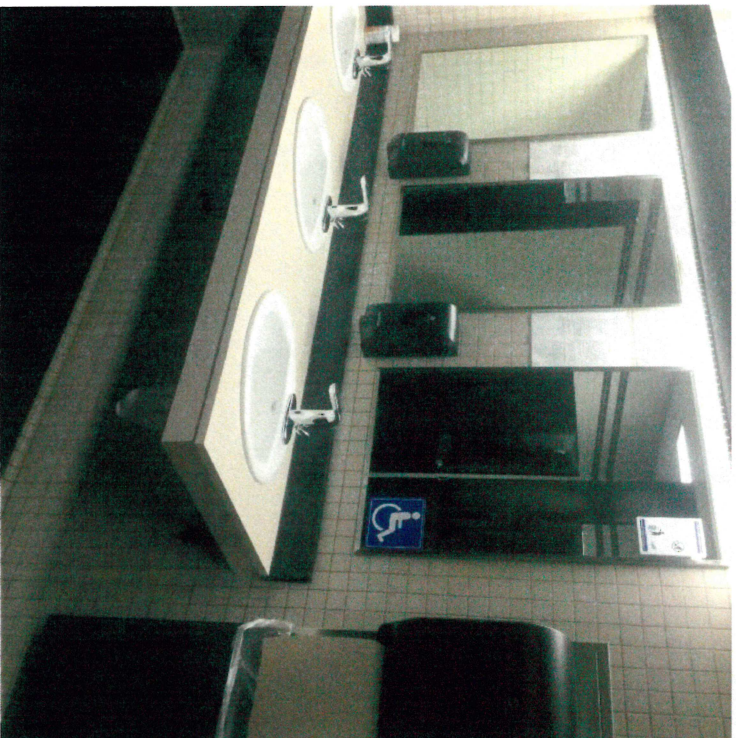
Judicial Wing – 2nd Floor

- This is the sink and paper towel setup inside all Judicial wing hall bathrooms
- Cover all sink plumbing

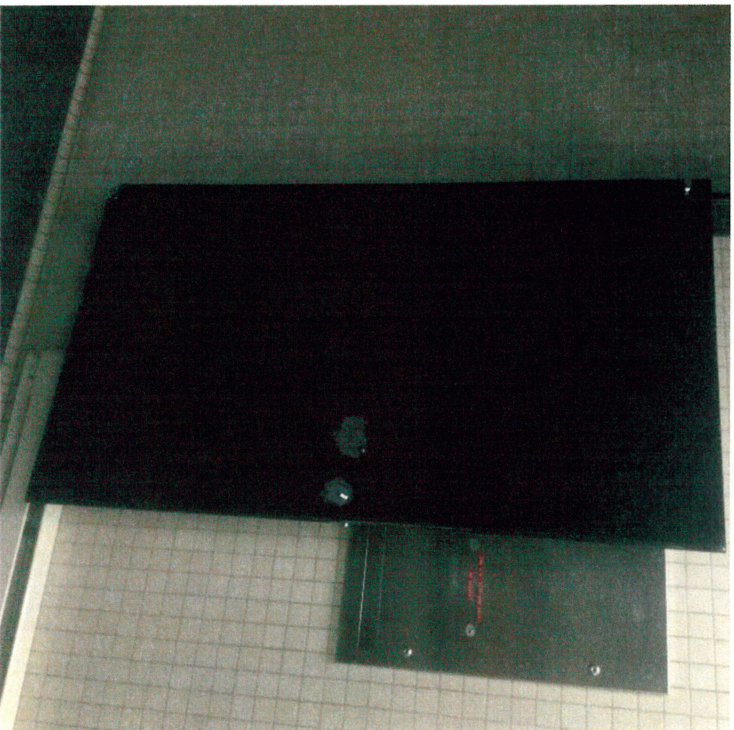
Judicial Wing – Women’s Ground Floor

- Missing door handle
- Put in request during 2019 session
- Also missing in women’s 1st floor Judicial wing bathroom

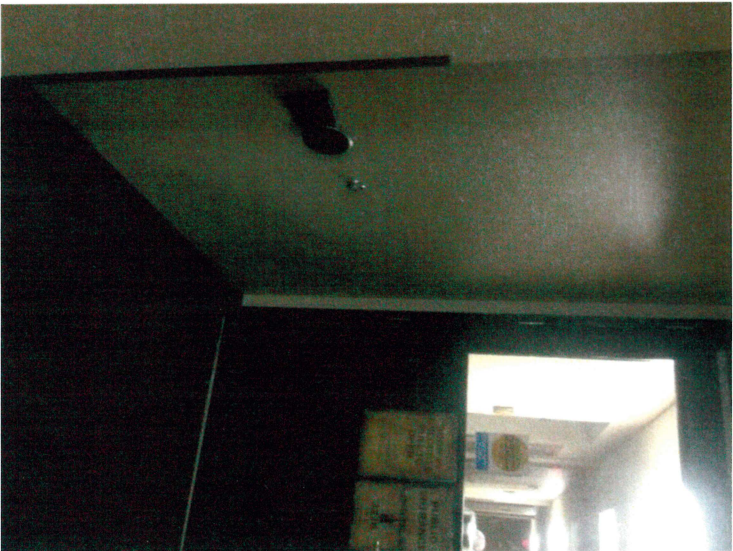
Judicial Wing – 3rd Floor

- Target (button) does not work on first contact – going in
- Random signage like door signage throughout this floor
