ADA Accessibility Assessment

Date: January 20, 2020; Updated July 16, 2020

Project: State Capitol Building ADA Review

J2 Studio Project No.: J21932

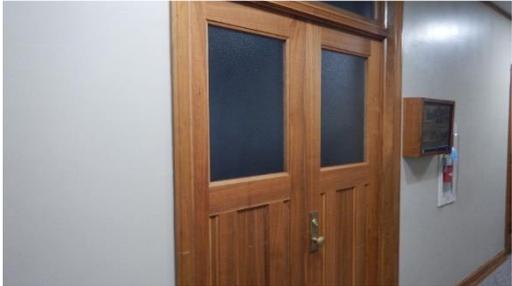
Room/Area	Accessibility Compliance Issue	
General Building Notes		
	<p>Lack of ADA/Braille Signage at Room Entrances (2010 ADA; Sections 216.1 and 703.5)</p> <p><i>Suggested Resolution: Install ADA/Braille signage throughout public areas of Capitol building. This would include doors to non-public spaces off public corridors and access points, as well as the Capitol tower elevator lobby.</i></p>

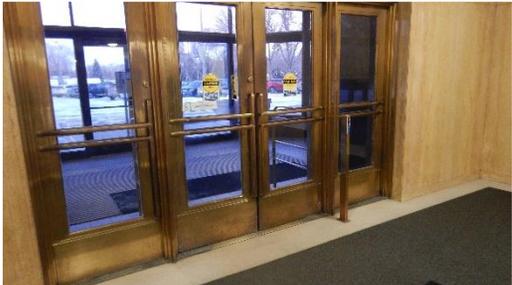
<p>Vestibule is too narrow for ADA accessibility. (2010 ADA; Section 404.2.6)</p> <p><i>Suggested Resolution: Both sets of doors should open at the same time, program operators for this function.</i></p>

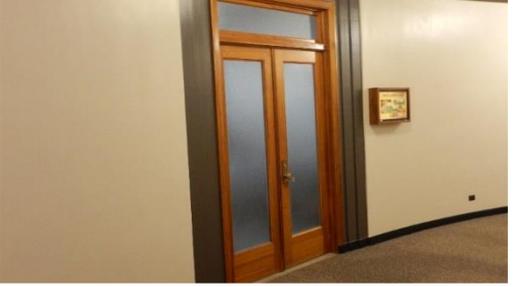
<p>Fort Lincoln Room</p>	<p>Clear width at double doors is too narrow if only one leaf is open (2 - 30" leaves) (2010 ADA; Section 404.2.3)</p> <p><i>Suggested Resolution: Both leaves need to be open at the same time. Doors suggested to be open during hearings (requires policy change). If doors need to be closed during hearings, two options:</i></p> <ul style="list-style-type: none"> - <i>Install operators at both doors</i> - <i>Install (1) 36" wide door, and 24" sidelight or fixed leaf in lieu of double doors.</i>

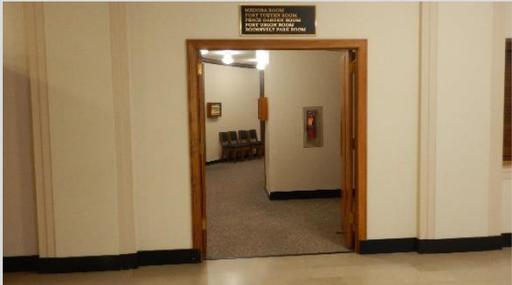
<p>Roosevelt Park Room</p>	<p>Clear width at double doors is too narrow if only 1 leaf open (2 - 30" leaves). (2010 ADA; Section 404.2.3)</p> <p><i>Suggested Resolution: Both leaves need to be open at the same time during hearings (Requires policy change). If doors need to be closed during hearings, two options:</i></p> <ul style="list-style-type: none"> - <i>Install operators at both doors</i> - <i>Install (1) 36" wide door, and 24" sidelight or fixed leaf in lieu of double doors.</i>

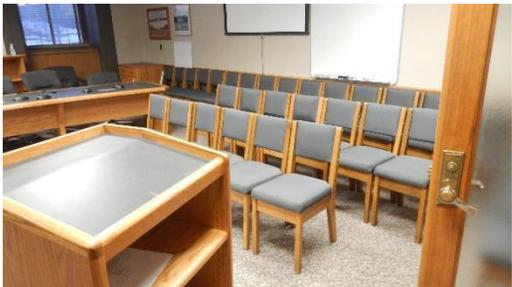
<p>Assisted Listening Devices are not available for use during hearings. (2010 ADA; Sections 216.10 and 219)</p>

<p><i>Suggested Resolution: Provide assistive listening devices in each assembly area where audible communication is integral to the use of the space, where audio amplification is provided. Rooms with capacity of less than 50 shall have 2, which shall also be hearing aid compatible.</i></p>	
<p>Fort Totten Room</p>	<p>Clear width at double doors is too narrow if only 1 leaf open (2 - 30" leaves). (2010 ADA; Section 40.4.2.3)</p> <p><i>Suggested Resolution: Both leaves need to be open at the same time during hearings (Requires policy change). If doors need to be closed during hearings, two options:</i></p> <ul style="list-style-type: none"> - <i>Install operators at both doors</i> - <i>Install (1) 36" wide door, and 24" sidelight or fixed leaf in lieu of double doors</i>

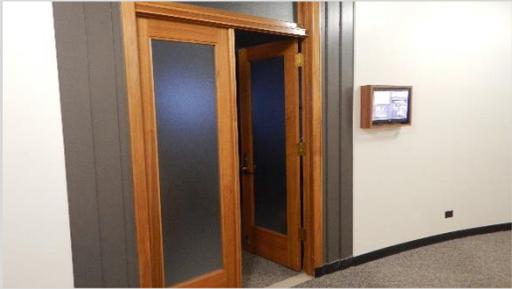
<p>Furniture is too close to doors and aisles. (2010 ADA; Sections 403.5.1 and 404.2.4)</p> <p><i>Suggested Resolution: Move chairs/furniture as required for accessibility during hearings.</i></p>

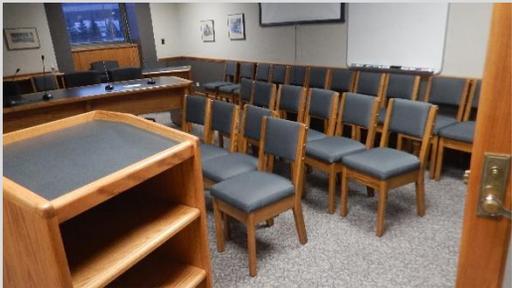
<p>Assisted Listening Devices are not available for use during hearings. (2010 ADA; Sections 216.10 and 219)</p> <p><i>Suggested Resolution: Provide assistive listening devices in each assembly area where audible communication is integral to the use of the space, where audio amplification is provided. Rooms with capacity of less than 50 shall have 2, which shall also be hearing aid compatible.</i></p>

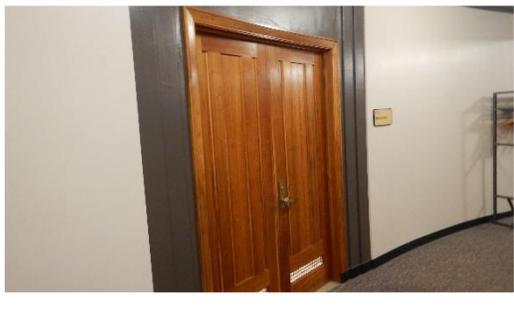
<p>Furniture is too close to doors and aisles. (2010 ADA; Sections 403.5.1 and 404.2.4)</p> <p>Suggested Resolution: <i>Move chairs/furniture as required for accessibility during hearings.</i></p>

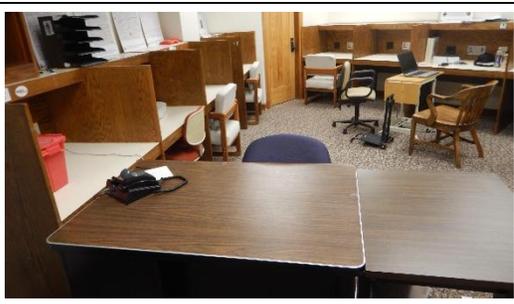
<p>Assisted Listening Devices are not available for use during hearings. (2010 ADA; Sections 216.10 and 219)</p> <p>Suggested Resolution: <i>Provide assistive listening devices in each assembly area where audible communication is integral to the use of the space, where audio amplification is provided. Rooms with capacity of less than 50 shall have 2, which shall also be hearing aid compatible.</i></p>

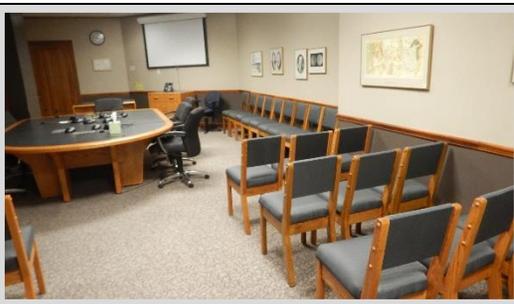
<p>Assisted Listening Devices are not available for use during hearings. (2010 ADA; Sections 216.10 and 219)</p>

<p><i>Suggested Resolution: Provide assistive listening devices in each assembly area where audible communication is integral to the use of the space, where audio amplification is provided. Rooms with capacity of less than 50 shall have 2, which shall also be hearing aid compatible.</i></p>	
<p>Women's Restroom (All at Ground Floor)</p>	<p>ADA stall is not deep enough with floor mounted toilet (58" deep, 59" required) (2010 ADA; Section 604.8.1.1)</p> <p><i>Suggested Resolution: Reconfigure restroom for ADA compliant stall.</i></p>

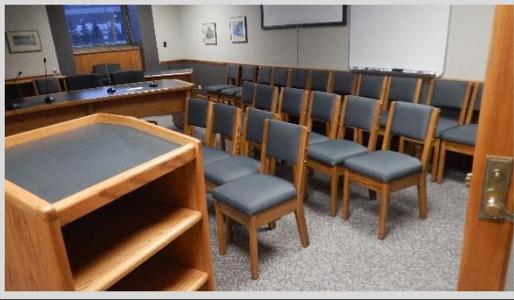
<p>Assisted Listening Devices are not available for use during hearings.</p>

<p>(2010 ADA; Sections 216.10 and 219)</p> <p><i>Suggested Resolution: Provide assistive listening devices in each assembly area where audible communication is integral to the use of the space, where audio amplification is provided. Rooms with capacity of less than 50 shall have 2, which shall also be hearing aid compatible.</i></p>	
Harvest Room	<p>Clear width at double doors is too narrow if only 1 leaf open (2 - 30" leaves) (2010 ADA; Section 404.2.3)</p> <p><i>Suggested Resolution: Both leaves need to be open at the same time during hearings (Requires policy change). If doors need to be closed during hearings, two options:</i></p> <ul style="list-style-type: none"> - <i>Install operators at both doors</i> - <i>Install (1) 36" wide door, and 24" sidelight or fixed leaf in lieu of double doors.</i>

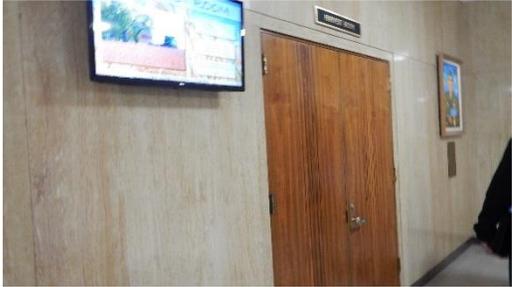
<p>Furniture is too close to doors and aisles. (2010 ADA; Sections 403.5.1 and 404.2.4)</p> <p><i>Suggested Resolution: Move chairs/furniture as required for accessibility during hearings.</i></p>

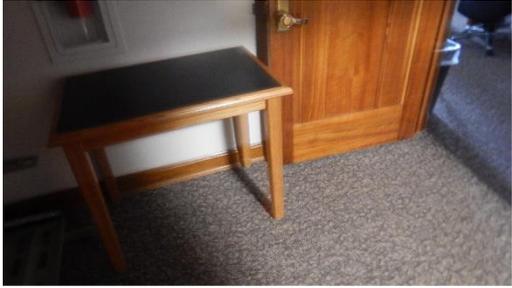
<p>Assisted Listening Devices are not available for use during hearings. (2010 ADA; Sections 216.10 and 219)</p> <p><i>Suggested Resolution: Provide assistive listening devices in each assembly area where audible communication is integral to the use of the space, where audio amplification is provided. Rooms with capacity of less than 50 shall have 2, which shall also be hearing aid compatible.</i></p>

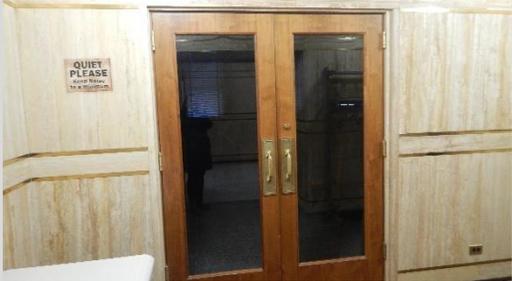
<p>Assisted Listening Devices are not available for use during hearings. (2010 ADA; Sections 216.10 and 219)</p> <p><i>Suggested Resolution: Provide assistive listening devices in each assembly area where audible communication is integral to the use of the space, where audio amplification is provided. Rooms with capacity of less than 50 shall have 2, which shall also be hearing aid compatible.</i></p>

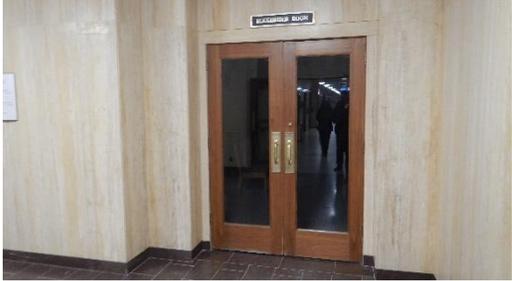
<p>Assisted Listening Devices are not available for use during hearings. (2010 ADA; Sections 216.10 and 219)</p> <p><i>Suggested Resolution: Provide assistive listening devices in each assembly area where audible communication is integral to the use of the space, where audio amplification is</i></p>

<p><i>provided. Rooms with capacity of less than 50 shall have 2, which shall also be hearing aid compatible.</i></p>	
<p>Red River Room</p>	<p>Door is noted to be hard to push/pull open. (2010 ADA; Section 404.2.9)</p> <p><i>Suggested Resolution: Verify force required for push/pull is 5 lbs. maximum. Adjust closer as required.</i></p>

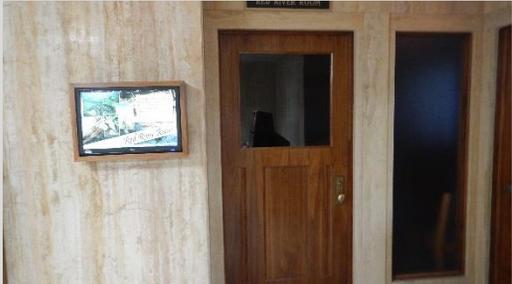
<p>Handle at door is noted to be a knob on the outside, but lever on the inside. (2010 ADA; Sections 309.4 and 404.2.7)</p> <p><i>Suggested Resolution: Replace existing knob or add modified lever to existing knob as required.</i></p>

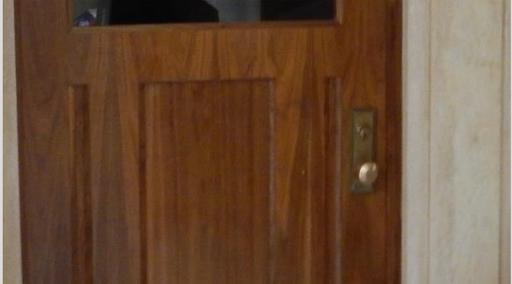
<p>Assisted Listening Devices are not available for use during hearings. (2010 ADA; Sections 216.10 and 219)</p> <p><i>Suggested Resolution: Provide assistive listening devices in each assembly area where audible communication is integral to the use of the space, where audio amplification is provided. Rooms with capacity of less than 50 shall have 2, which shall also be hearing aid compatible.</i></p>

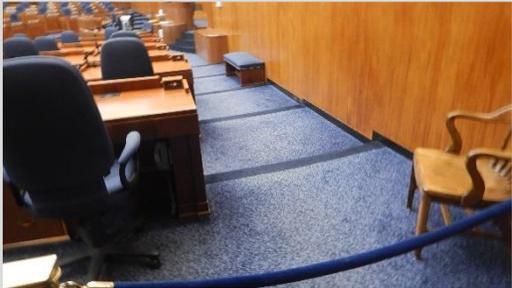
<p>Assisted Listening Devices are not available for use during hearings. (2010 ADA; Sections 216.10 and 219)</p> <p><i>Suggested Resolution: Provide assistive listening devices in each assembly area where audible communication is integral to the use of the space, where audio amplification is provided. Rooms with capacity of 51 shall be as follows:</i></p> <ul style="list-style-type: none"> - 51 to 200; 2 plus 1 per 25 seats over 50. 2 shall be hearing air compatible 201 to 500; 2 plus 1 per 25 seats over 50. 1 per 4 receivers shall be hearing aid compatible. 	
<p>Senate Chambers</p>	<p>Clear width at double doors is too narrow if only 1 leaf open (2 - 32" leaves) (2010 ADA; Section 404.2.3)</p> <p><i>Suggested Resolution: There are three options:</i></p> <ul style="list-style-type: none"> - Install operators at both doors - Reconfigure existing doors into one larger and one smaller leaf. One door shall be 36" wide. - Cut existing leaves to make (1) 36" wide opening and dowel.

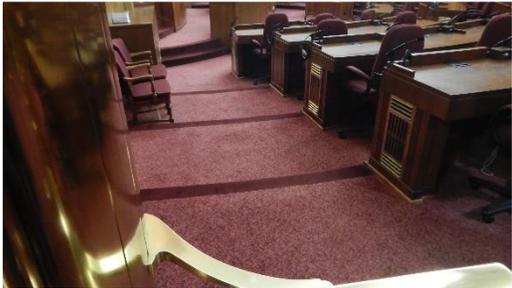
<p>Assisted Listening Devices are not available for use during hearings. (2010 ADA; Sections 216.10 and 219)</p> <p><i>Suggested Resolution: Provide assistive listening devices in each assembly area where audible communication is integral to the use of the space, where audio amplification is provided. Rooms with capacity of 51 shall be as follows:</i></p> <ul style="list-style-type: none"> - 51 to 200; 2 plus 1 per 25 seats over 50. 2 shall be hearing aid compatible - 201 to 500; 2 plus 1 per 25 seats over 50. 1 per 4 receivers shall be hearing aid compatible. - 	
2nd Floor Capitol Tower		
2 nd Floor Elevator Lobby	None noted.	
Prairie Room Lobby	<p>Clear width at double doors is too narrow if only 1 leaf open (2 - 32" leaves) (2010 ADA; Section 404.2.3)</p> <p><i>Suggested Resolution: There are three options:</i></p> <ul style="list-style-type: none"> - Install operators at both doors - Reconfigure existing doors into one larger and one smaller leaf. One door shall be 36" wide. - Leave doors in open position

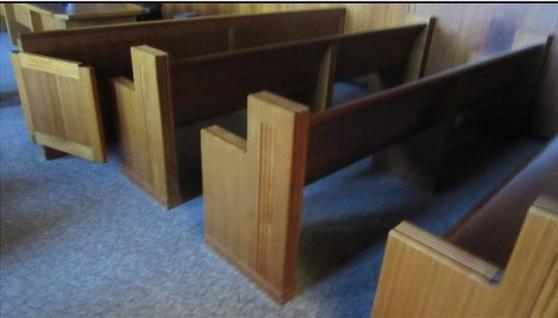
<p>Assisted Listening Devices are not available for use during hearings. (2010 ADA; Sections 216.10 and 219)</p> <p><i>Suggested Resolution: Provide assistive listening devices in each assembly area where audible communication is integral to the use of the space, where audio amplification is provided. Rooms with capacity of less than 50 shall have 2, which shall also be hearing aid compatible.</i></p>

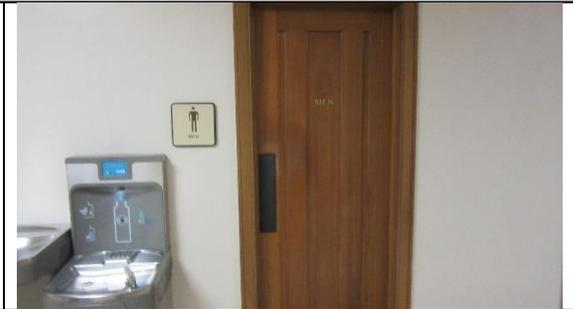
Restroom vestibule is too short and push/pull at doors is too narrow. (2010 ADA; Section 404.2.6 and 2010 ADA Section 404.2.4)

Suggested Resolution (vestibule): Remove interior vestibule door, frame and create opening larger than 32" clear.

Suggested Resolution (Door push/pull): Install handicap operator at new door leaf. Note: Recommend to convert 50% of the men and 50% of the women's restrooms to be ADA Compliant dispersed evenly in tower.

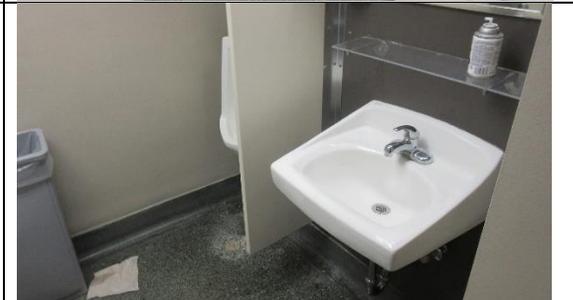
Sink Trap/Supply Exposed (2010 ADA; Section 606.5)

Suggested Resolution: Install trap/supply covers.

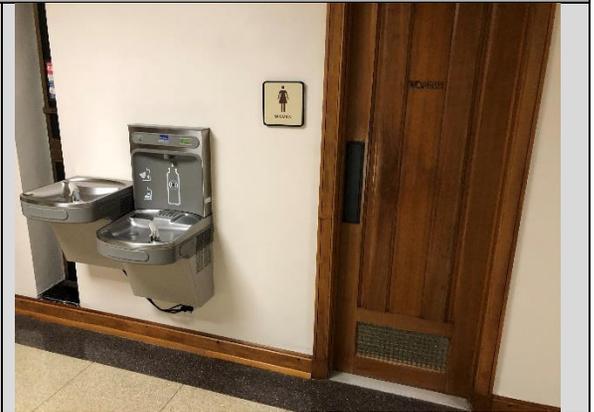
<p>Women's Restroom</p>	<p>Clear width at door is too narrow at both door in lobby and door in vestibule. (1 - 30" leaf) (2010 ADA; Section 404.2.3)</p> <p><i>Suggested Resolution:</i> <i>Install new 36" wide door at lobby entrance. Refer to suggested resolution below for push/pull and vestibule. Note: Recommend to convert 50% of the men's and 50% of the women's restrooms to be ADA Compliant dispersed evenly in tower.</i></p>

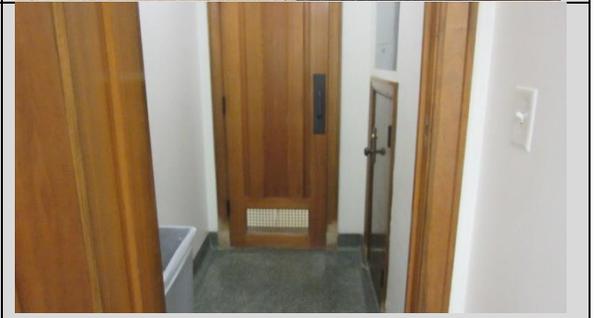
<p>Restroom vestibule is too short and push/pull at doors is too narrow. (2010 ADA; Section 404.2.6 and 2010 ADA Section 404.2.4)</p> <p><i>Suggested Resolution (vestibule): Remove interior vestibule door, frame and create opening larger than 32" clear.</i></p> <p><i>Suggested Resolution (Door push/pull): Install handicap operator at new door leaf.</i> <i>Note: Recommend to convert 50% of the men and 50% of the women's restrooms to be ADA Compliant dispersed evenly in tower.</i></p>

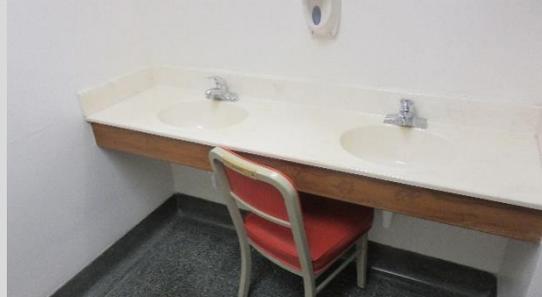
<p>Sink Trap/Supply Exposed. (2010 ADA; Section 606.5)</p> <p><i>Suggested Resolution: Install trap/supply covers.</i></p>

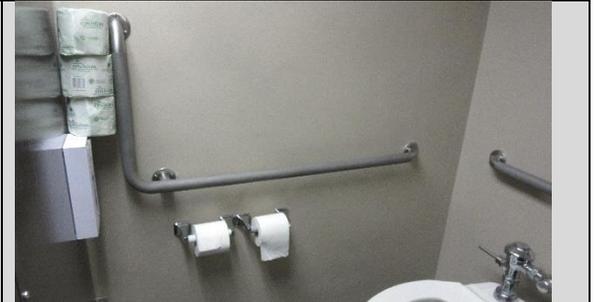
<p>Women's Restroom (Labeled ADA)</p>	<p>Grab bars do not meet ADA guidelines (lengths are not correct and no vertical bar) <i>(2010 ADA; Section 604.5)</i></p> <p><i>Suggested Resolution: Install (1) 42" long grab bar and (1) 18" tall grab bar vertically beside toilet, and (1) 36" long grab bar behind toilet.</i></p>

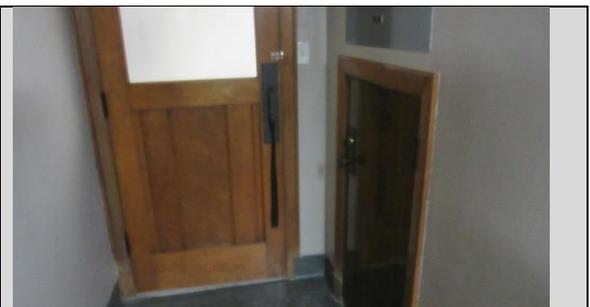
<p>Push/pull at doors is too narrow. (2010 ADA Section 404.2.4)</p> <p><i>Suggested Resolution (Door push/pull): Install handicap operator at new door leaf.</i></p>

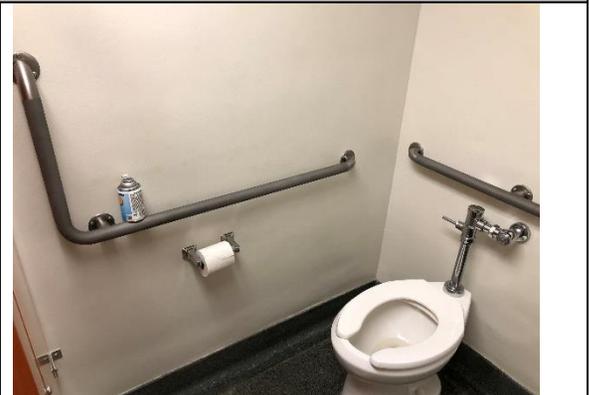
<p>Men's Restroom</p> <p>(Labeled ADA)</p>	<p>Grab bars do not meet ADA guidelines (lengths are not correct and no vertical bar) (2010 ADA; Section 604.5)</p> <p><i>Suggested Resolution: Install (1) 42" long grab bar and (1) 18" tall grab bar vertically beside toilet, and (1) 36" long grab bar behind toilet.</i></p>

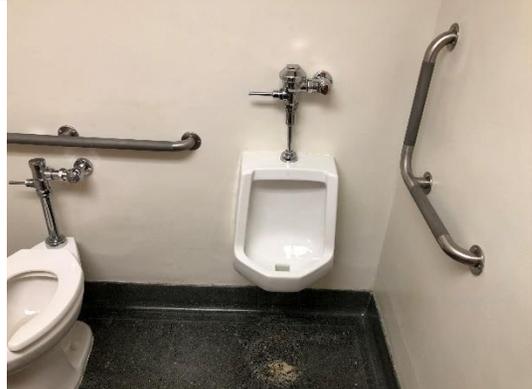
<p>Urinal installed adjacent to water closet does not allow water closet to meet required clearances.</p> <p><i>Suggested Resolution: Remove urinal and create single stall toilet room.</i></p>

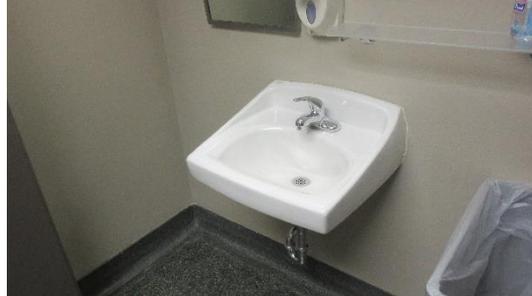
<p>Sink Trap/Supply Exposed. (2010 ADA; Section 606.5)</p> <p><i>Suggested Resolution: Install trap/supply covers.</i></p>

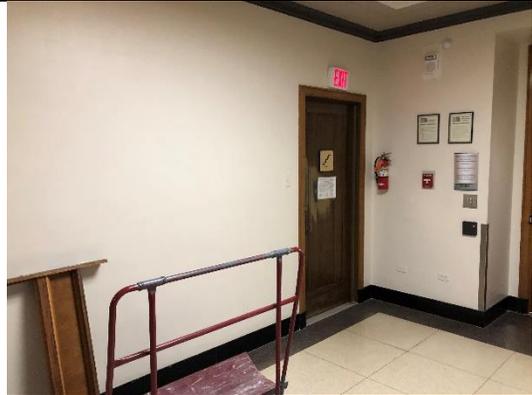
<p>Sink Trap/Supply Exposed. (2010 ADA; Section 606.5)</p> <p><i>Suggested Resolution: Install trap/supply covers.</i></p>	
13th Floor Capitol Tower		
Lobby	<p>Locksets is a knob and should be lever for ADA accessibility. (2010 ADA; Sections 309.4 and 404.2.7)</p> <p><i>Suggested Resolution: Replace existing knob or add modified levers to existing knob as required.</i></p>

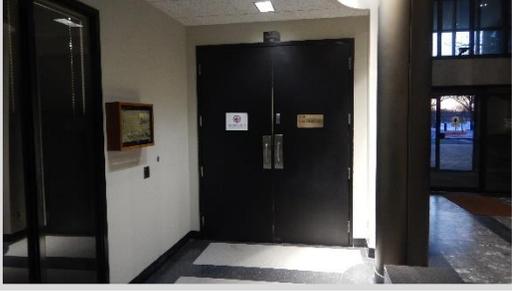
<p>Door is noted to be hard to push/pull open. (2010 ADA; Section 404.2.9)</p> <p><i>Suggested Resolution: Verify force required for push/pull is 5 lbs. maximum.</i></p>

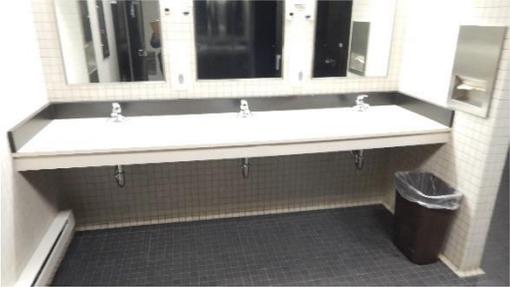
<p>Men's Restroom (First Floor Floor)</p>	<p><i>Suggested Resolution: Provide assistive listening devices in each assembly area where audible communication is integral to the use of the space, where audio amplification is provided. Rooms with capacity of 51 shall be as follows:</i></p> <ul style="list-style-type: none"> - 51 to 200; 2 plus 1 per 25 seats over 50. 2 shall be hearing air compatible 201 to 500; 2 plus 1 per 25 seats over 50. - 1 per 4 receivers shall be hearing aid compatible. 	
	<p>Sink Trap/Supply Exposed (2010 ADA; Section 606.5)</p> <p><i>Suggested Resolution: Install trap/supply covers.</i></p>

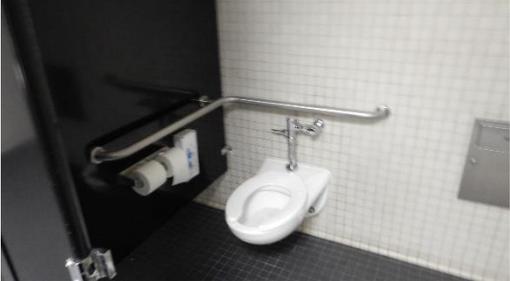
<p>Men's Restroom (First Floor Floor) Women's Restroom (First Floor)</p>	<p>Grab bars do not meet ADA guidelines (lengths are not correct and no vertical bar) (2010 ADA; Section 604.5)</p> <p><i>Suggested Resolution: Install (1) 42" long grab bar and (1) 18" tall grab bar vertically beside toilet, and (1) 36" long grab bar behind toilet.</i></p>

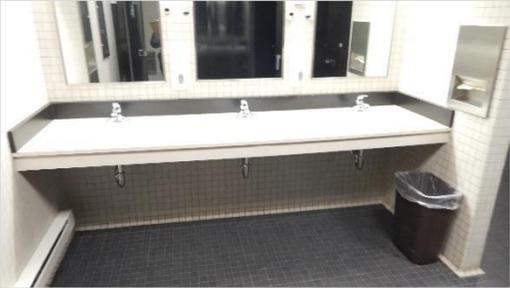
<p>Sink Trap/Supply Exposed (2010 ADA; Section 606.5)</p> <p><i>Suggested Resolution: Install trap/supply covers.</i></p>

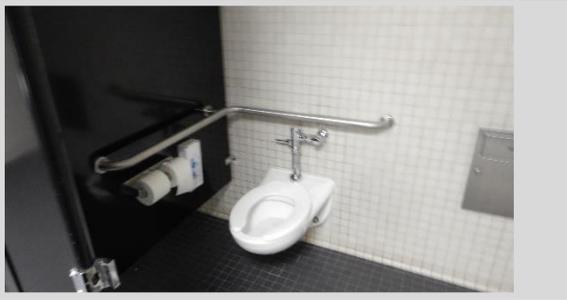
<p>Women's Restroom (First Floor) Supreme Court Conference Rooms</p>	<p>Grab bars do not meet ADA guidelines (lengths are not correct and no vertical bar) (2010 ADA; Section 604.5)</p> <p><i>Suggested Resolution: Install (1) 42" long grab bar and (1) 18" tall grab bar vertically beside toilet, and (1) 36" long grab bar behind toilet.</i></p>

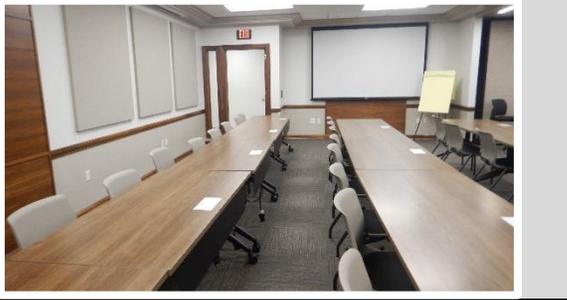
<p>Furniture is too close to doors and aisles. (2010 ADA; Sections 403.5.1 and 404.2.4)</p> <p><i>Suggested Resolution: Move chairs/furniture as required for accessibility during hearings.</i></p>

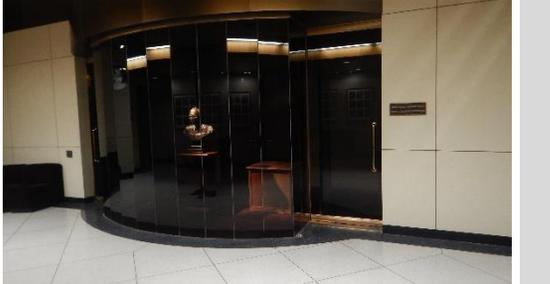
Supreme Court	<p>Doors are noted to be hard to push/pull open. (2010 ADA; Section 404.2.9)</p> <p><i>Suggested Resolution: Verify force required for push/pull is 5 lbs. maximum. Adjust closer as required. Install operator on at least one door for accessibility.</i></p>

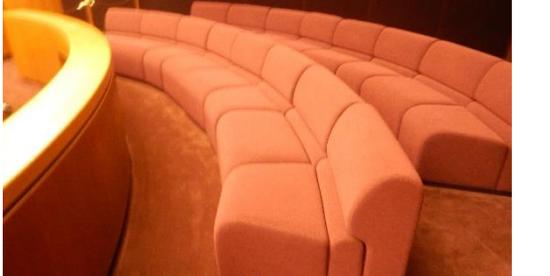
Supreme Court Secretary of State Office	<p>Furniture is too close to doors and aisles. (2010 ADA; Sections 403.5.1 and 404.2.4)</p> <p><i>Suggested Resolution: Move chairs/furniture as required for accessibility during hearings.</i></p>

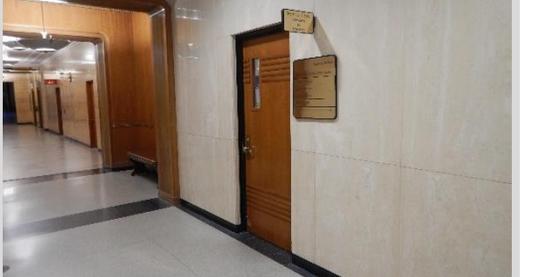
<p>Doors are noted to be hard to push/pull open. (2010 ADA; Section 404.2.9)</p> <p><i>Suggested Resolution: Verify force required for push/pull is 5 lbs. maximum. Adjust closer as required.</i></p>
